# LANGLADE COUNTY U.S. PUBLIC LAND CORNER RESTORATION

The Southeast corner of Section 30, T. 30 N., R. 11 E., Langlade County, WI.

Index No. 30-11 <sup>V5</sup>

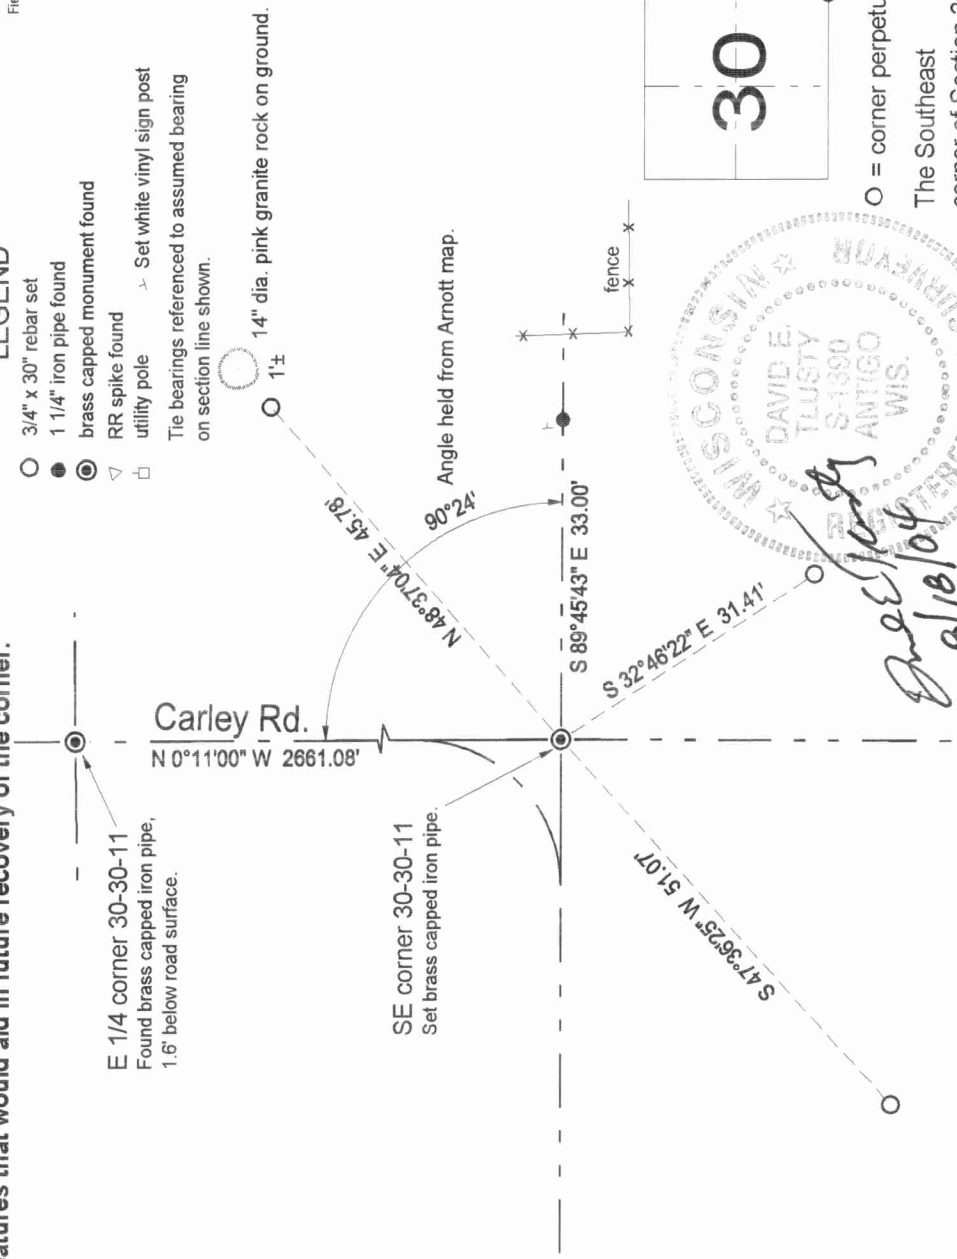
- Field book: FB10-66
- 3/4" x 30" rebar set
  - 1 1/4" iron pipe found
  - brass capped monument found
  - RR spike found
  - utility pole
  - Set white vinyl sign post
- Tie bearings referenced to assumed bearing on section line shown.

For the corner, I set a Berritsen Deep1 magnet, 4' below ground. I then re-stamped and re-set the monument (a 1 1/4" (ID) x 36" iron pipe with a 4" dia. brass cap bolted to the top) previously set by Arnott which had been removed and was found leaning against a nearby power pole. The top of the re-set monument is 0.6' below ground.
