# U. S. PUBLIC LAND SURVEY MONUMENT RECORD

NORTHEAST CORNER SECTION 4-30-12

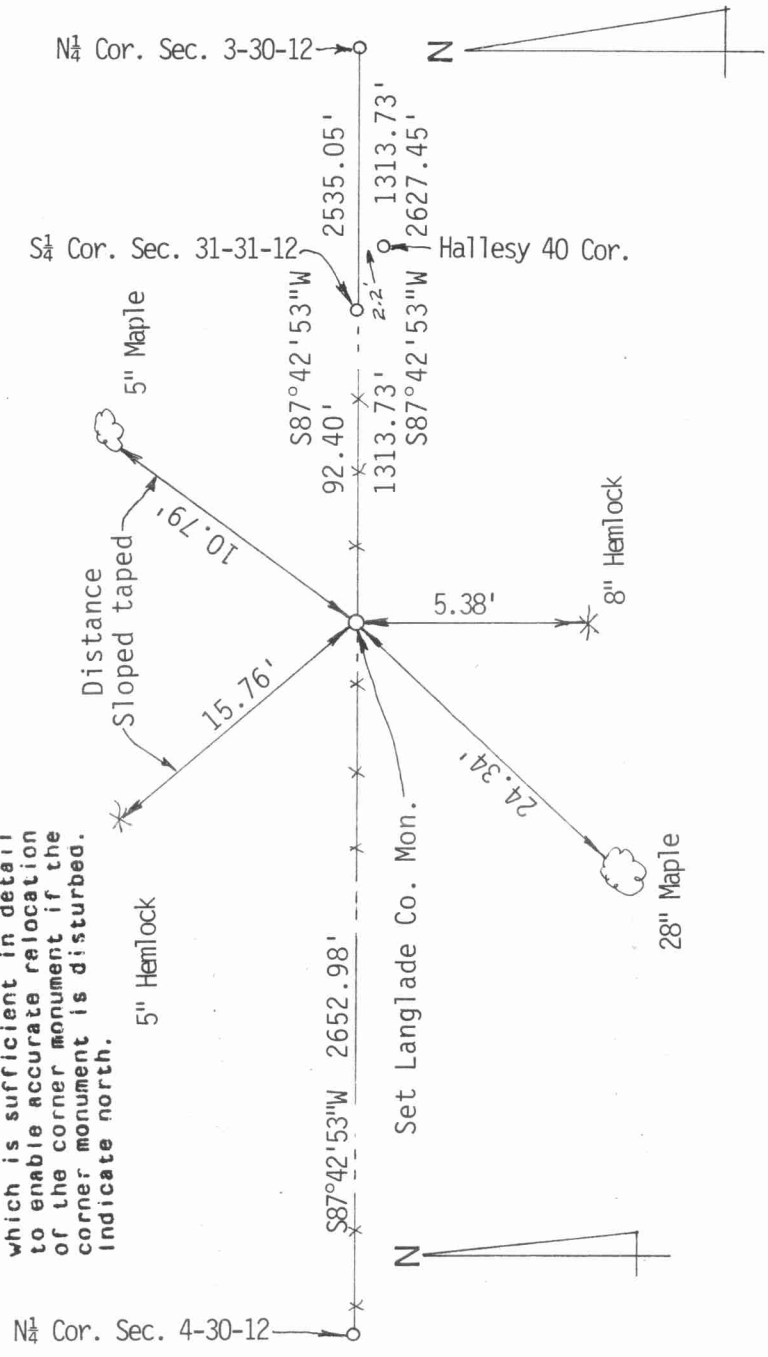
This corner was not on record. The only reference I found was to original Cedar Stake set by James Marsh in 1851. Traversed to area, found existing Langlade County Monument sticking 2' out of ground, leaning Northerly. There were 4 trees blazed around corner, and by growth on blazes, I would estimate the corner was set 5-10 years ago. There are no recorded, or unrecorded surveys tied to this corner. Removed corner from ground, dug new hole, deeper, and set on line from SW Cor. Sec. 31-31-12 to N $\frac{1}{4}$  Cor. Sec. 3-30-12. Set at doubled "40" distance from East, from 40 corner set by Hallsey. Put 60D nails in blazes, measured to head of nails. Due to steep bank corner is on, some tie distances (as shown) are slope taped. Painted ties and corner yellow.

NOTE: All trees blazed with 60D Nail. Distance to head of nail.

NONE, Existing Monument was leaning over on steep slope. Hard to determine where it was originally set. I moved it approximately 1.2 East, and 0.6 South.
