U. S. PUBLIC LAND SURVEY MONUMENT RECORD

The Southwest corner of Section 19, Township 32 North, Range 10 East, Langlade County, Wisconsin.

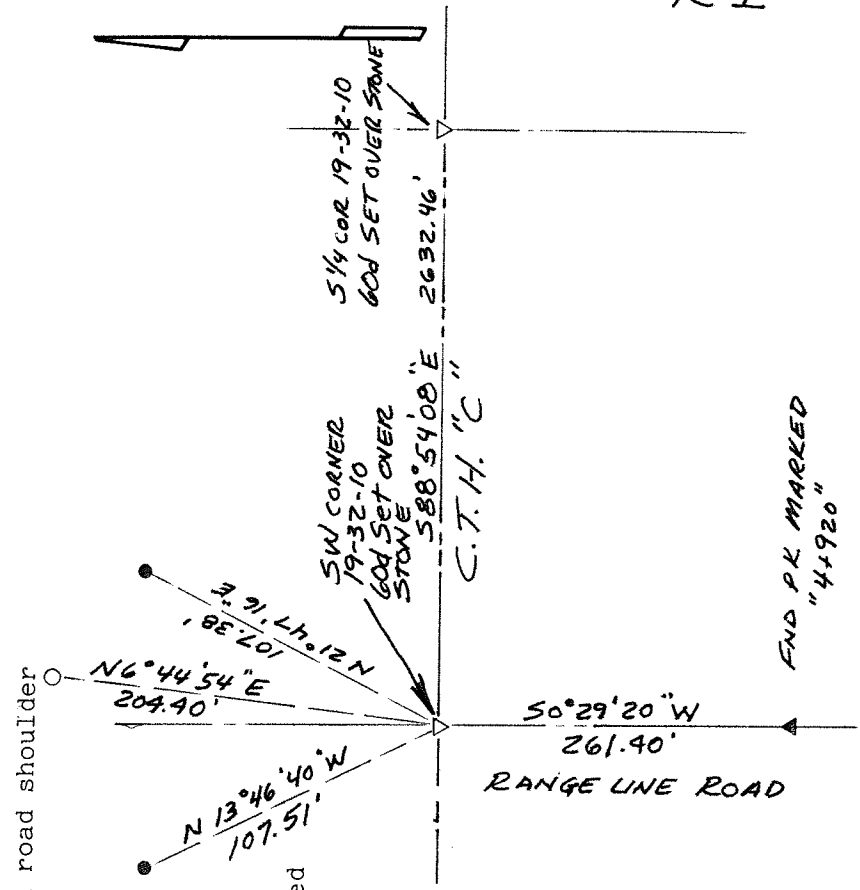
- (c) In the plan view drawing below, provide reference ties to at least 4 witness monuments, or, if the location is within a municipality, to at least 2 witness monuments. (Witness monuments shall be made of concrete, natural stone, iron or other equally durable material).
 Describe witness monuments.
 ● = 3/4" iron pipe found
 ○ = 3/4" x 30" re-bar set in road shoulder
 FB 4-102

Stone found is 1.50 feet SW of the corner marked by Kelly.
