# LANGLADE COUNTY U.S. PUBLIC LAND CORNER RESTORATION

The East quarter corner of Section 12, T. 33 N., R. 8 E., Lincoln County, WI.  
The West quarter corner of Section 7, T. 33 N., R. 9 E., Langlade County, WI.

Index No. G1 33-09

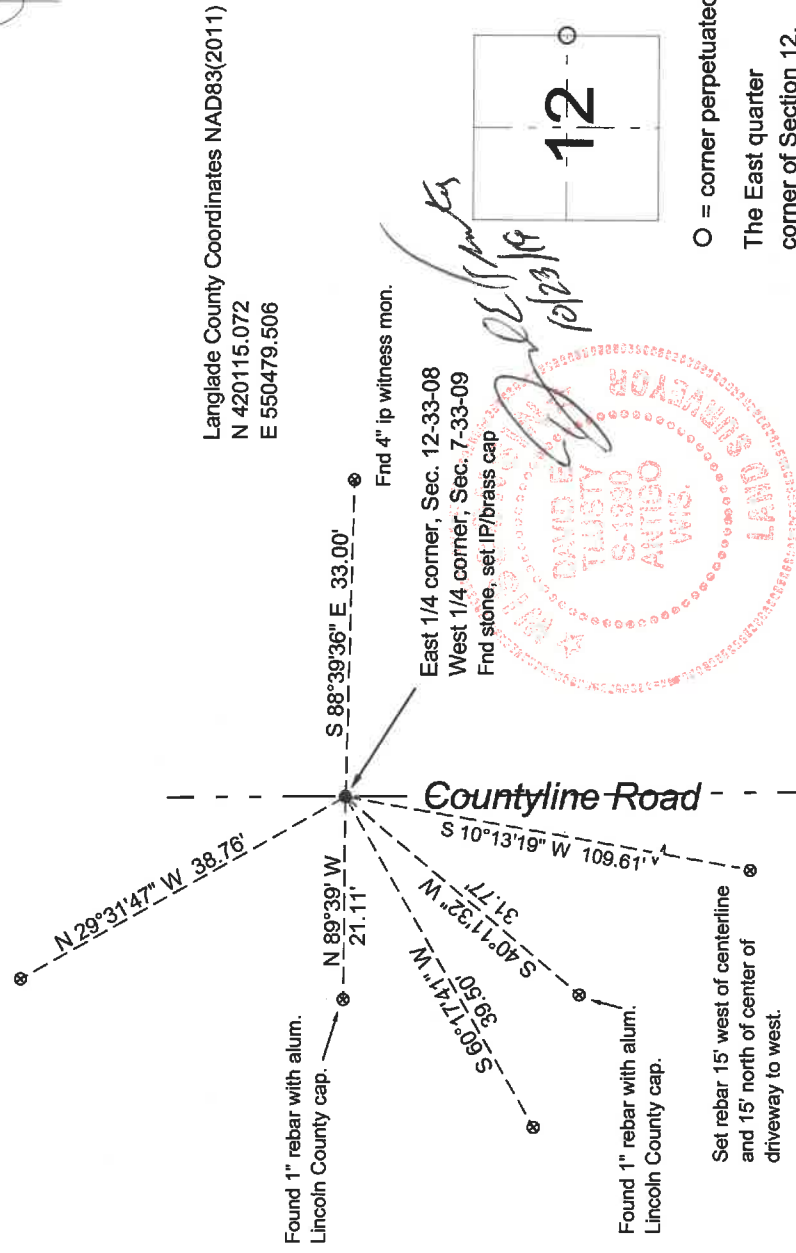
11/02/16 D. Tlusty found an aluminum monument and magnet. Top is broken off and monument leans to the south approximately 0.6'. I removed the damaged aluminum monument, dug wider and deeper and found a 7" x 7" x 22" granite stone lying on its side, to the west of the aluminum monument. Found no evidence of a field stone mentioned by Kelly. On the south end of the granite stone, I found a chiseled diagonal groove, which I believe was the top of the stone. The north end of the granite appears to be the base, and at a straightened position for the granite stone and at 33 feet west of the still solid and upright 1938 witness monument, I set the monument described below as the true position for the quarter corner.

At the corner location described above, I set a 2" x 30" galvanized flanged bottom iron pipe with brass cap, top of which is 0.9' below road surface. I set and measured witness monuments as shown below.
