SURVEY MONUMENT RECORD PUBLIC LAND U.S.

1/4 corner sec. 17 and 18 T33N, R11E

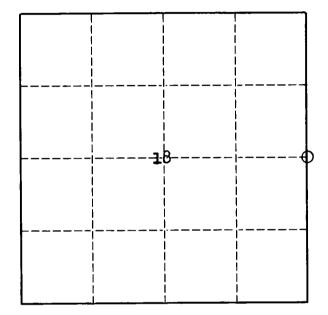
Monument was set by the C.C.C. in the 1930's. It was pulled out of the ground and buried during the construction of H'way "45" about 30 years ago. In searching I found the monument out of the ground and buried about 3" underground. I doubled the distance from the section corner to the south and the S1/16 corner and was able to locate a small possible afea for it. In futher digging I found the rock used for the tie from the 1930's survey. The rock had a cross-cut on the top and the monument was 1.4° north of the rock. When we dug in the monument we found rust from the monument when it was originally in the hole. The 4" steel pipe filled with concrete with a brass cap was set back in place.

6" maple 54'z to center H'way "45"monument reset

Orig. rock

sign with steel

post 1.5' west

Spruce

8" Maple

Red Pine

Same place.
