# U.S. PUBLIC LAND SURVEY MONUMENT RECORD

The East 1/4  
corner of Section 14  
T.33N., R. 12E.,  
Langlade County, WI

PLSS field condition report

Section 14 Town 33N Range 12E

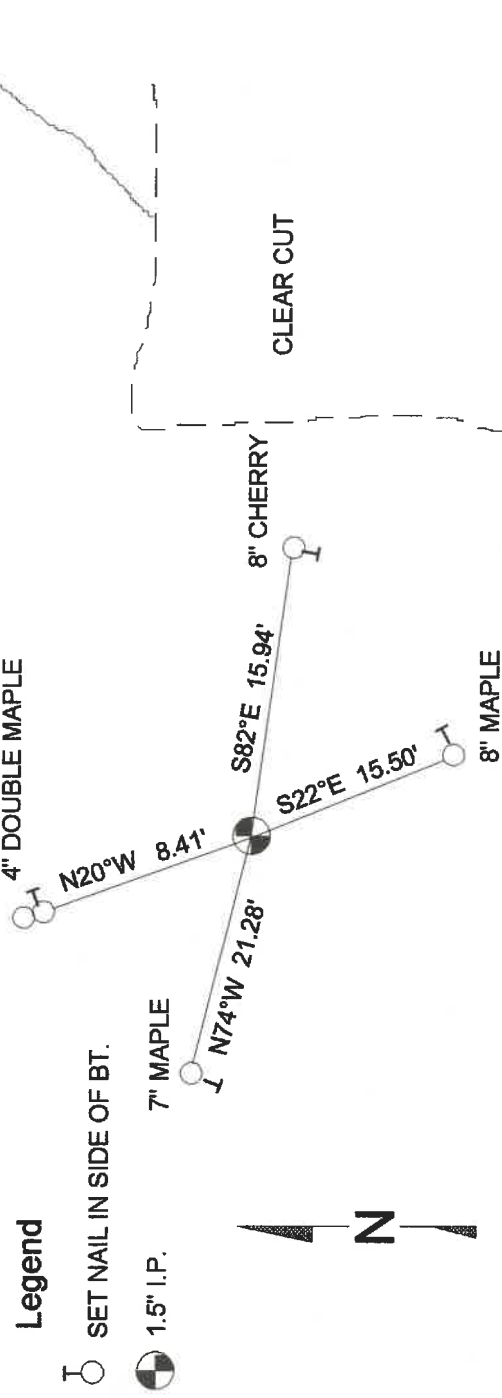
2004 - Dean A. Williams found 1.5" iron pipe, projecting one foot above ground.  
Accepted as best possible evidence of corner location

Found 1.3" Iron Pipe .5 feet below road surface and two of Kelly ties.  
Retief and accepted as best possible evidence of corner location.
