LANGLADE COUNTY U.S. PUBLIC LAND CORNER RESTORATION

The Southeast corner of Section 26, T. 33 N., R. 12 E., Langlade County, WI.

4331226 0000

CERTIFIED LAND CORNER RESTORATION

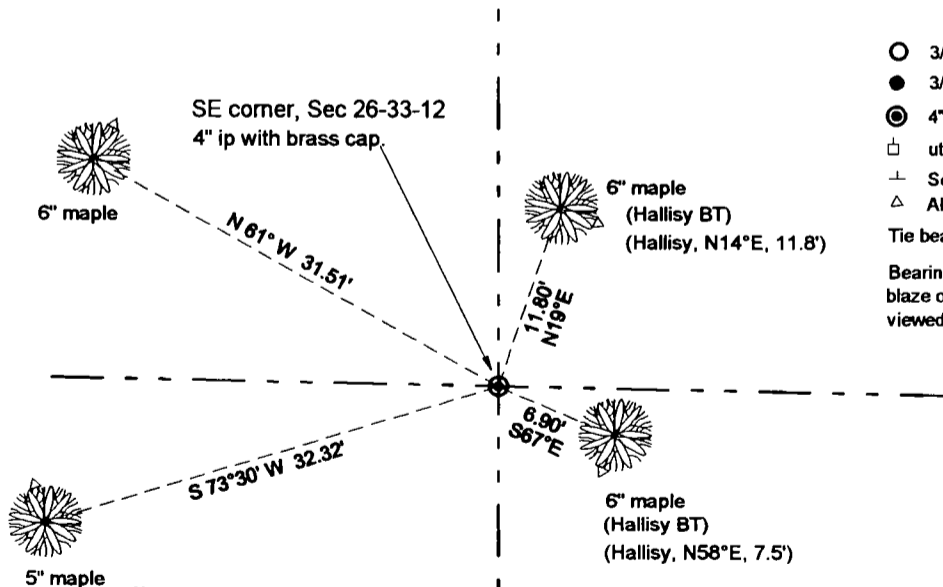
On Sept. 4, 2008, I found the 1939 4" iron pipe with brass cap leaning NE. I redug it straight and firmly planted and added a decent stone mound. Measured BT's as shown below

Redug and straightened the existing 4" iron pipe with brass cap, in mound of stone.

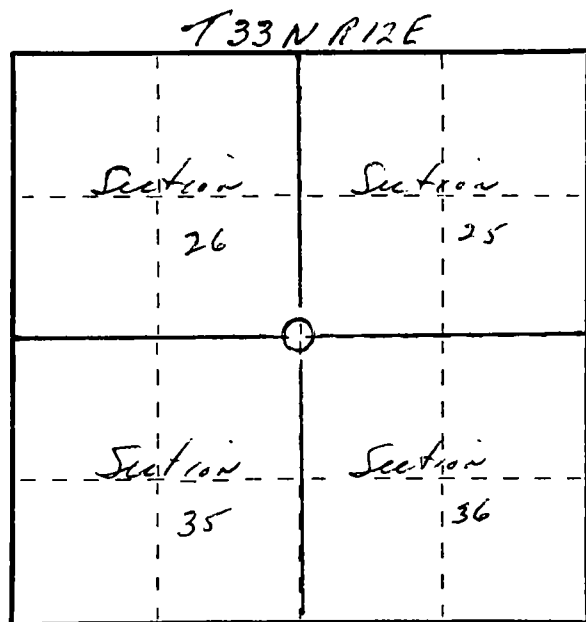
○ = Corner monument restored.

4" iron pipe with brass cap.

New BT's Rock Mound.

4" Hard Maple N14E 11.8'
7" Hard Maple S58E 7.5'
8" Hard Maple S60W 21.4'
9" Hard Maple N86W 16.2'
