LANGLADE COUNTY U.S. PUBLIC LAND CORNER RESTORATION

The Southeast corner of Section 10, T. 34 N., R. 10 E., Langlade County, WI.

CERTIFIED LAND CORNER RESTORATION

Index No. 9-17

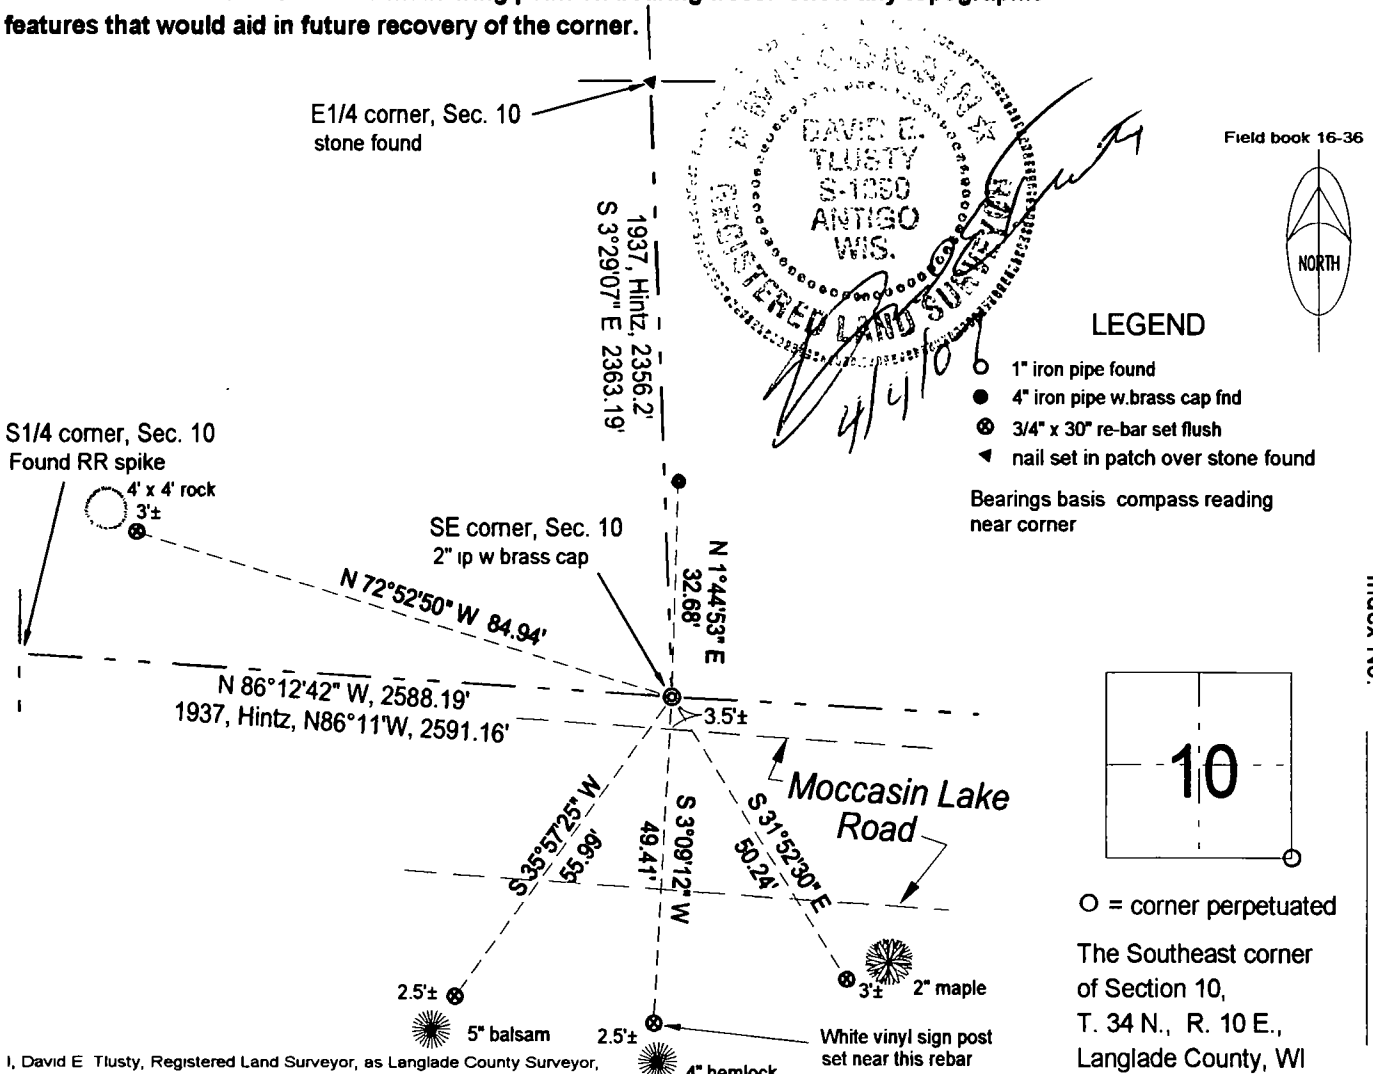
The original corner was established in 1865 by James L. Nowlin. Original bearing trees: birch, 15", S45°E, 10 lks., and a birch, 6", N20°E, 8 lks. In October 1899, B.F. Dorr marked a new BT: sugar, 7", N15-1/4E, 22 lks. In 1937, Darwin Hintz resurveyed this township and said "to sec cor in E-W Hwy. Cor. set at intersection with road N. Set WC 50 lks N. Iron pin for cor. New W. pine, 8", S67°E, 187.3 lks (123.6)". In June 1978, former surveyor Kelly "located witness corner set on re-survey of township. Set 1" iron pipe below road surface and marked bearing trees and initialized and dated old brass cap". 6/10/98 D. Tlusty, D. Willams found Kelly's iron pipe, the 1937 4" brass capped witness monument and the 1937 w. pine BT to the SE. I removed the pipe to search for the 1937 iron pin. None found. I accepted the 1" iron pipe found as the best evidence of the corner and replaced it with the monument described below.

For the corner, I set a 2" x 30" iron pipe with brass cap, top is 0.3' below ground in the North shoulder of the road.

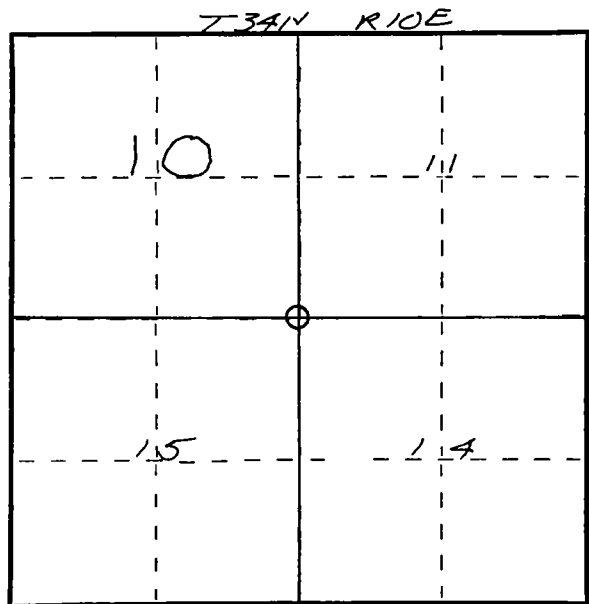
LOCATED WITNESS CORNER SET ON 1938 RE-SURVEY OF TOWNSHIP

SET 1" IRON PIPE BELOW ROAD SURFACE & MARKED BEARING TREES, ALSO INITIALIZED & DATED OLD BRASS CAP.

WITNESS CORNER 1" BRASS CAP
