+
**LANGLADE COUNTY
 U.S. PUBLIC LAND CORNER RESTORATION**

The East quarter corner of Section 33, T. 34 N., R. 11 E., Langlade County, WI.

Index No. X 13 34-11

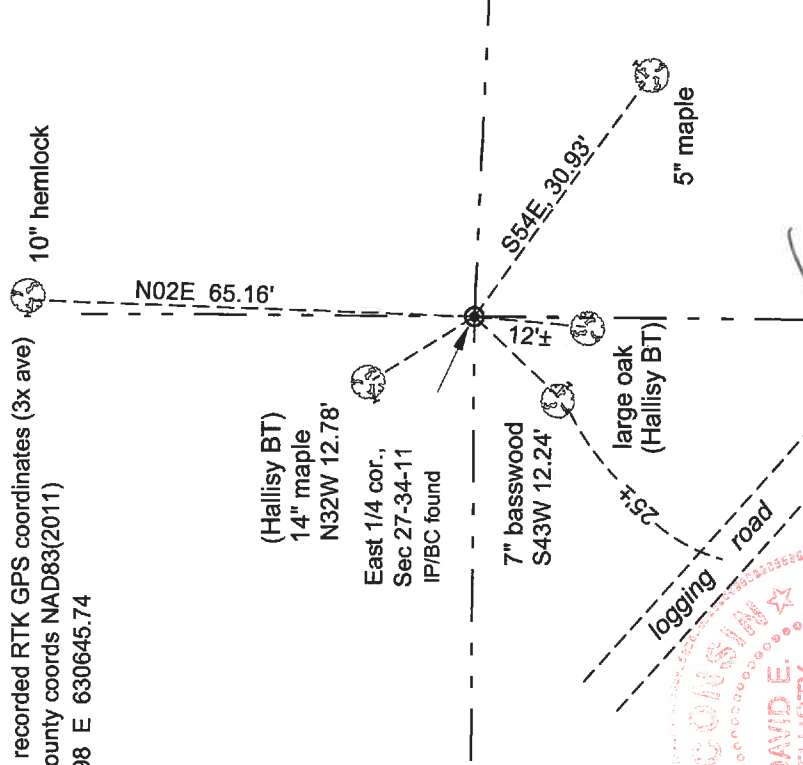
Found 2" iron pipe with brass cap in good condition, did not replace it.

10/20/2014 recorded RTK GPS coordinates (3x ave) 10" hemlock
 Langlade County coords NAD83(2011)
 N 430369.98 E 630645.74

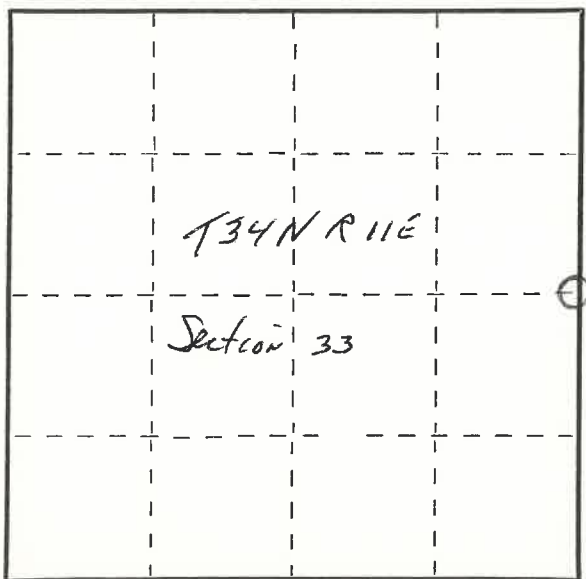
Found pipe run over by logging skidder and out of place.

Reset pipe and made rock mound.

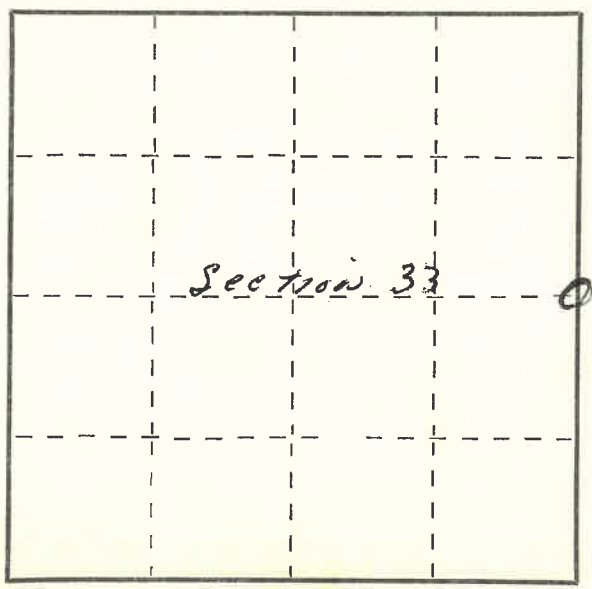
Found wood post down, MARKED 1/4, ROCK MOUND

MAPLE 14" S80°E 4 PACE, MARKINGS GROWN OVER
BASSWOOD 20" S28°W 4 PACE MARKINGS GROWN OVER

Set 2" PIPE WITH BRASS CAP, ROCK MOUND.

OAK 12" S5°W 12 FT. 2 inches
MAPLE 8" N33°W 12 FT. 6 inches
