LANGLADE COUNTY U.S. PUBLIC LAND CORNER RESTORATION

The South Quarter corner of Section 33, T. 34 N., R. 12 E., Langlade County, WI.

PLSS field condition report

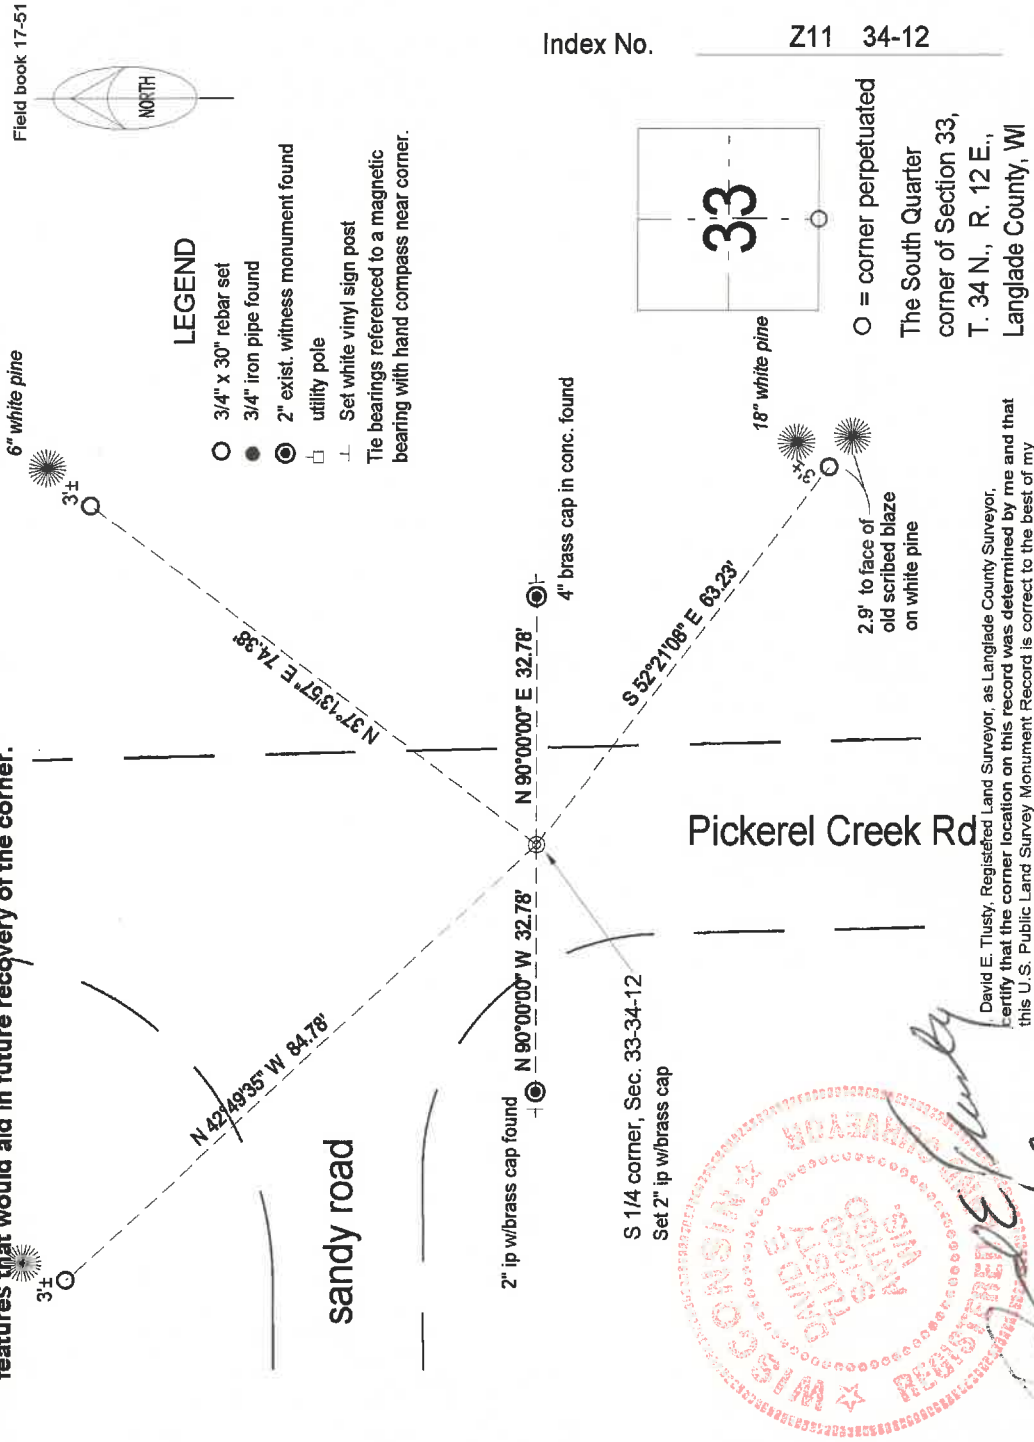
The original corner was established in 1857 by Alfred Millard. Original bearing trees: y. pine, 10, S75°W, 180 links, and a y. pine, 10", S66°E, 37 links. Brooks (date unknown) in FB 44 found orig. y. pine BT, SW, good, other gone. Set stone with "+" on top for corner and marked two new w. pine BT's. Robert Poss, 1968, found stone with "+" on top and 2 WC's by other surveyors. He set a brass cap 2 rods east and a wood post 2 rods west. Ray Hallisy, 1979, found stone. He also found Poss's 4" BC bulldozed out and re-set it. He set a 2" ip w/bc 2 rods west and marked two W. pine BT's. 08/17/99 D. Tlusty, D. Williams found 2" IP w/bc to the West, 4" brass capped mon. to the East and Hallisys SE BT. Stone is gone. Re-set the corner from ties found and re-measured as shown below.

Set a 2" x 30" galvanized, flared bottom iron pipe with brass cap, top of which is 1.0' below road surface.
