LANGLADE COUNTY U.S. PUBLIC LAND CORNER RESTORATION

The Southeast corner of Section 11, T. 32 N., R. 10 E., Langlade County, WI.

3210110000

Index No. J21 32-10

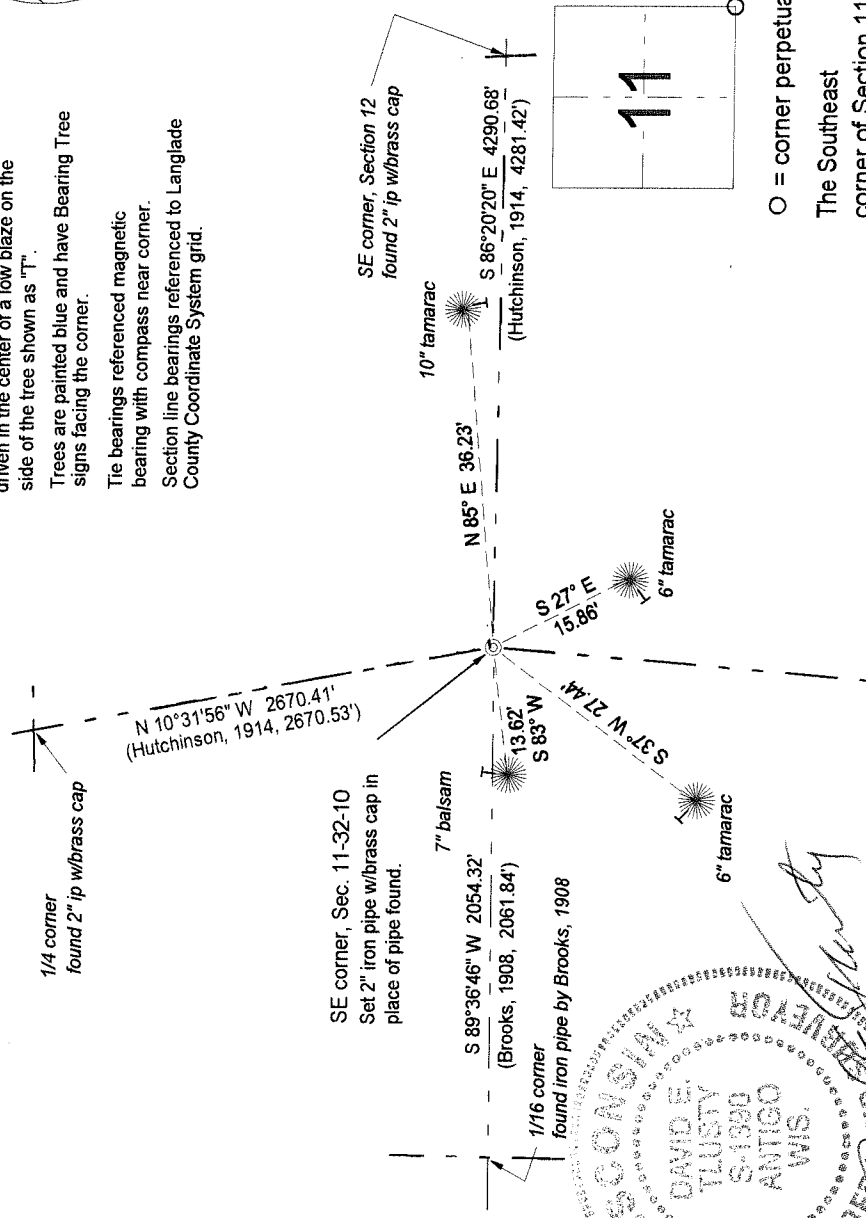
The original corner was established in 1860 by Hiram C. Fellows. Original bearing trees: birch, 12", S62°E, 12 links and a hemlock, 15", N80°W, 10 links (6.6'). In 1907, E.S. Brooks, county surveyor, described corner as "Orig. BT stg. Birch 22 lks. instead of 12. Corner good in every way". He measured (4,123.68') west to the quarter corner and set the 1/16th corner between. He set "gass" pipe for all corners. In 1914 Hutchinson surveyed in Section 12 and described this corner as: "Cor. both orig. BT's plainly marked: birch, 14, S79°E, 22 lks. and hemlock, 24", N69°W, 10 lks. Pipe 1 1/2" x 2 ft. for cor." 11/09/01 D. Tlusty computed search area from Hutch's distances from the W 1/4 corner and the SE corner of Section 12. Found a 1 1/2" (OD) x 36" rusty pipe lying on the ground, 0.2' below surface. Found rotten stump, N69°E, 6.6', other original BT completely gone. Accepted pipe found as the best evidence of the original corner location.

10/11/01 D. Tlusty, D. Williams. In place of the pipe found, I set a new, 2" x 30" flared bottom, galvanized iron pipe with 3 1/4" brass cap stamped to identify corner, top of which is 0.3' above ground. Set white vinyl sign post, 0.4' north.
