LANGLADE COUNTY U.S. PUBLIC LAND CORNER RESTORATION

The Southeast corner of Section 25, T. 32 N., R. 10 E., Langlade County, WI.

Index No. V25 32-10

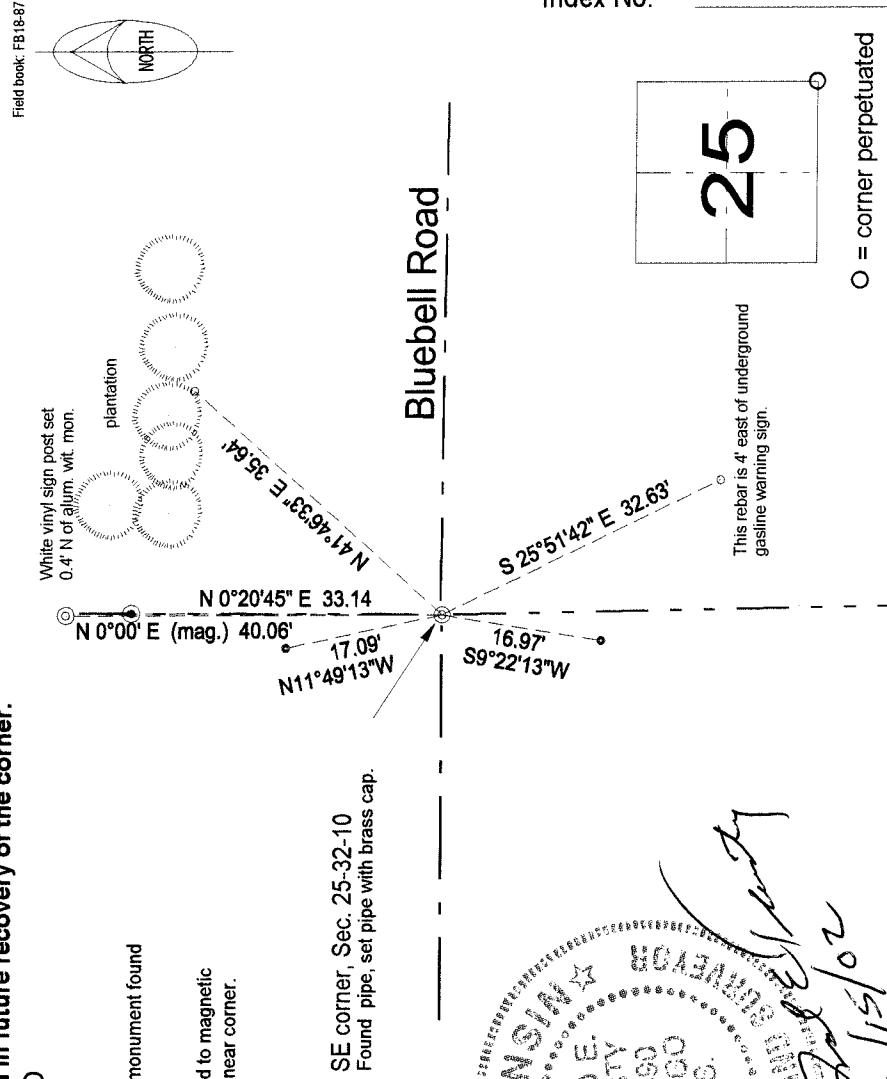
I removed the existing pipe and replaced it with a 2" x 30" galvanized, flanged bottom iron pipe with a 3 1/4" brass cap set flush with the road surface.

Tie bearings referenced to magnetic bearing with compass near corner.
