Langlade County

U. S. PUBLIC LAND SURVEY MONUMENT RECORD.

Meander Corner, East Shore of Peninsula on Rose Lake, Sections 23 and 26, T.32N., R.14E., Langlade County, Wisconsin.

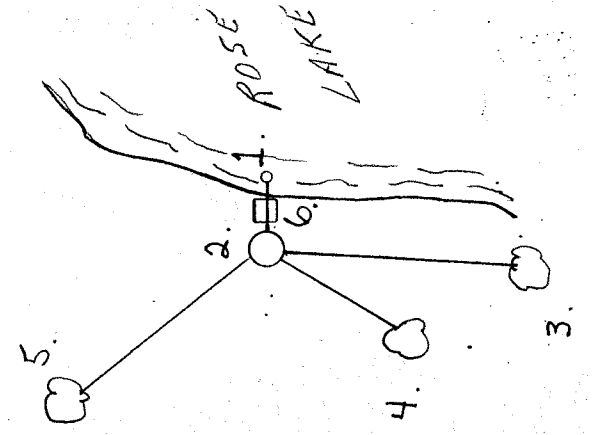
1. Position of Meander Corner in Rose Lake.
2. 2½" x 36" aluminum monument stamped as to Witness Corner location.
3. W. Birch, 7", S.07°W., 24.28 feet.
4. Y. Birch, 4", S.28°W., 11.05 feet.
5. W. Birch, 6", N.38°W., 27.34 feet.
6. Steel sign post, East, 1.03 feet.
7. Lake Shore, East, 2.56 feet.

Iron pipe by Hammes, N.43°W., 65.97 feet.
