**LANGLADE COUNTY
U.S. PUBLIC LAND CORNER RESTORATION**

The South Quarter corner of Section 16, T. 33 N., R. 9 E., Langlade County, WI.

4330916 0020

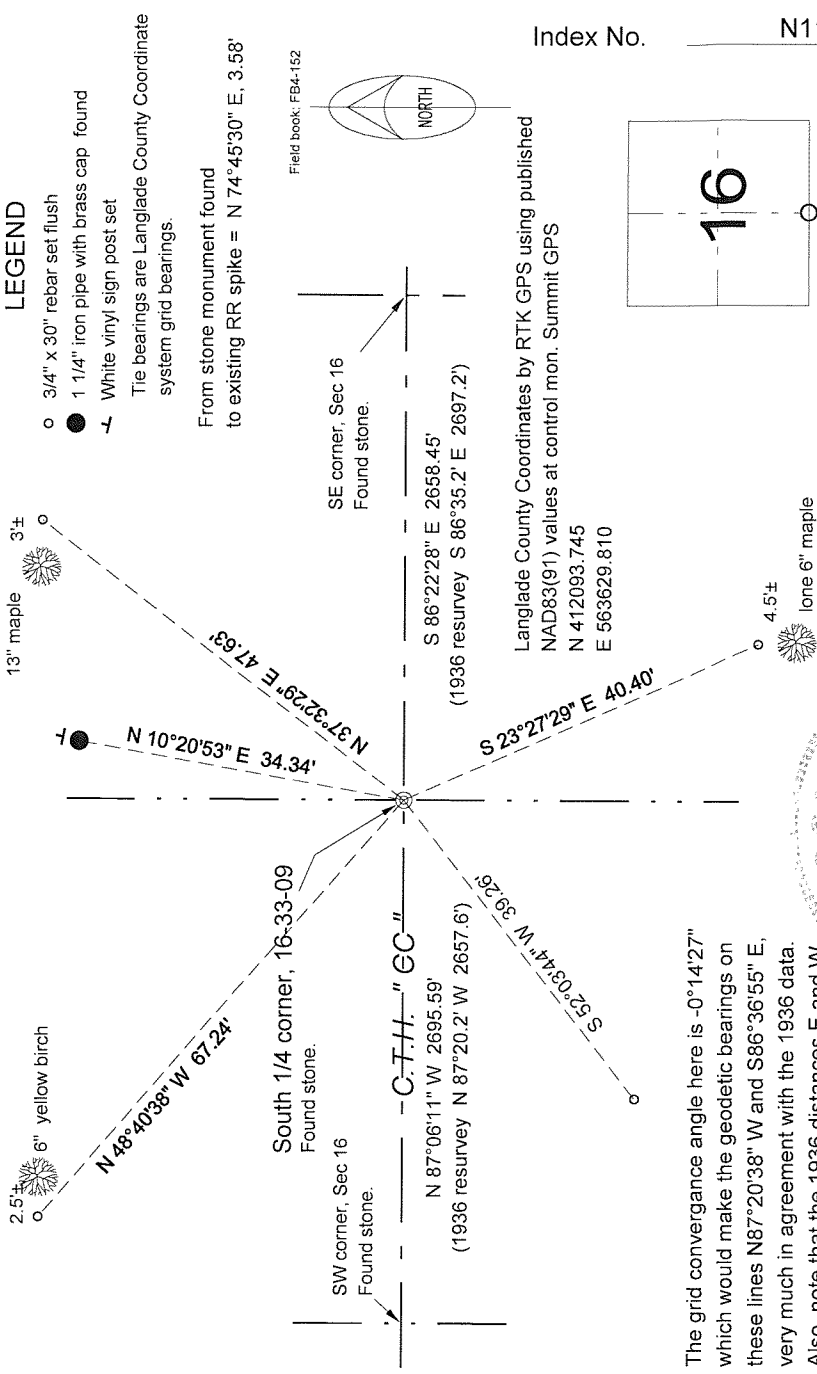
The original corner was established in 1860 by Hiram C. Fellows. Original bearing trees: birch, 15", N 41° W, 18 links and a birch, 16", S 31° E, 32 links. In 1902, Webley (FB126-11) said: "both OBT's standing, set grey boulder 8 x 8 x 22 with cross on top". On April 11, 1936, C.H. Parker, on a re-survey of a portion of 33-09 said: "This corner is a field stone in the center of the road on fence line". On a corner form dated 12/28/81 by former surveyor Kelly, he said: "Set PK nail over existing iron bar (buried in road). Set a 1 1/2" x 42" black iron pipe with brass cap witness monument. Location identified by resident witness as 1/4 sect. cor.". 06/11/01 D. Tlusty, Emily Tlusty, Mike Kielcheski found RR spike in pavement, dug with backhoe. Down 2', found stone, size as described above, but no X apparent. Based on the above history, I accept it as the best evidence of the original corner location. Did not find "iron bar" or any other iron in the road, except the RR spike at surface. I don't believe Kelly found "iron bar" based on the time of year he was there (the road would have been to hard to dig) and based on many other instances where he said he found something iron in the road and searches by hand and with backhoes, in most instances, found nothing.

The grid convergence angle here is -0°14'27" which would make the geodetic bearings on these lines N87°20'38" W and S86°36'55" E, very much in agreement with the 1936 data. Also, note that the 1936 distances E and W appear to have been flopped.

I removed the existing stone and replaced it with a 1" x 30" iron pipe, top of which is 2.6' below the road. I placed the stone on the north side of the iron pipe set.

12/09/03 For the corner, I set a Bernitsen SN-1 nail in the new pavement.
