LANGLADE COUNTY U.S. PUBLIC LAND CORNER RESTORATION

The South 1/4 corner of Section 21, T. 33 N., R. 9 E., Langlade County, WI.

4330921 0020

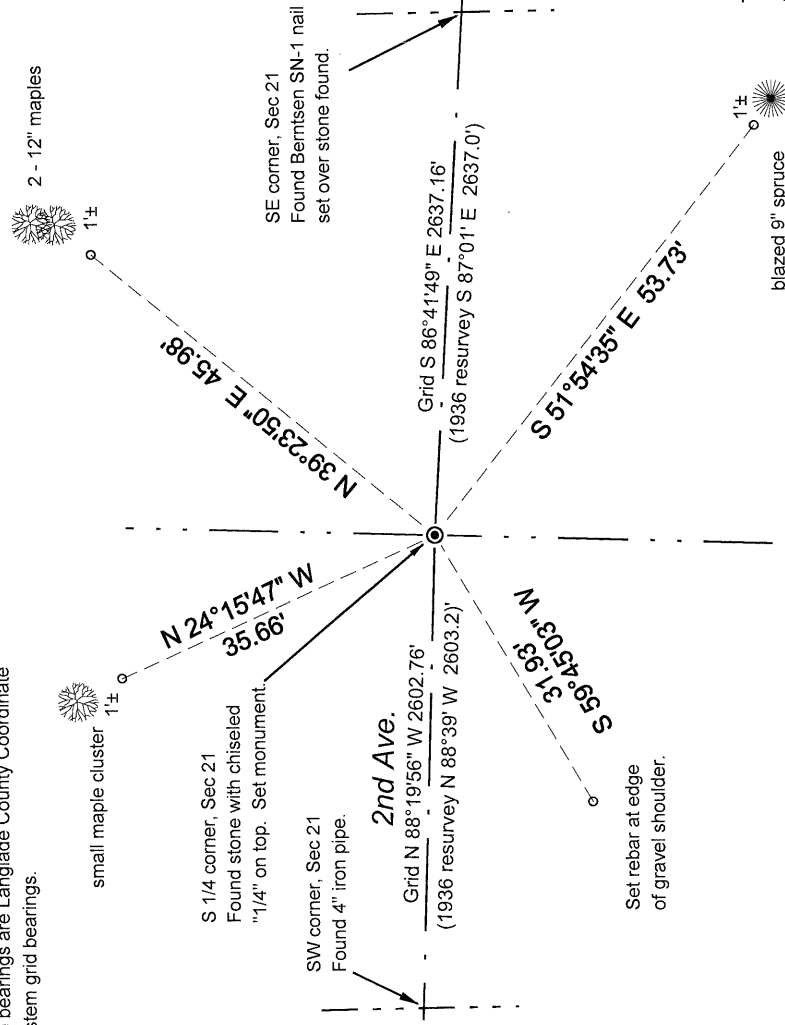
For the corner, I set a 2" x 30" iron pipe, top down 0.4'. Laid the found stone on the west edge of the pipe set. I set a Berntsen Deep-1 magnet under the monument set.

- 3/4" x 30" rebar set flush
- ⊙ 2" iron pipe with brass cap set in place of stone found.
- white vinyl sign post set

Tie bearings are Langlade County Coordinate system grid bearings.
