LANGLADE COUNTY U.S. PUBLIC LAND CORNER RESTORATION

The South quarter corner of Section 10, T. 33 N., R. 10 E., Langlade County, WI.

4331010 0020

Index No. J15 33-10

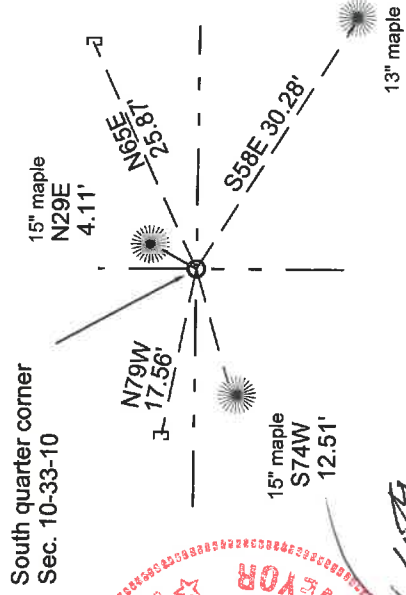
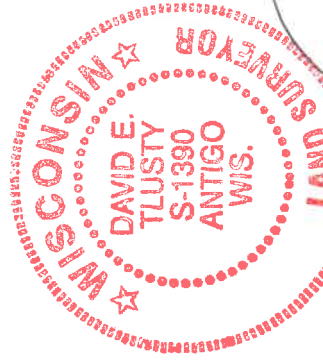
For the corner, I left the existing monument in place and measured ties as shown below
 Added steel sign post 1' NW of monument.

Remarkd three Hallisy bearing trees.
 Distances are to the center face of low blaze remarked.

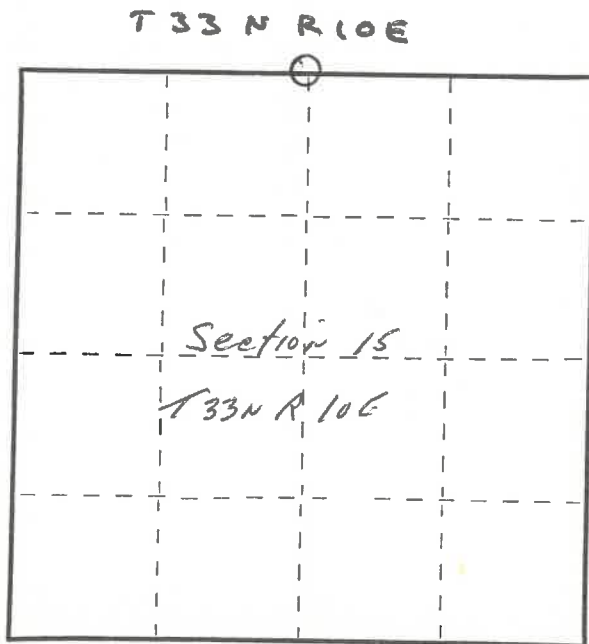
4" pipe with brass cap
Stone with X N60E 39.21 Links
Stone with X N85W 26.6 Links

12" Hard Maple S66E 30'6"
12" Hard Maple N24E 4'3"
14" Hard Maple S70W 12'8"
