LANGLADE COUNTY U.S. PUBLIC LAND CORNER RESTORATION

The East Quarter corner of Section 17, T. 33 N., R. 10 E., Langlade County, WI.

Index No. L9 33-10

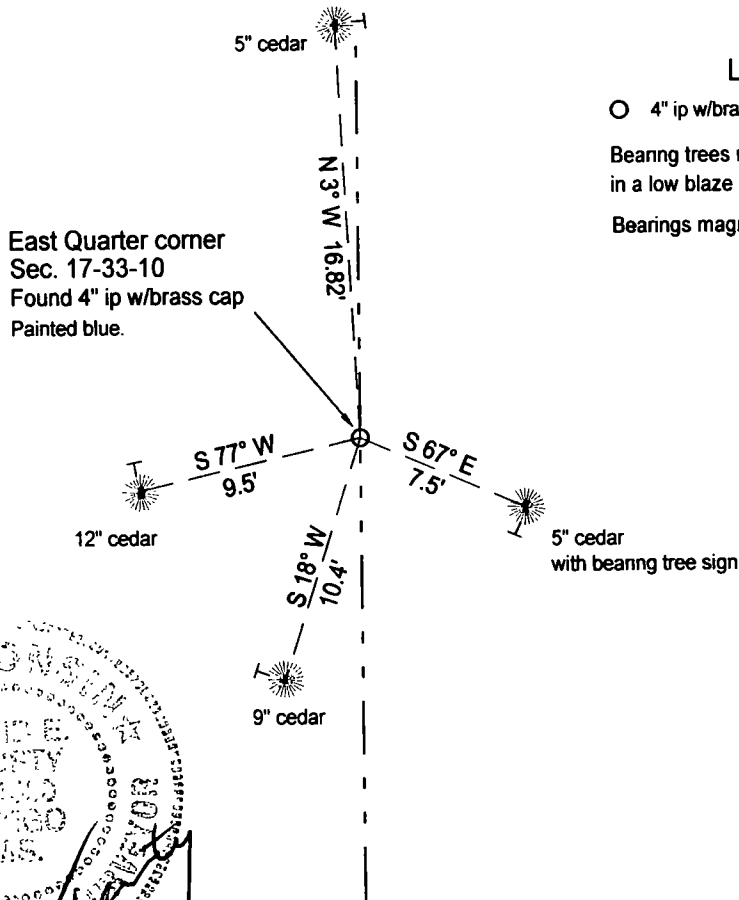
The original corner was established in 1860 by Hiram Fellows. Original bearing trees: hemlock, 12", S30°E, 4 links and a cedar, 9" N21°W, 7 links. In 1939, D. A. Hintze set the corner by proportion and marked BT's: cedar, 7", S 75° W, 14.4 links (9.5') and a cedar, 7", N 70° E, 13 links (8.6'). 10/30/06 D. Tlusty found 4" iron pipe with brass cap in good condition, top of monument 1.4' up. Corner is on the east side of a small swampy area, 20' from high ground to the East. I found the old SW cedar BT in good condition. I accepted the monument as found as the best evidence of the corner.

For the corner, I left the existing 4" pipe with brass cap from the 1939 resurvey, in place.
Set a white vinyl sign post, 0.3' North of the corner monument.
