U.S. PUBLIC LAND SURVEY MONUMENT RECORD

The South 1/4 corner of Section 14, T. 33 N., R. 12 E., Langlade County, WI

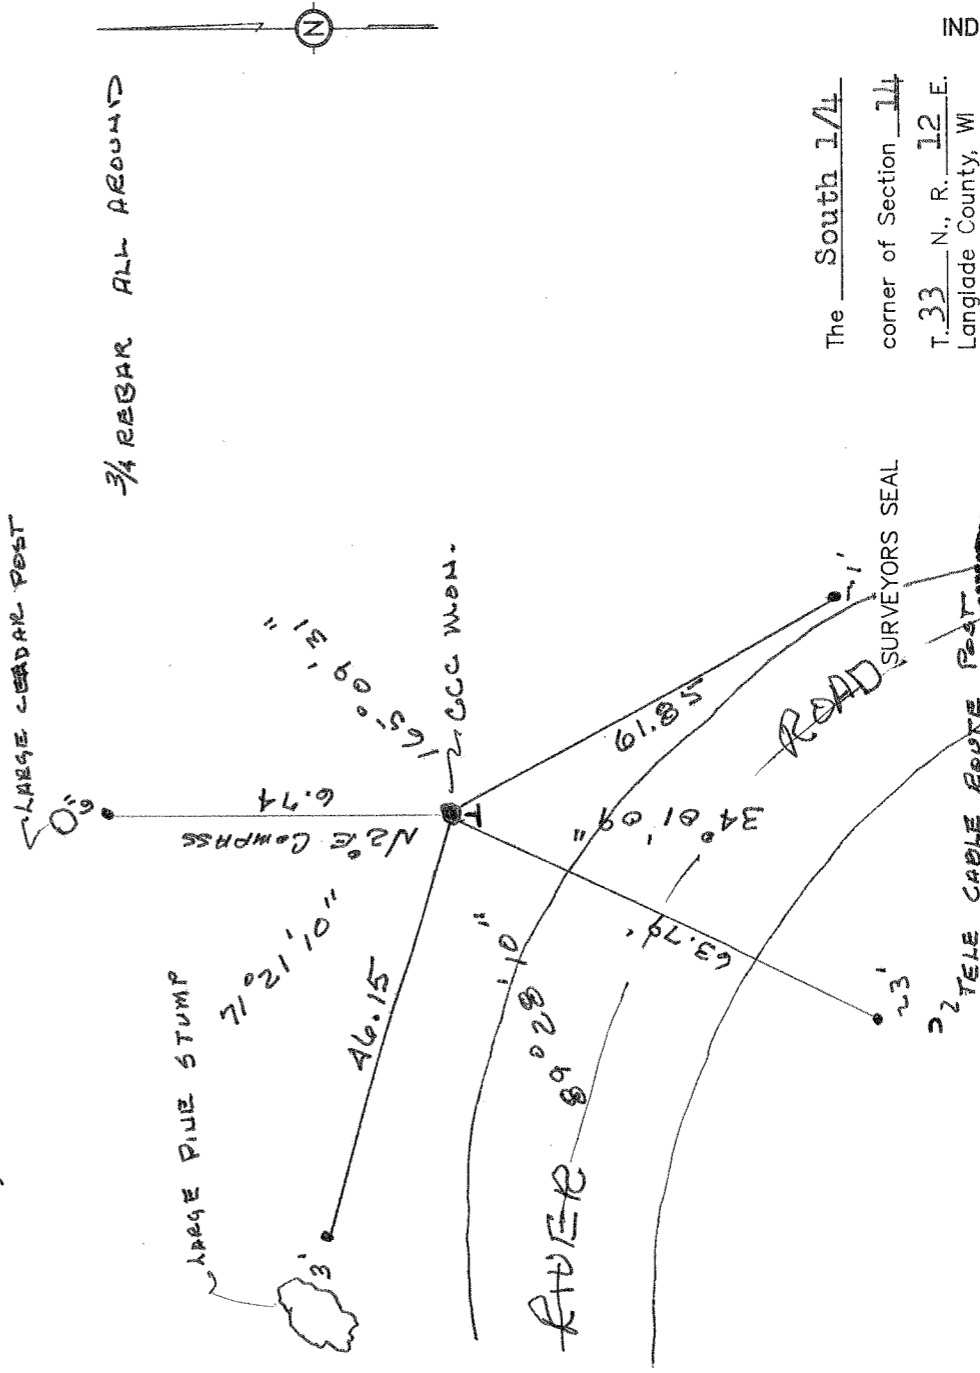
Elm 6 S47W 110 Lks (dead and has fallen down)

Elm 10 N47W 130 Lks. (dead and has fallen down)

Found 4" steel pipe with brass cap 6" below ground level.

No new monument set.
