LANGLADE COUNTY U.S. PUBLIC LAND CORNER RESTORATION

The East 1/4 corner of Section 2, T. 33 N., R. 13 E., Langlade County, WI.

History
of the Quarter corner common to
Sections 1 & 2, T33N, R13E.

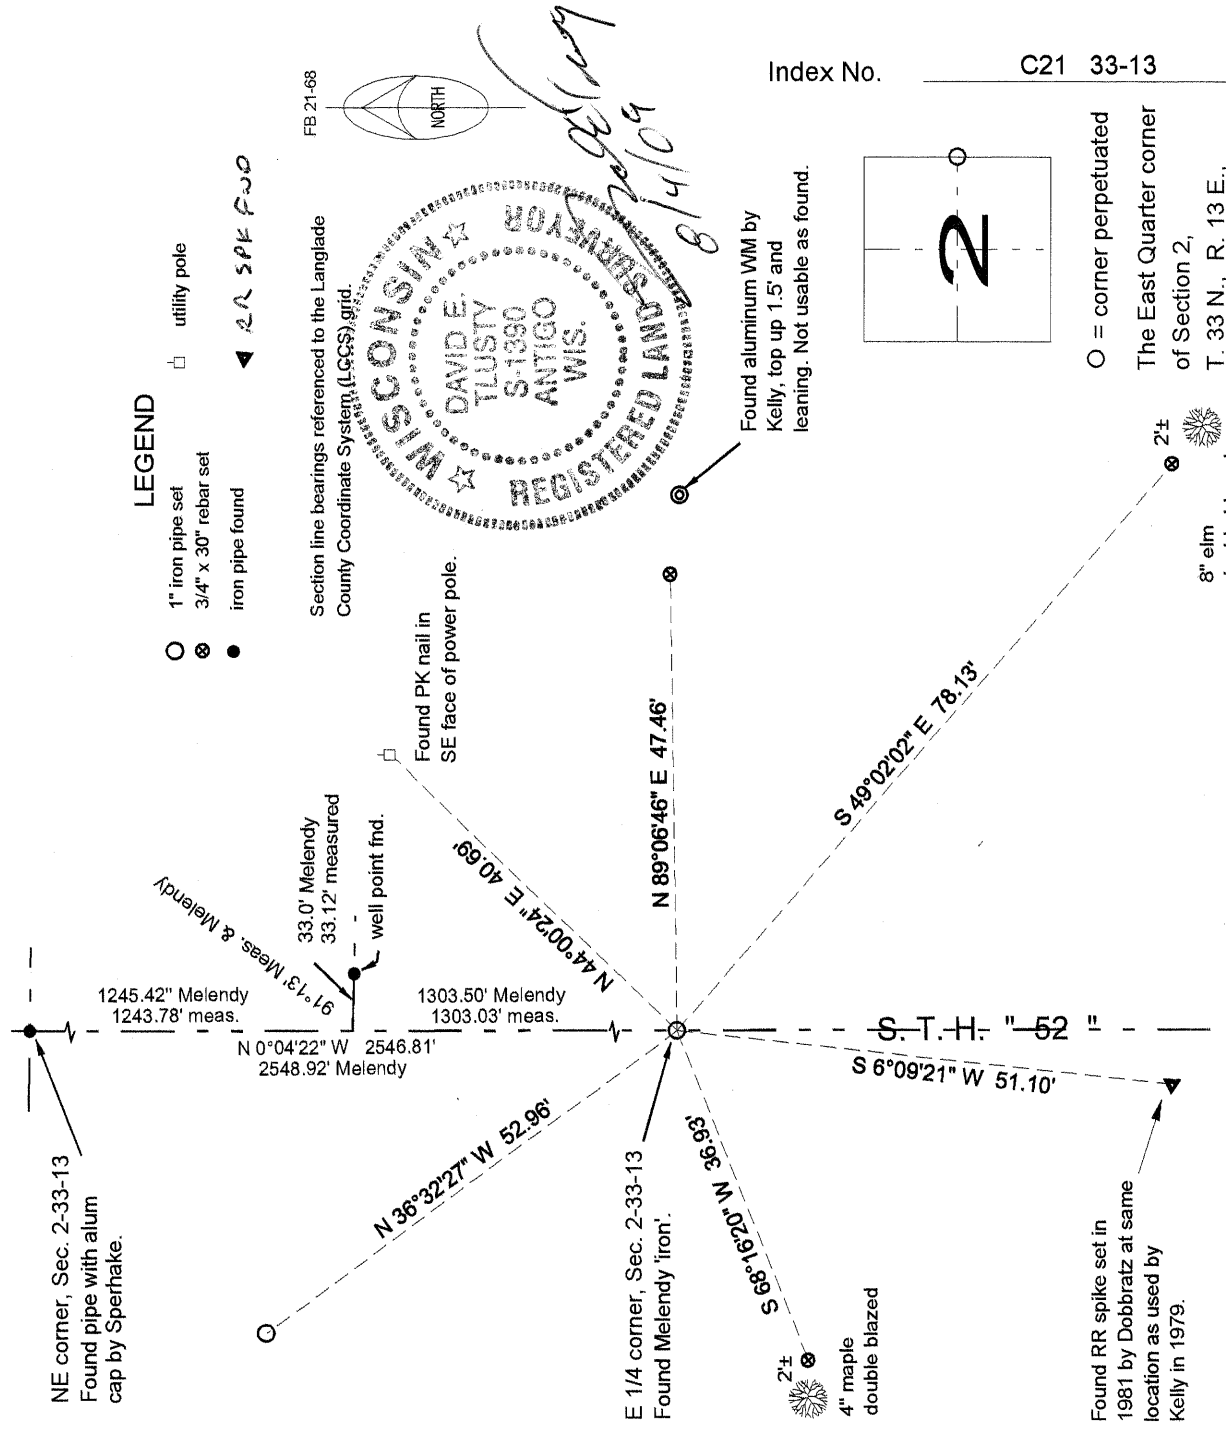
Set a 1" x 30" iron pipe in place of the angle iron found. Top of pipe is 0.8' below road surface. Reset the angle iron found at the west edge of the pipe set.

NOTE: As shown of the front side of this sheet, at 51.10 feet south of this location, I found a RR spike in the location shown and used by Dobbratz in 1981, being also the same location used by Kelly in 1979 for his work in the North Half of Section 2 (map # 30224). To clarify, Kelly used this southerly location in 1979 and then 11 years later, in 1990, he tied the correct corner, 51.10 feet to the north.
