LANGLADE COUNTY U.S. PUBLIC LAND CORNER RESTORATION

The Southeast corner of Section 7, T. 34 N., R. 10 E., Langlade County, WI.

U. S. PUBLIC LAND SURVEY MONUMENT RECORD

CERTIFIED LAND CORNER RESTORATION

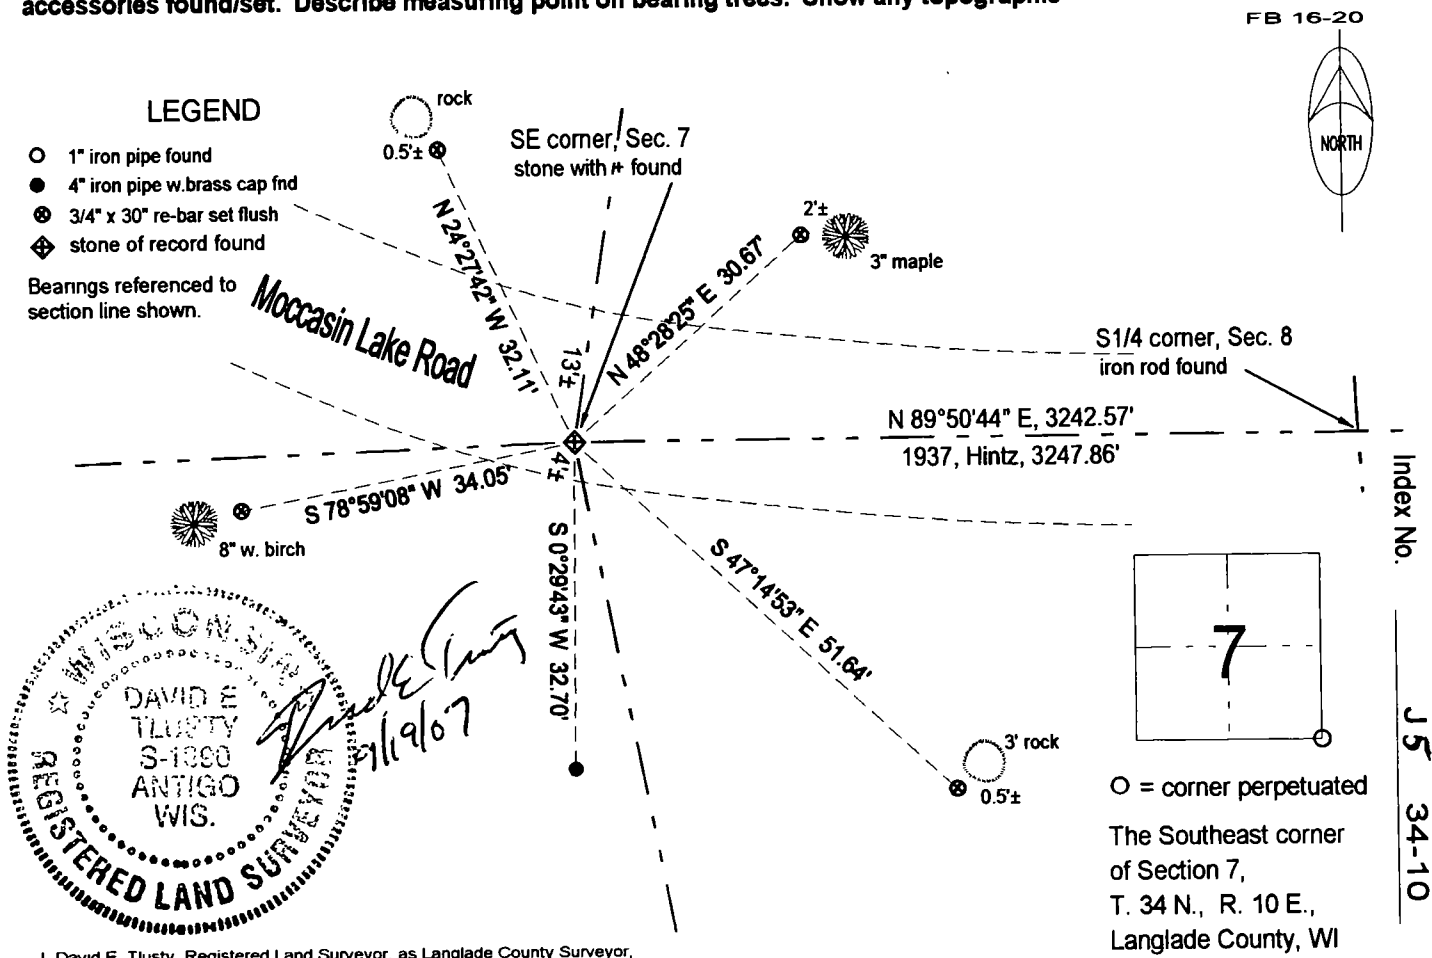
The original corner was established in 1865 by James L. Nowlin. Original bearing trees: sugar, 8", N20°E, 13 lks. and a hemlock, 7", N52°W, 40 lks. In Dec. 1904 Dorr said: northeast tree standing, new BT, cedar 10", N52°W, 38-1/2 lks. In June 1916, Brooks said: stake and BT by Dorr, hemlock 14", S62-1/2°E, 43-1/2 lks., this cor. is about 36 rods west of where it should be but the trees at this one correspond with notes. others do not. Also measured from east from 1/4, 49.15 chains, 21-1/4 lks., south of section corner iron pipe. In 1937, Hintz desc. this corner as: To section corner in east-west road of 7-8-17-18. This corner re-established by Dorr, his corner gone but re-established again by Brooks, his old hemlock, 14", S 62-1/2°E, 43-1/2 lks. still there. Put stone in road and set a witness corner (4" iron pipe with brass cap) south 50 lks. In June 1978, former surveyor Kelly found 4" brass cap set in concrete in a pipe, corner 50 lks., north, set 1" iron pipe for corner below road surface. December 1995, Tom Amott found 1" iron pipe in road, 1937 witness corner to south, and BT to NW and measured to S 1/4 cor. Sec. 8, 3241.41'. April 21, 1998, D. Tlusty, D. Williams found iron pipe with 4" BC marked as witness corner, corner is 50 lks., north. We dug in the road, 33' north of witness corner. Found Amott's iron pipe bent ESE. We continued to dig and found the stone set by Hintz, 1.3' WNW of Amotts iron pipe. The stone is 5" x 5" with a clear + chiseled on top and 0.35' below gravel road surface. I accepted stone found as best evidence of the perpetuated corner location. Pulled Amott pipe and set 1' x 30" iron pipe 0.3' north of center of stone's X. Also found rotten 1937 hemlock stump hole at S58°E 28.7'.

For the corner, I left the existing stone in place and set a 1" x 30" iron pipe on the north edge of it. We put a white vinyl post by witness monument south.

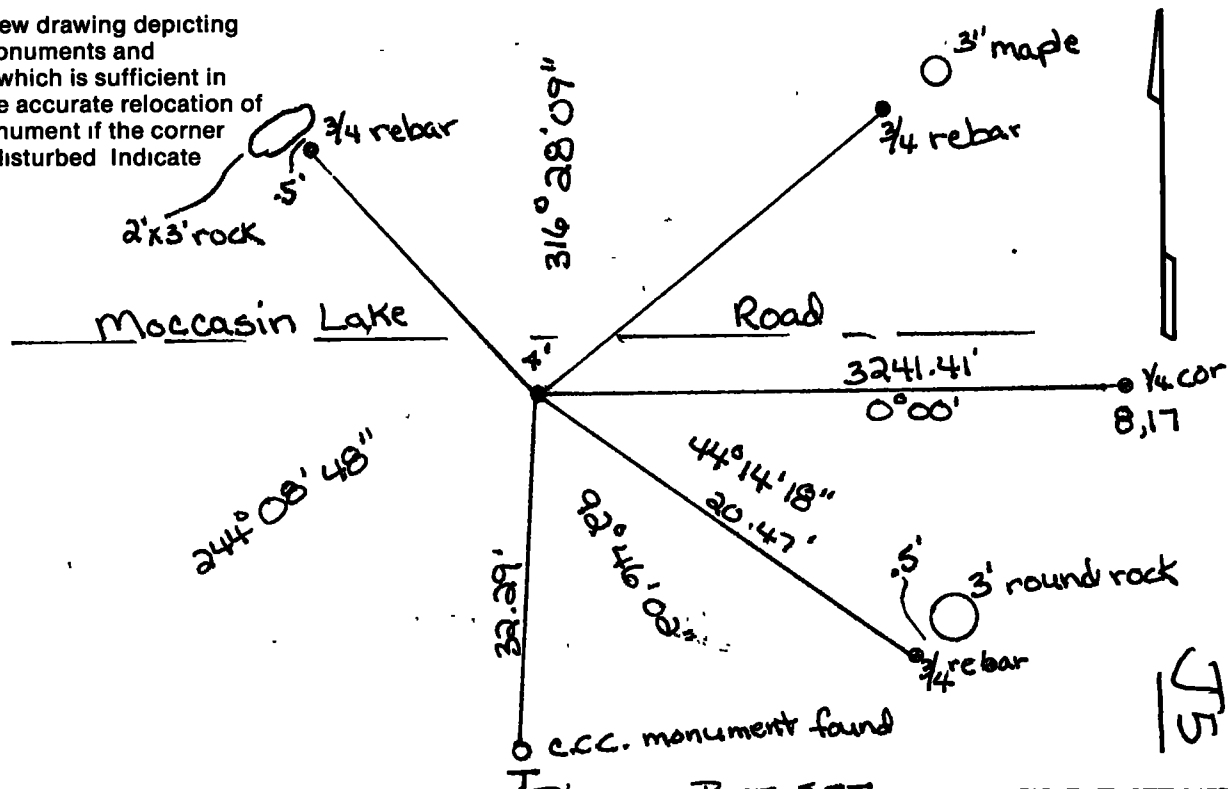
Found iron pipe in gravel road and a C.C.C. monument to the south of the road. Also found BT to the northwest of corner.

*TRUSTY FND
STONE
SEE NEW TIES*

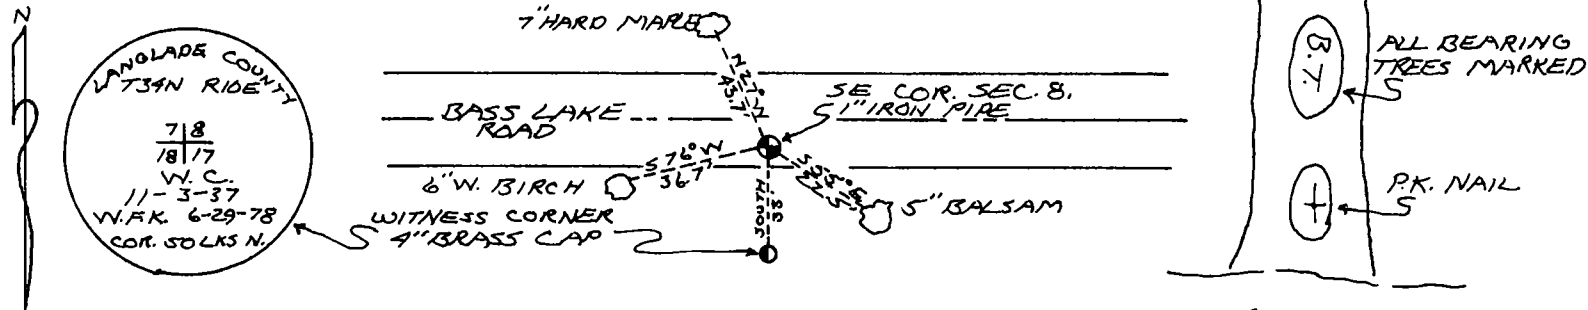
LOCATED WITNESS CORNER SET ON 1937 RE-SURVEY OF TOWNSHIP.

SET 1" IRON PIPE UNDER ROAD SURFACE AND MARKED NEW B.T.'s
