U. S. PUBLIC LAND SURVEY MONUMENT RECORD - ADDENDUM

A-E 7.08(3)(a) Identity of corner:
South 1/4 Corner Section 08,
Township 34 North, Range 10 East
of the Fourth Principal Meridian,
Town of Eicho, Langlade County, Wisconsin

LANGLADE COUNTY U.S. PUBLIC LAND CORNER RESTORATION

The South Quarter corner of Section 8, T. 34 N., R. 10 E., Langlade County, WI.

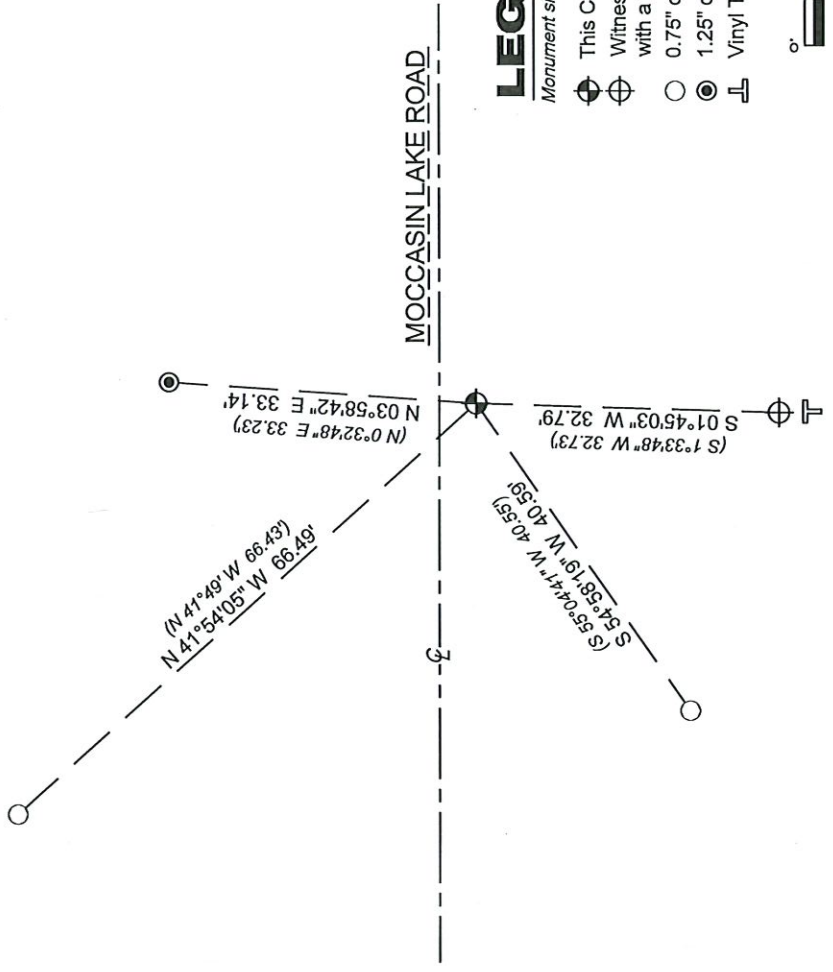
A-E 7.08(3)(c)(d) Plan view of corner with references to at least 4 witness monuments.

- May 7, 2014 - Surveyor 2663 - Darren B. Krzanowski - indicates this position as "4" brass cap fnd." on county record Map #10888.
April 5, 2024 - I found a mini - MAG Nail. The monument is ±4' south of the centerline of Moccasin Lake Road. I also found all of Tlusty's reference monuments as shown on the previous monument record.

I did not establish any new reference monuments.

A-E 7.08(3)(e) 1865 Surveyor set a post, 2007 Surveyor found an iron rod, 2014 Surveyor found a 4" brass cap. I found a mini - MAG Nail in 2024.

A-E 7.08(3)(f) I accept this monument in good faith as a FOUND PERPETUATED LOCATION of the corner.
A-E 7.08(3)(g)(h) This corner was not determined through lost-corner-proportionate methods.

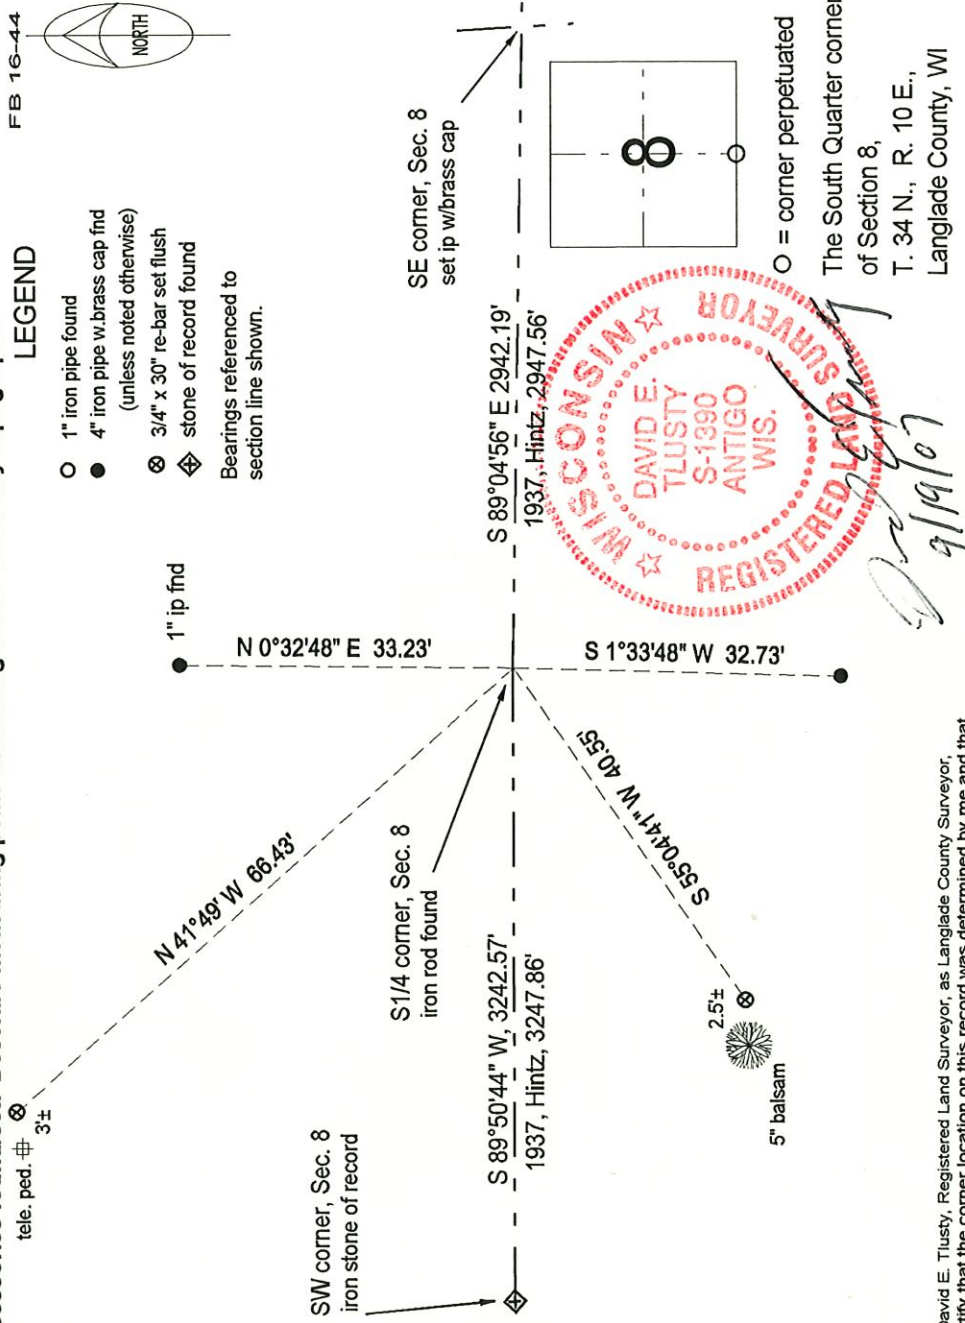
The original corner was established in 1865 by James L. Nowlin. Original bearing trees: Aspen, 8", S70°W, 5 lks. and a birch, 8", N60°E, 35 lks. In Dec. 1904, B. F. Dorr said: south 1/4 post, northeast BT standing, new BT: spruce, 6", S17°W, 50-1/4 lks. In June 1916, Brooks used this corner but didn't describe it. At a date unknown, C. Baker surveyed the south line of Sec 8 (total 93.6325 ch) but didn't describe this corner. In 1930, J.J. Melendy measured 40.725 ch south, from the center of Sec 8 to this corner, but didn't describe it. In 1937, D.A. Hintz measured from SE corner of Section 8, 44.66 chains to this 1/4 corner. He described this corner as: found BO by Hutchinson, stone, N45°E, 41 lks. Iron pin for corner and witness corner 50 lks. south. In June 1978, former surveyor Kelly found a 3/4" iron rod in center of road and a witness corner. The iron rod was protruding through road surface and witness corner has been frost heaved out of position; also a RR spike was found "close to the actual corner location". He reset the iron rod below road surface and straightened and made solid the witness corner and made 3 new BT's. In 1995, Tom Arnott found bent iron pipe in road. He replaced it with 3/4" rebar and added new ties. 06/17/98 D. Tlusty D. Williams found rebar in road, replaced it with the monument described below. Measured ties as shown below.

For the corner, I replaced the found rebar with a 1 1/4" x 30" iron pipe with 4" brass cap.

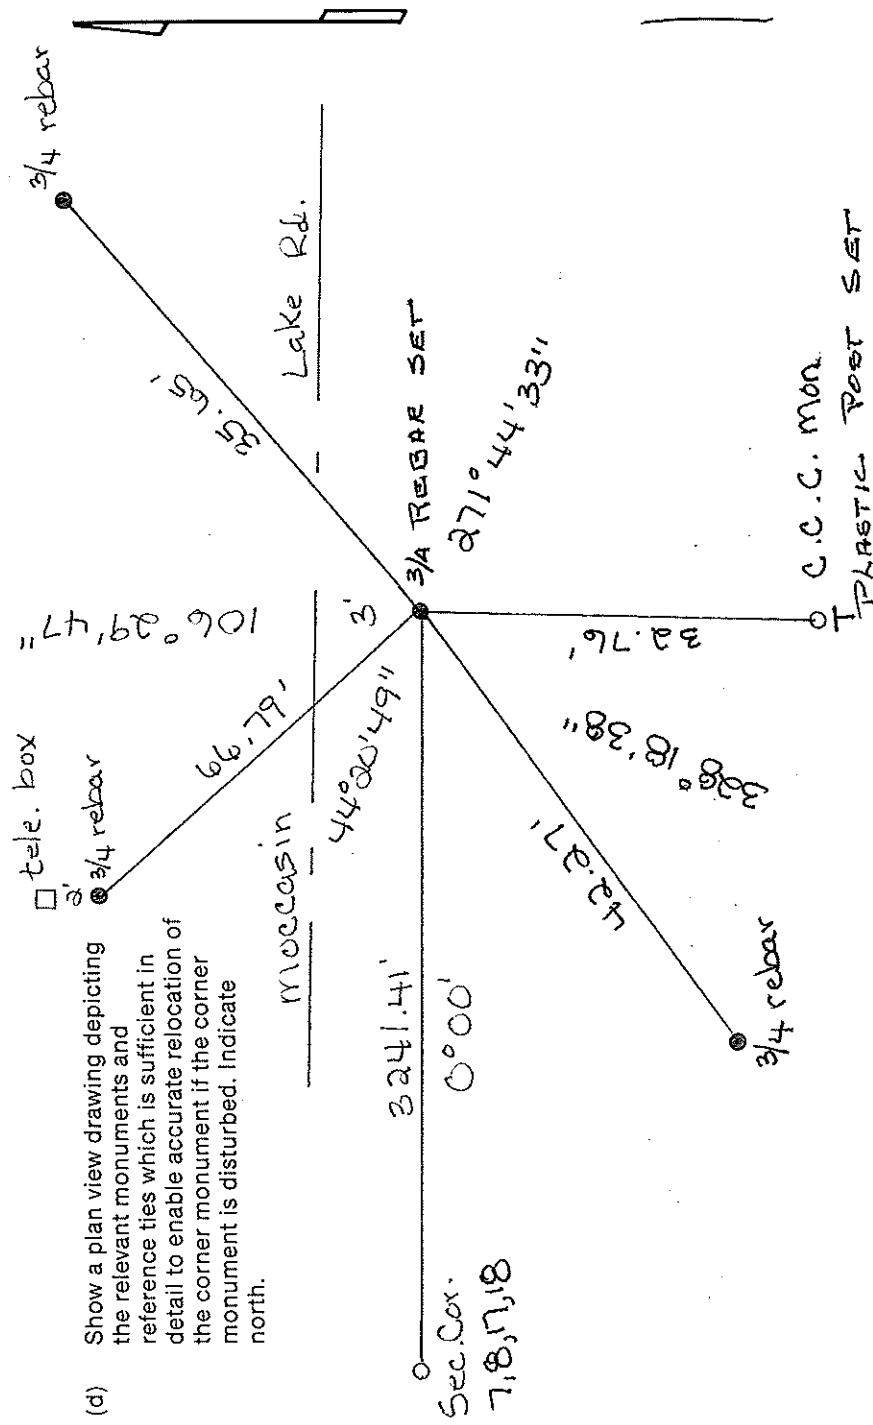
Found iron pipe in road bent. Replaced with 3/4 rebar with red cap. Also found C.C.C. monument to south of road. Kelly's ties were to w. birch and they are dead or gone.

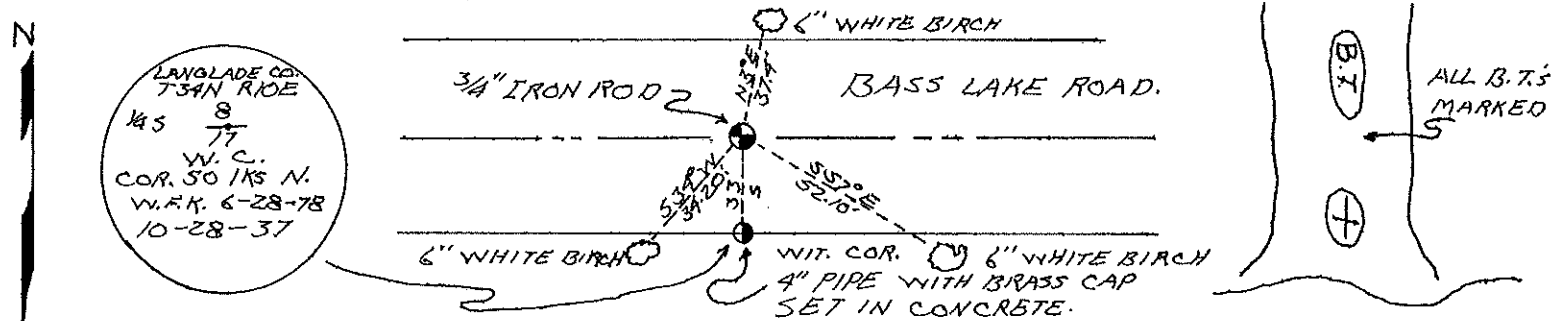
Description of corner evidence found:
FOUND 3/4" IRON ROD IN CENTER OF ROAD & ONE WITNESS CORNER. IRON ROD WAS PROTRUDING THRU ROAD SURFACE & WITNESS CORNER HAD BEEN FROST HEAVED OUT OF POSITION.

THERE IS A R.R. SPIKE IN THE ROAD THAT IS CLOSE TO THE ACTUAL CORNER. THE 3/4" ROD IS THE ACTUAL CORNER LOCATION.

Description of monument and accessories I established to perpetuate the original location of this corner.
RESET IRON ROD BELOW SURFACE OF ROADWAY & RESET WITNESS CORNER. MARKED NEW BEARING TREES.
