# LANGLADE COUNTY U.S. PUBLIC LAND CORNER RESTORATION

The Southeast corner of Section 24, T. 34 N., R. 11 E., Langlade County, WI.

PLSS field condition report

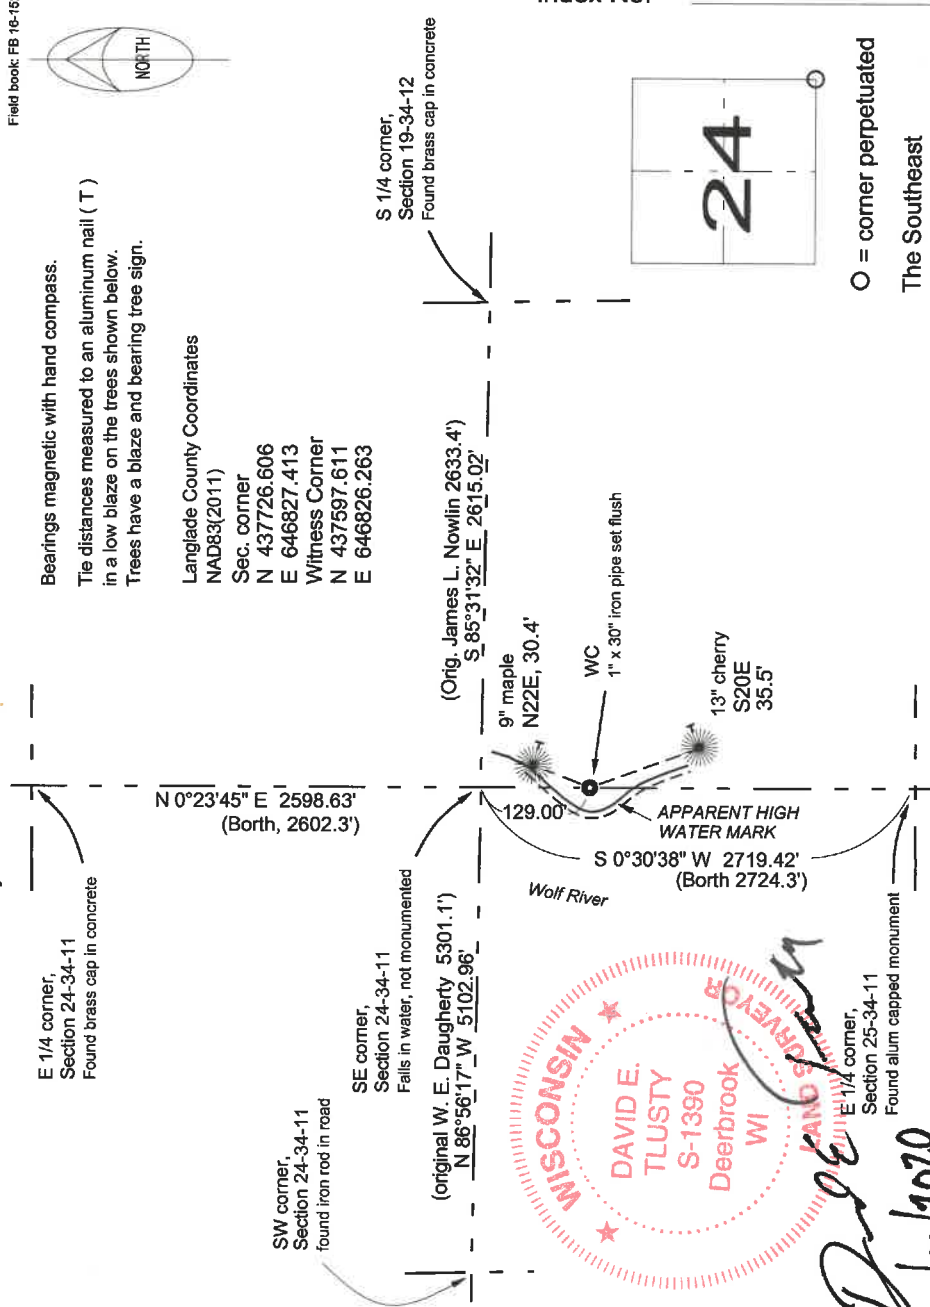
The original corner was established in 1857 by Alfred Millard; corner falls in river. Millard established a witness corner at 78.50 chains. Bearing trees for the witness corner: W. pine, 15", N78E, 282 links and a W. pine, 18", S58E, 220 links. In 1935, Charles Borth ran north on the east line of section 25 and hit this WC at 2526.3' north of the quarter corner. He found "old scribed pine stake about rotten". He found both original pine BT's, the NE being rotten stump; the SE being a rampike. He said this WC: "cor. in slough". In 1936, Borth ran south from the quarter corner of 24 & 19, and at 2701.6 feet, he fell 9.5' east of this Witness corner. 2011, D. Tusty, after several attempts of searching for the "corner in slough", I used the recovered original pine stump to re-establish the WC location. As the corner falls in slough as described by Borth and because the chance of a reset corner monument being washed out by spring ice melt, is great, I set a new witness corner, 30 feet to the south, on the section line, on a piece of high ground. The new witness corner falls 15 feet south, 10 feet east and 18 feet north of the apparent high water mark of the Wolf River. I set the monument and preserved the corner location at shown below. Considering the difficult river bottom terrain both north and south of here, Borths distances compare very well with actual distances. See sketch below.

- I set a 1" x 30" iron pipe for the witness corner.
- Set a 6' white vinyl sign post 0.4' north of the monument.
