## LANGLADE COUNTY U.S. PUBLIC LAND CORNER RESTORATION

The East Quarter corner of Section 27, T. 34 N., R. 12 E., Langlade County, WI.

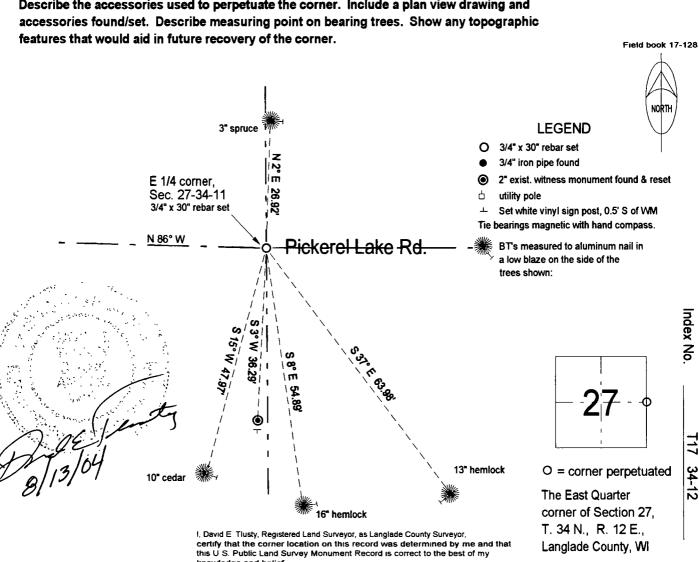
The original corner was established in 1865 by James L. Nowlin. Original bearing trees: hemlock, 12", S57°W, 17 links and a birch, 16", S15°E, 20 links. In 1925, Malcolm Hutchinson established this corner by proportionate methods and marked a new BT: spruce, 17", N24°E, 27 links. In June of 1936 he measured west from this corner, 5318.45' to the W1/4 corner of Sec. 27. In 1970, Ray Hallisy: "Found wood stake down, marked W.C. 36 Links N. to Cor. 2" iron pipe." 36 links = 23.76' . He: "Set 2" iron pipe with brass cap in cement monument 4" x 2 Ft." and marked bearing trees for th WC. 08/14/04 D. Tlusty found Hallisys iron pipe with b/cap witness monument, bent and lying on ground on south side of road, but with no concrete. Approx. 23.76 feet north of destroyed WC, I found 2 railroad spikes, a PK nail and another small nail, all within 0.1'. From this position, Higginbotham measured 5323.35' to the W1/4 corner of Sec. 27 which is within 4.9' of Hutch's distance. I accept the evidence found as the best location for the 1/4 corner.

I replaced the existing spikes with a 3/4" x 30" rebar, top of which is 0.3' below the road surface. I set a Berntsen Deep1 magnet on the east edge of the rebar.

I straightened Hallisys WC (2" OD x 42" ip w/brass cap) and drove it flush with the ground as shown below.

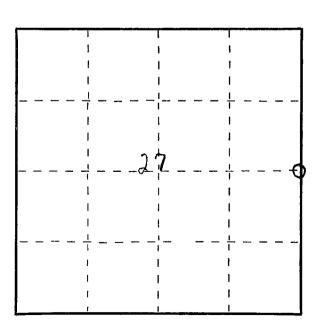
O = Corner monument restored.

Found wood stake down, marked W.C. 36 Links N. to Cor. 2" iron pipe.

Set 2" ipon pipe with brass cap in cement ronume at \$2 4" by 2 Ft.

New B.T. 's Balsam 12 Links 30.6 Links S60E 10" He lock R.T.'s faced at base of tree and scribed BT.
