U.S. PUBLIC LAND SURVEY MONUMENT RECORD

The WEST 1/4 corner of Section 34, T. 34 N., R. 12 E., Langlade County, WI

PLSS field condition report

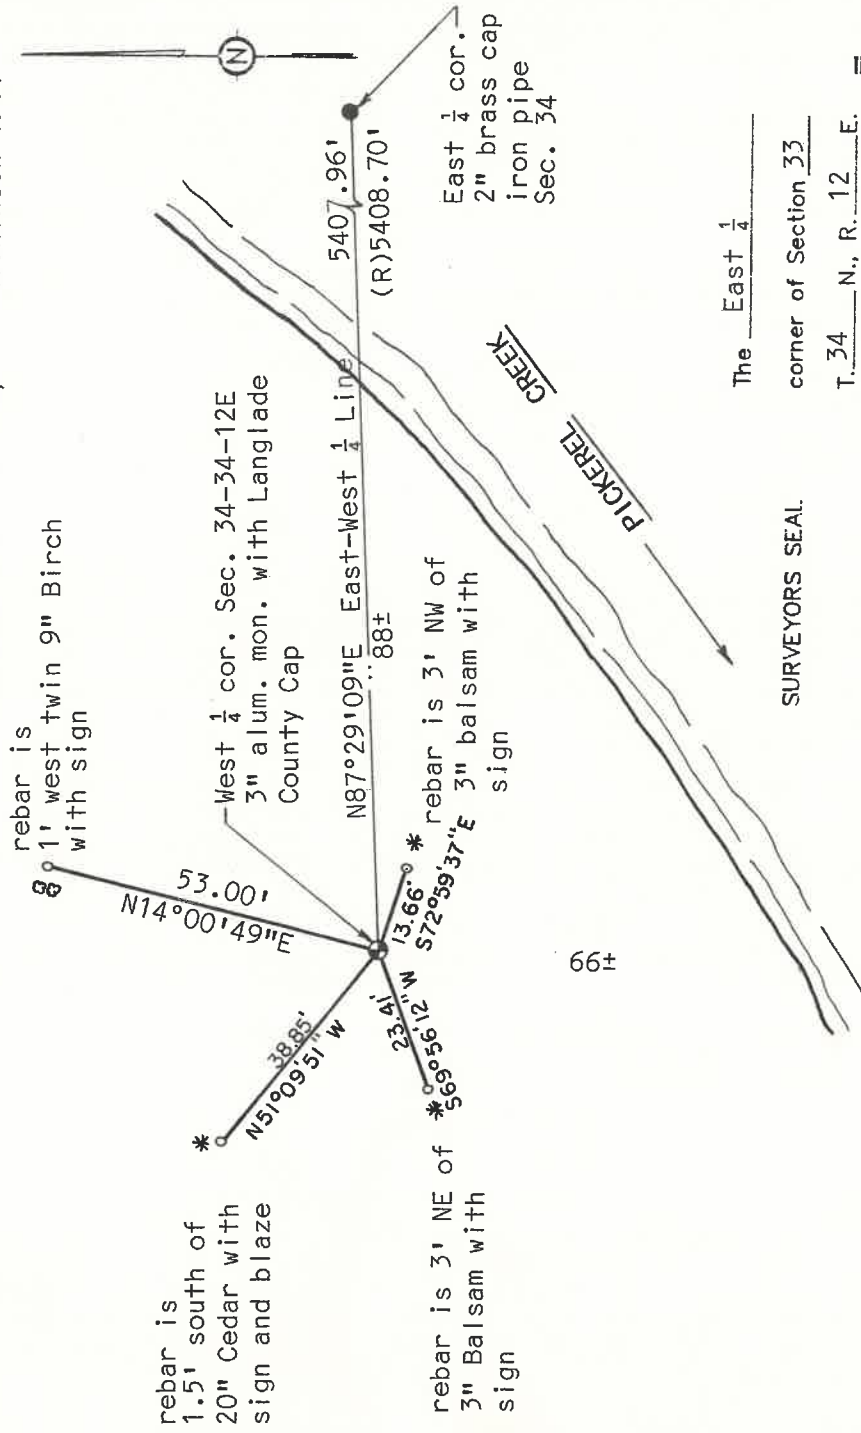
3" aluminum monument with Langlade County cap 1.5 feet above ground. There is a 4" x 4" wood post, 2 feet above ground, on the north side of monument and set a white vinyl post 0.5 feet south of monument. Corner is located west of creek in Tag Alders.

Signs on reference trees are yellow 3/4" x 30" rebar

rebar is 1.5' south of 20" Cedar with sign and blaze

rebar is 3' NE of 3" Balsam with sign

* rebar is 3' NW of 3" balsam with sign
