LANGLADE COUNTY U.S. PUBLIC LAND CORNER RESTORATION

The section corner common to Sections 5 & 6-33-09 and Sections 31 & 32-34-09, Langlade County, WI.

CERTIFIED LAND CORNER RESTORATION

Index No. A-5

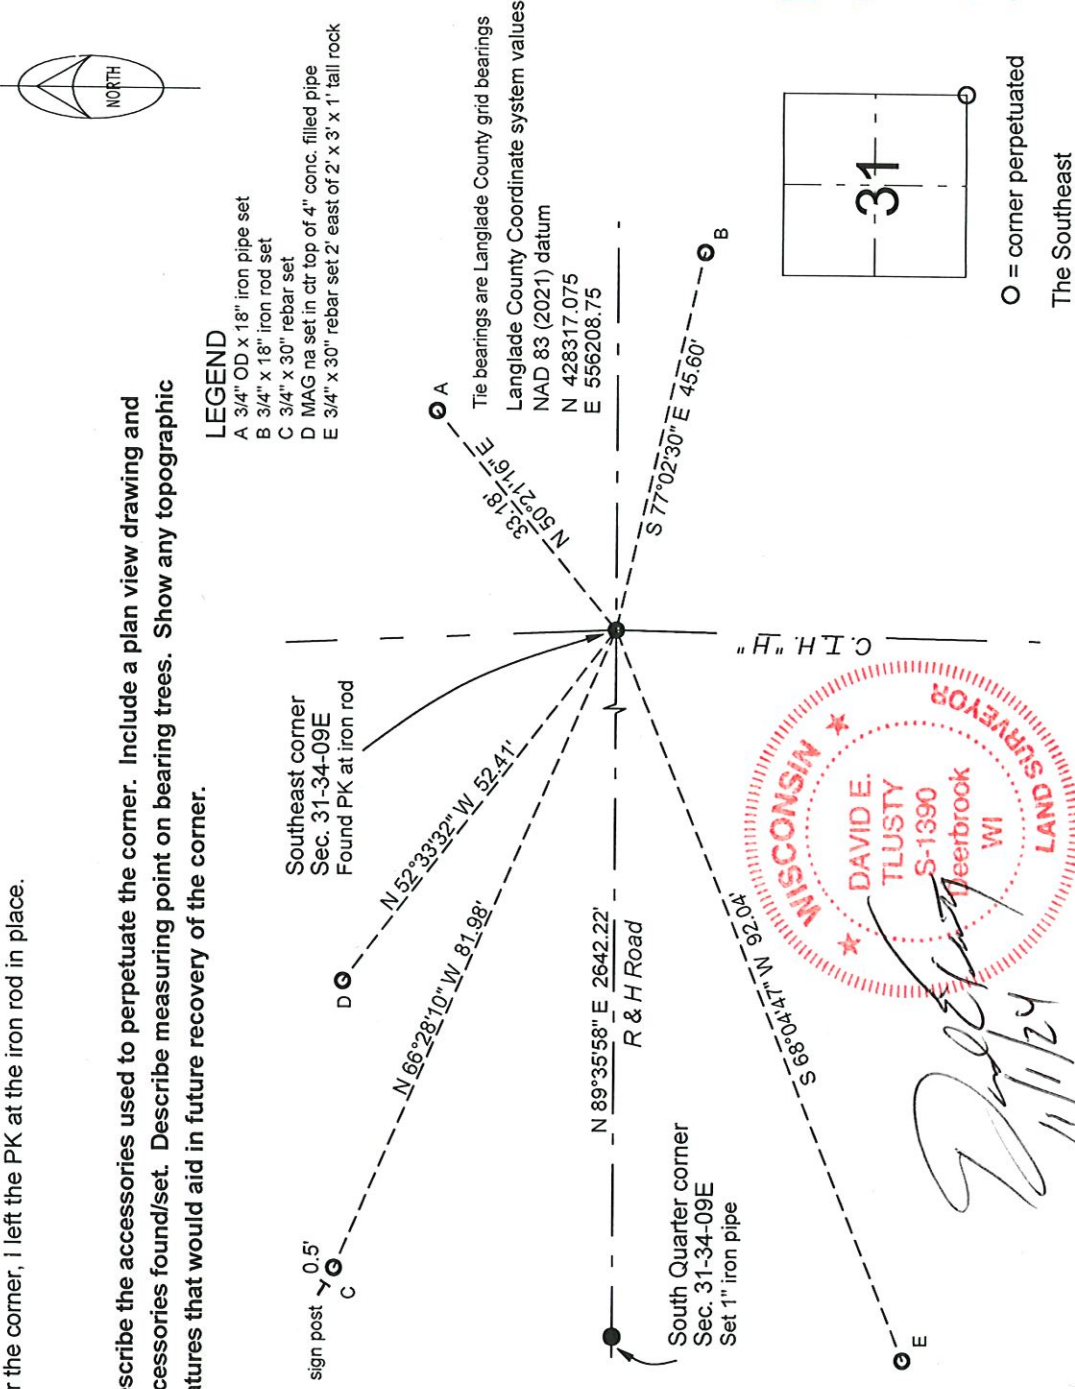
O = corner perpetuated
The Southeast
corner of Section 31,
T. 34 N., R. 09 E.,
Langlade County, WI

Bernitsen SN-1 of unknown origin falls S 42°50' W, 2.81' from recovered iron rod section corner.

For the corner, I left the PK at the iron rod in place.

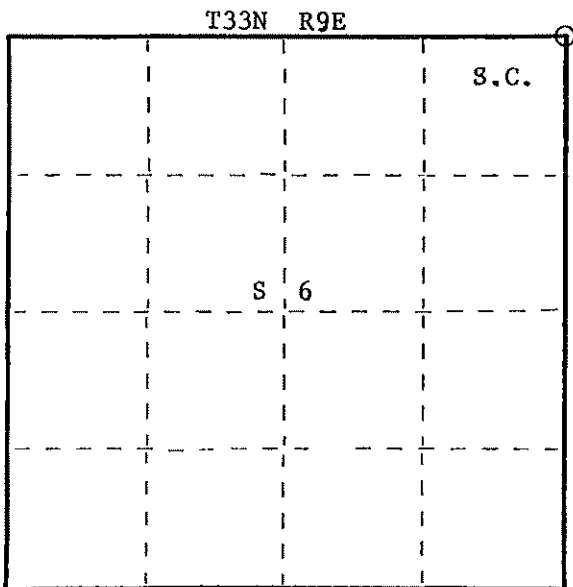
○ = Corner monument restored.

Recovered a 1" iron rod 2-1/2 feet below road surface of C.T.H. "H" - rod is driven in original road bed. This position falls in line with fence line which runs East and Town Line Road which runs west. Recovered a 4" diameter iron pipe with brass cap N50°W 52.40 feet of iron rod. Brass cap stamped:

As witness corner recovered conflicts with iron rod, I believe that the W.C. has been disturbed and moved by road construction. Witness Corner falls in west ditch line next to a new culvert. I don't believe the culvert could have been replaced without moving the witness corner.

Set a 2-1/2" iron pipe with screw-on brass cap 45.0 east of true corner. Brass cap stamped:
Monument projects 18" above ground.
Marked N.B.T. - Sugar 10" S65°W 121.70 feet - scribed S.C. BT
B.O. - Road sign post N59°W 67.45 feet.
