CERTIFIED LAND CORNER RESTORATION

Index No. R-11

PLSS field condition report

Section 28 Town 34 Range 12E
(circle corner location on diagram)

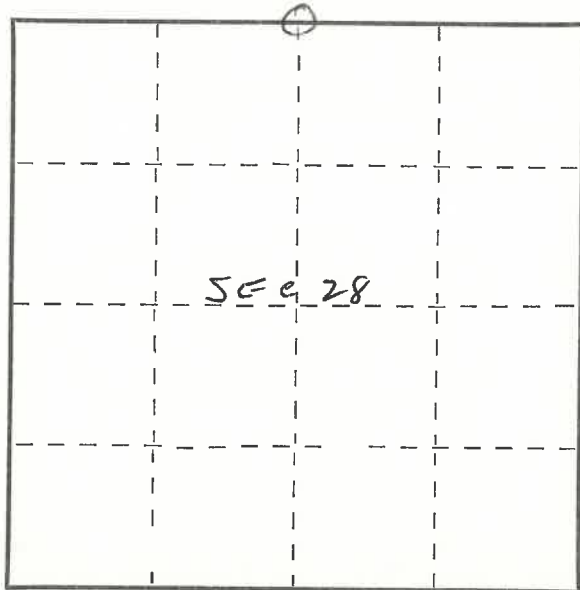
6" BALSAM
N 30 W 4' 10"
SCRIBED BT

B.E.

10" W/BIRCH
N 29 E 8' 8"
SCRIBED BT

○ = Corner monument restored.
