CERTIFIED LAND CORNER RESTORATION

Index No. 2-13

PLSS field condition report

Section 33 Town 34 Range 12
(circle corner location on diagram)

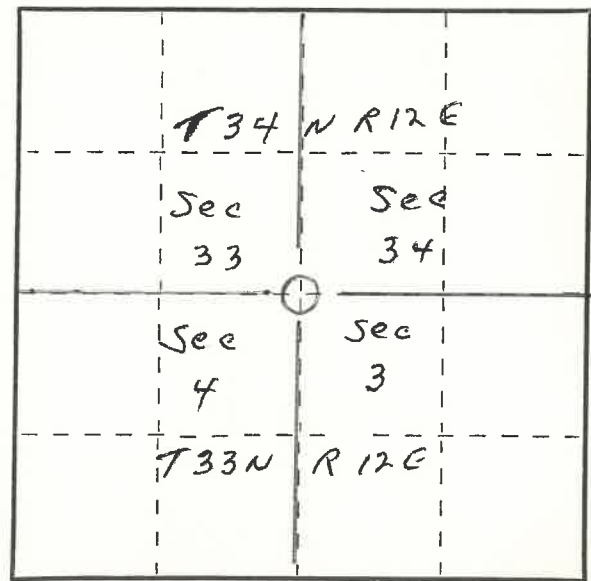
Set 2" iron pipe with brass cap
 New BT's

- 10" Red Maple S67E 18.6 Ft.
- 5" White Pine N21W 28.1 Ft.
- 12" Jack Pine N79E 34.1 Ft.

○ = Corner monument restored.
