U. S. PUBLIC LAND SURVEY MONUMENT RECORD - ADDENDUM

A-E 7.08(3)(a) Identity of corner:
South 1/4 Corner Section 08,
Township 34 North, Range 10 East
of the Fourth Principal Meridian,
Town of Eicho, Langlade County, Wisconsin

LANGLADE COUNTY U.S. PUBLIC LAND CORNER RESTORATION

The South Quarter corner of Section 8, T. 34 N., R. 10 E., Langlade County, WI.

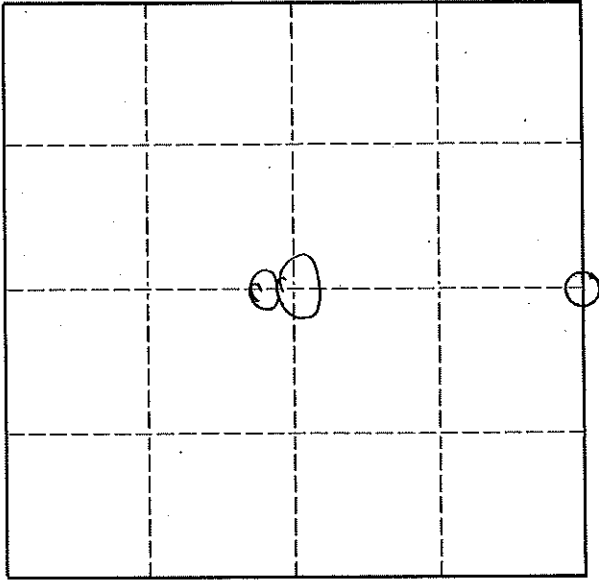
$\frac{1}{2}$ COR. 8, 17
 T34N, R10E

Found iron pipe in road bent. Replaced with 3/4 rebar with red cap. Also found C.C.C. monument to south of road. Kelly's ties were to w. birch and they are dead or gone.
