U.S. PUBLIC LAND SURVEY MONUMENT RECORD

The WEST 1/4 corner of Section 34, T. 34 N., R. 12 E., Langlade County, WI

PLSS field condition report

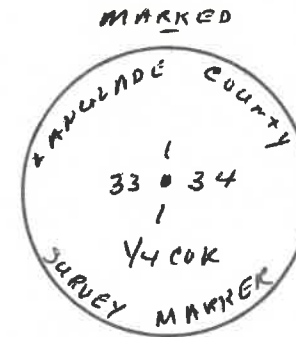
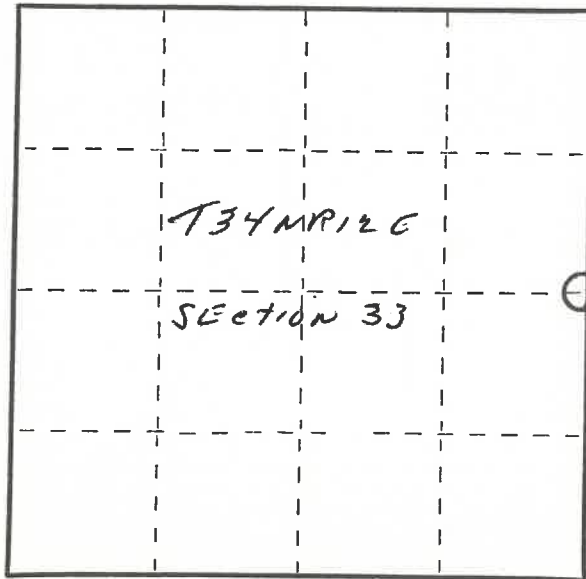
6" SCRIBED WOOD POST DOWN, POINT INTACT

SET 3" ALUMINUM PIPE WITH CAP
WITH POST ALONGSIDE

16" CEDAR N51W 39.8'
9" BLACK SPRUCE N40W 48.5'
10" TAMARACK N38W 45.7'
4" BLACK SPRUCE N28W 48.7'
