# U.S. PUBLIC LAND SURVEY MONUMENT RECORD

The East Quarter corner of Section 1, T. 30 N., R. 11 E., Langlade County, WI

INDEX No. C25  
30-11

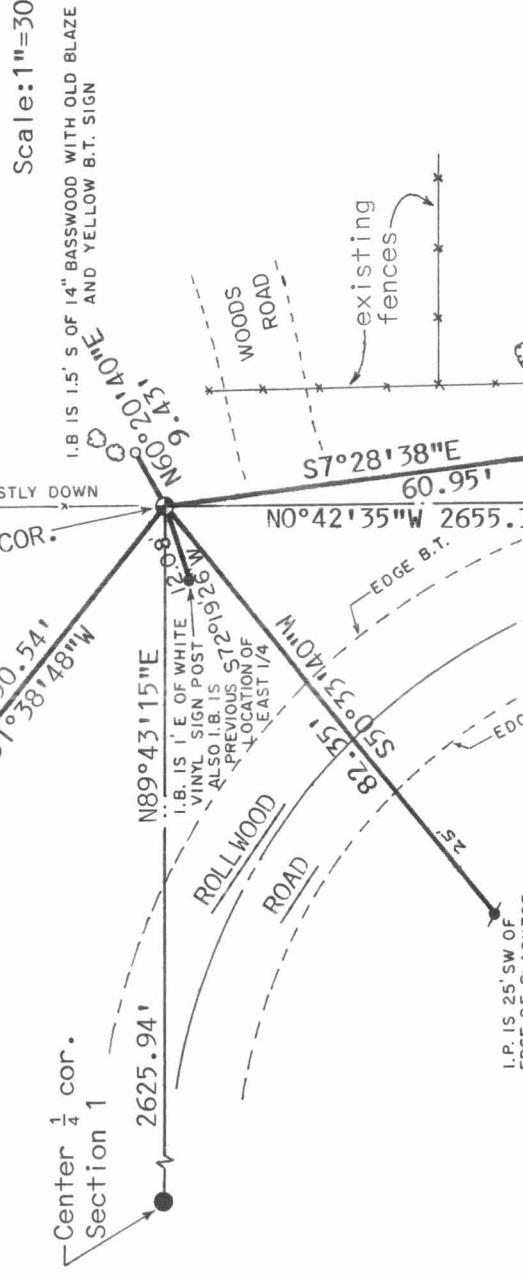
**Describe the accessories used to perpetuate the location of the corner. Include a plan view drawing and indicate accessories found/set. Describe measuring point on bearing trees. Show any topographic features that would aid in future recovery of the corner.**

#### LEGEND

• Existing 1"O.D. iron pipe

• Existing 3/4" iron bar

Bearings referenced to Section lines shown

Scale: 1"=30'

● = Location of corner

In 1995 D. Higginbotham found a 3/4" rod at PI of N. Rollwood Rd and W Rollwood Rd. and accepted it as the E $\frac{1}{4}$  location and set out the following ties: 1"x30" iron pipe N41°W 46.76', 40D nail in 12" Basswood N64°E 21.79', 40D nail in 24" Oak S28°E 63.28', 1"x30" iron pipe S48°W 71.29'.

Believed stone was moved due to road construction in the past. Moved stone and set  $1\frac{1}{4}$ " x 30" round iron bar at calculated position from Radtke map. Iron bar is set flush with ground and set stone on west side of iron bar. From West  $\frac{1}{4}$  corner through Center  $\frac{1}{4}$  to set East  $\frac{1}{4}$  is a straight line as shown on Section Summary filed with County Surveyor. Accepted this location as best evidence of East  $\frac{1}{4}$  corner and tied out as shown below. East  $\frac{1}{4}$  is N72°19'26"E, 12.08 feet from previous East  $\frac{1}{4}$  location found and tied out by D. Higginbotham.
