# U.S. PUBLIC LAND SURVEY MONUMENT RECORD

The SOUTH QUARTER corner of Section 18, T. 30 N., R. 11 E., Langlade County, WI

The SOUTH 1/4  
corner of Section 18  
Langlade County, WI

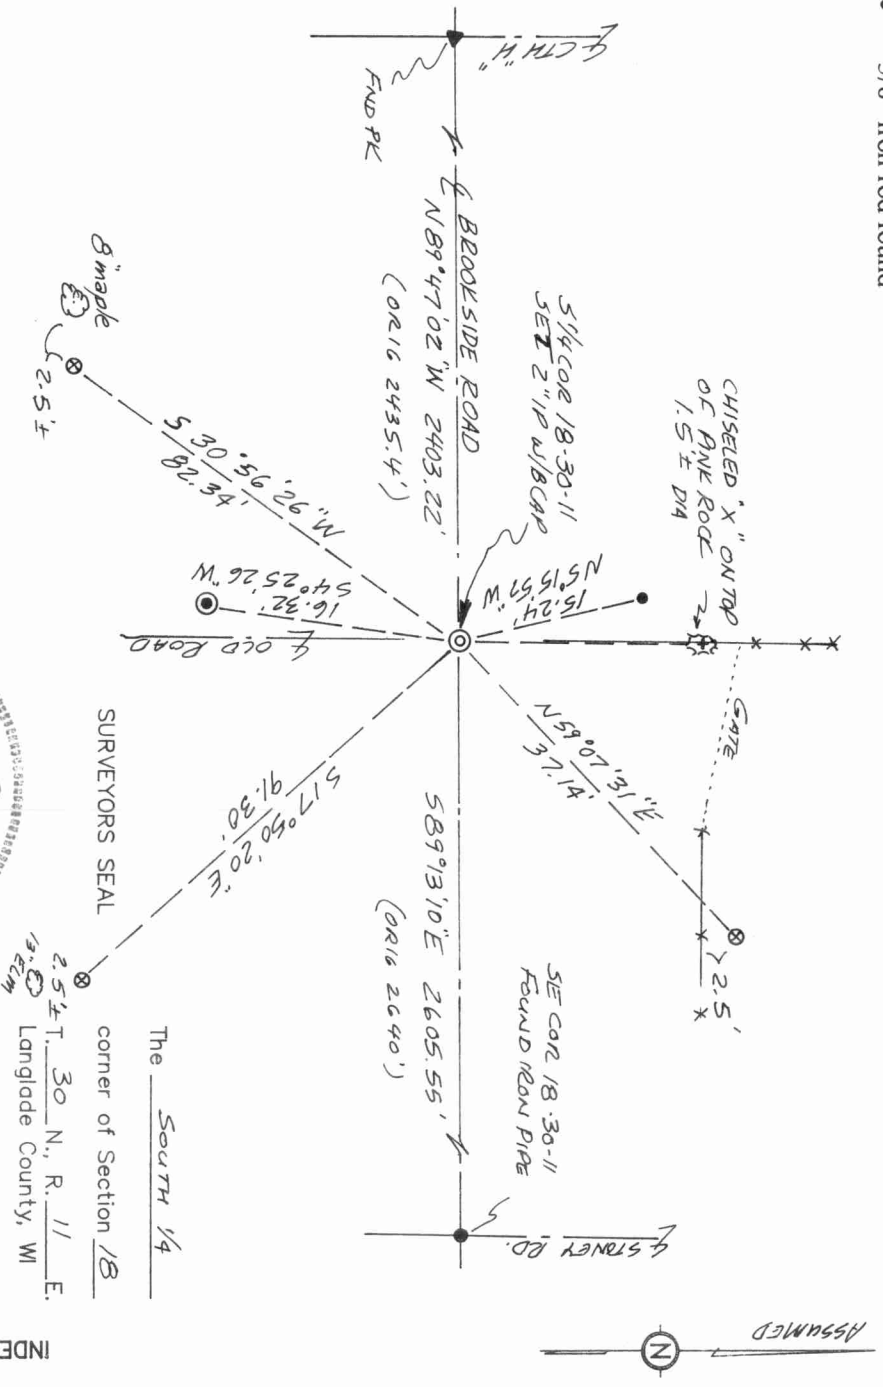
FB10-45

I set a new 2" x 30" galvanized, flared bottom, iron pipe with 3 1/4" brass cap, top of which is 0.8' below road surface.

**Describe the accessories used to perpetuate the location of the corner. Include a plan view drawing and indicate accessories found/set. Describe measuring point on bearing trees. Show any topographic features that would aid in future recovery of the corner.**

- ⊙ = 2" aluminum mon. with 3 1/4" alum cap found
- ⊗ = 3/4" x 30" rebar set flush
- = 5/8" iron rod found

This corner was established in October, 1853 by William T. Bradley. Original B.T.'s: elm, 11", S31°W, 11 links, and a maple, 10", S73°E, 10 links. In 1891, the Town Board of the town of Rolling, ordered that a road shall be laid out on the section line between Sections 17, 20, 18 & 19, and awarded damages for said road. I find no information of record other than this road information. In 1982, former surveyor Kelly called the corner: "Fence line intersection identified as corner location by occupation", and set an aluminum monument and marked three BT's. In 1997, we dug for evidence at the intersection of the center of Brookside Road, and the fence line to the North. Found nothing. As Kelly's corner does not fit fences in Sections 18 and 19, nor the center of Brookside Road, I do not agree with his location for the corner. I accepted the intersection of the centerline of Brookside Road at the intersection of a fence north and the center of a road to the south as the best evidence of the corner location. I set a monument and ties as described below.
