U. S. PUBLIC LAND SURVEY MONUMENT RECORD

The East Quarter corner of Section 1, Township 31 North, Range 10 East, Langlade County, Wisconsin.

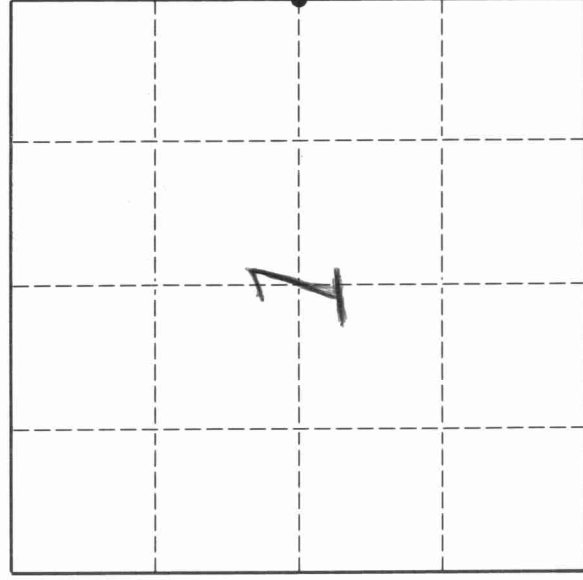
T. 31 N., R. 10 E.

- (a) Identify the corner by reference to the U.S. public land survey system.
- = Corner monument restored.

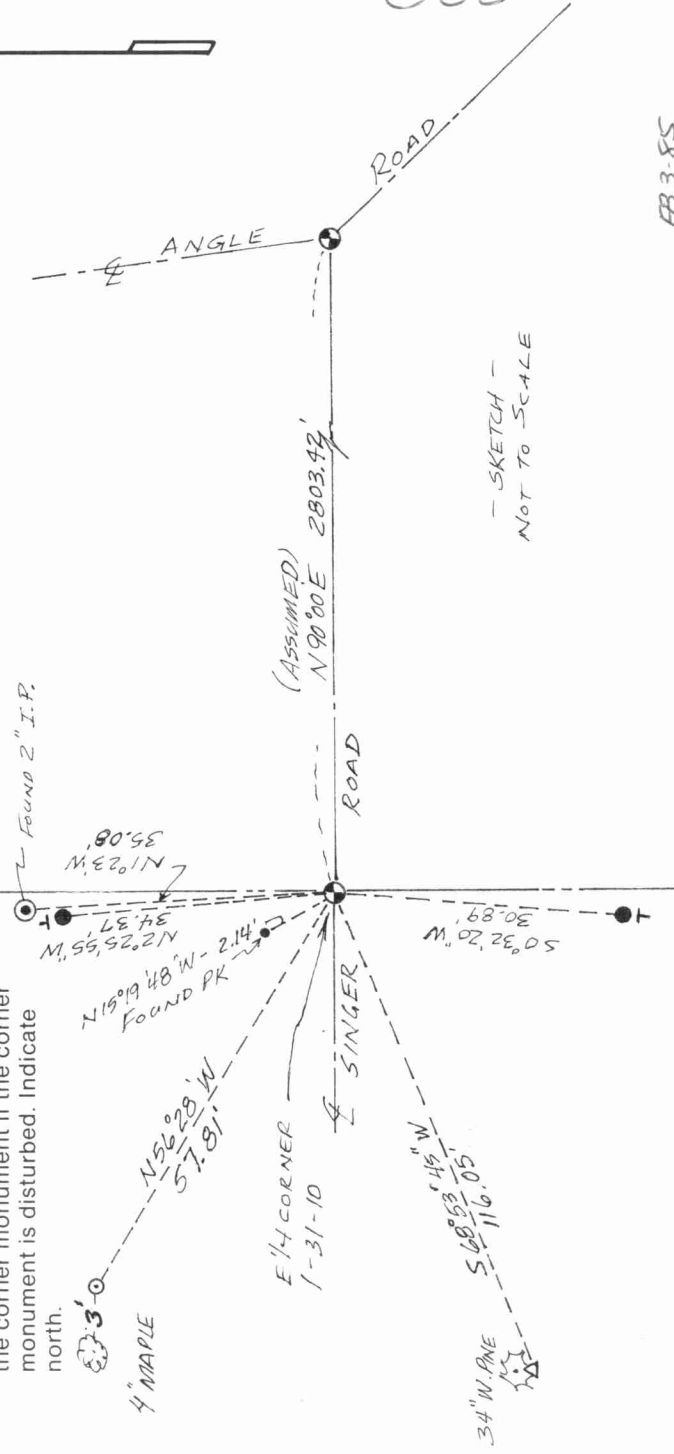
- SKETCH - NOT TO SCALE

In the plan view drawing below, provide reference ties to at least 4 witness monuments, or, if the location is within a municipality, to at least 2 witness monuments. (Witness monuments shall be made of concrete, natural stone, iron or other equally durable material.)
 Describe witness monuments.

- = 1 1/4" OD iron pipe with brass cap set @ = 3/4" x 30" re-bar set
- ↓ = vinyl sign post set within 0.5' of witness
- Δ = 60d nail set upright in root crown on south side of 34" white pine

- (d) Show a plan view drawing depicting the relevant monuments and reference ties which is sufficient in detail to enable accurate relocation of the corner monument if the corner monument is disturbed. Indicate north.

6/10/93 (con't) I also found the 2 brass capped wit. mon's. by Poss, both bent. I removed them, straightened them and re-set them flush with the ground. I found Kellys PK as shown on sketch. I don't think that Kelly dug out the iron pipe or his nail would have been closer to the pipe I found.
