LANGLADE COUNTY U.S. PUBLIC LAND CORNER RESTORATION

The Southeast corner of Section 15, T. 31 N., R. 11 E., Langlade County, WI.

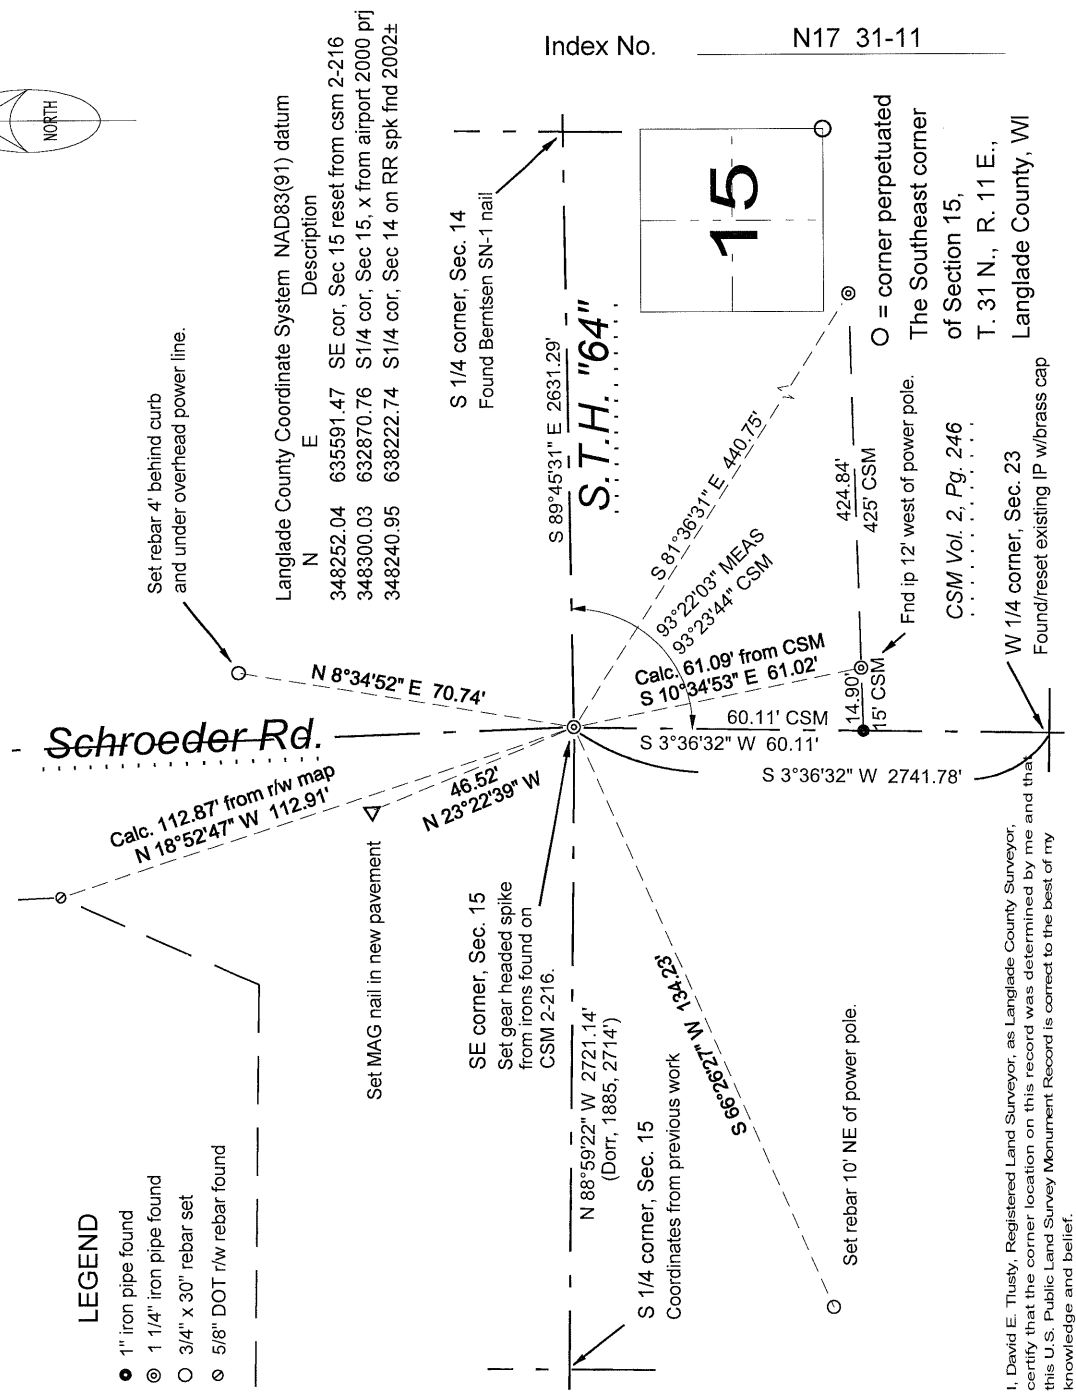
Describe the accessories used to perpetuate the corner. Include a plan view drawing and accessories found/set. Describe measuring point on bearing trees. Show any topographic features that would aid in future recovery of the corner.

- 1" iron pipe found
- ⊙ 1 1/4" iron pipe found
- 3/4" x 30" rebar set
- ⊙ 5/8" DOT r/w rebar found

The original corner was established in 1860 by Hiram C. Fellows. Original bearing trees: w pine, 14", N15E, 18 links and a w pine, 10", N44W 27 links. In 1878, Deleglise (FB144-31) mentions this corner and found two original bts: pine, 22", N16°1/2E, 22 1/3 links and a pine, 16", N44W, 27 links. He added two new bts: pine, 16", S22E, 21 1/2 links and an elm, 11", S51W, 57 2/3 links. In 1881±, Dorr (FB140-105) stated "Ogl fieldnotes reasona correct". In 1885, Dorr (Fb140-19) measured 41.12 chains (2714') from this corner to the quarter corner to the west. In July 1978, former surveyor Kelly said "Located a 1" iron pin in center of Hwy. 64 set by Becher-Hoppe Engineers, Inc." He set two witness monuments. In 1988 Kelly "Set new Wit. monuments to clear road for construction". He shows a RR spike for the corner and measured to ties to the south and southwest. In 2003, I found and shot RTK GPS on a RR spike. 12/06/2004 I set control points in area to save corners from a future repaving project. 6/15/11 DT checked into control points at set a nail at the location previously shot in 2004. However, after measuring to recovered pipe on CSM 2-216 and a DOT r/w rebar NW I realized that the previous RR spike found does not fit the CSM or the DOT rebar. Therefore, I computed the corner location based on said CSM as shown below. This location is S 68°49' E, 1.12 feet from the RR spike found in 2004.
