U.S. PUBLIC LAND SURVEY MONUMENT RECORD

THE SOUTH QUARTER CORNER OF SECTION 19, T. 31 N., R. 11 E., LANGLADE COUNTY, WISCONSIN.

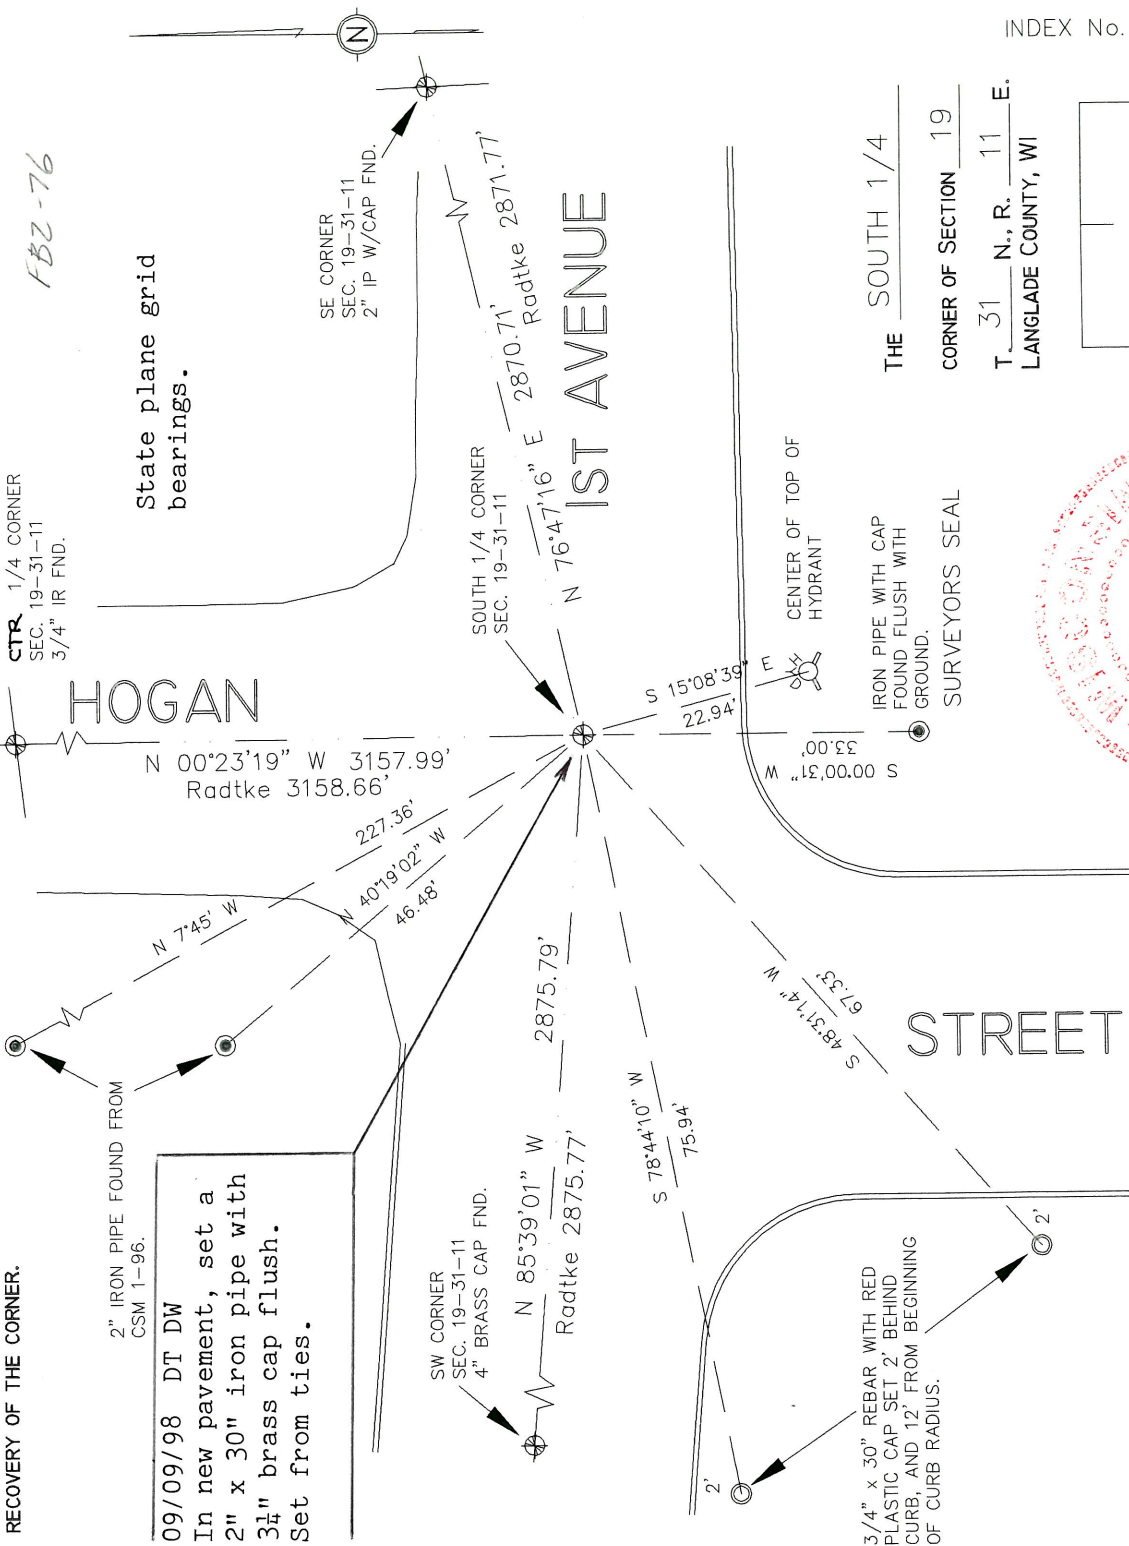
Re-established corner position is S 47°49'34" W, 2.07' from re-set nail and washer, and S 61°12'53" W, 1.93' from a PK nail found.

Set small nail as temporary corner until road thaws out. Corner falls approximately 2.7' NE of the center of manhole.

DESCRIBE THE ACCESSORIES USED TO PERPETUATE THE LOCATION OF THE CORNER. INCLUDE A PLAN VIEW DRAWING AND INDICATE ACCESSORIES FOUND AND SET. DESCRIBE THE MEASURING POINT ON BEARING TREES. SHOW ANY TOPOGRAPHIC FEATURES THAT WOULD AID IN THE FUTURE RECOVERY OF THE CORNER.

09/09/98 DT DW
In new pavement, set a .2" x 30" iron pipe with 3/4" brass cap flush. Set from ties.
