# LANGLADE COUNTY U.S. PUBLIC LAND CORNER RESTORATION

The South quarter corner of Section 25, T. 31 N., R. 11 E., Langlade County, WI.

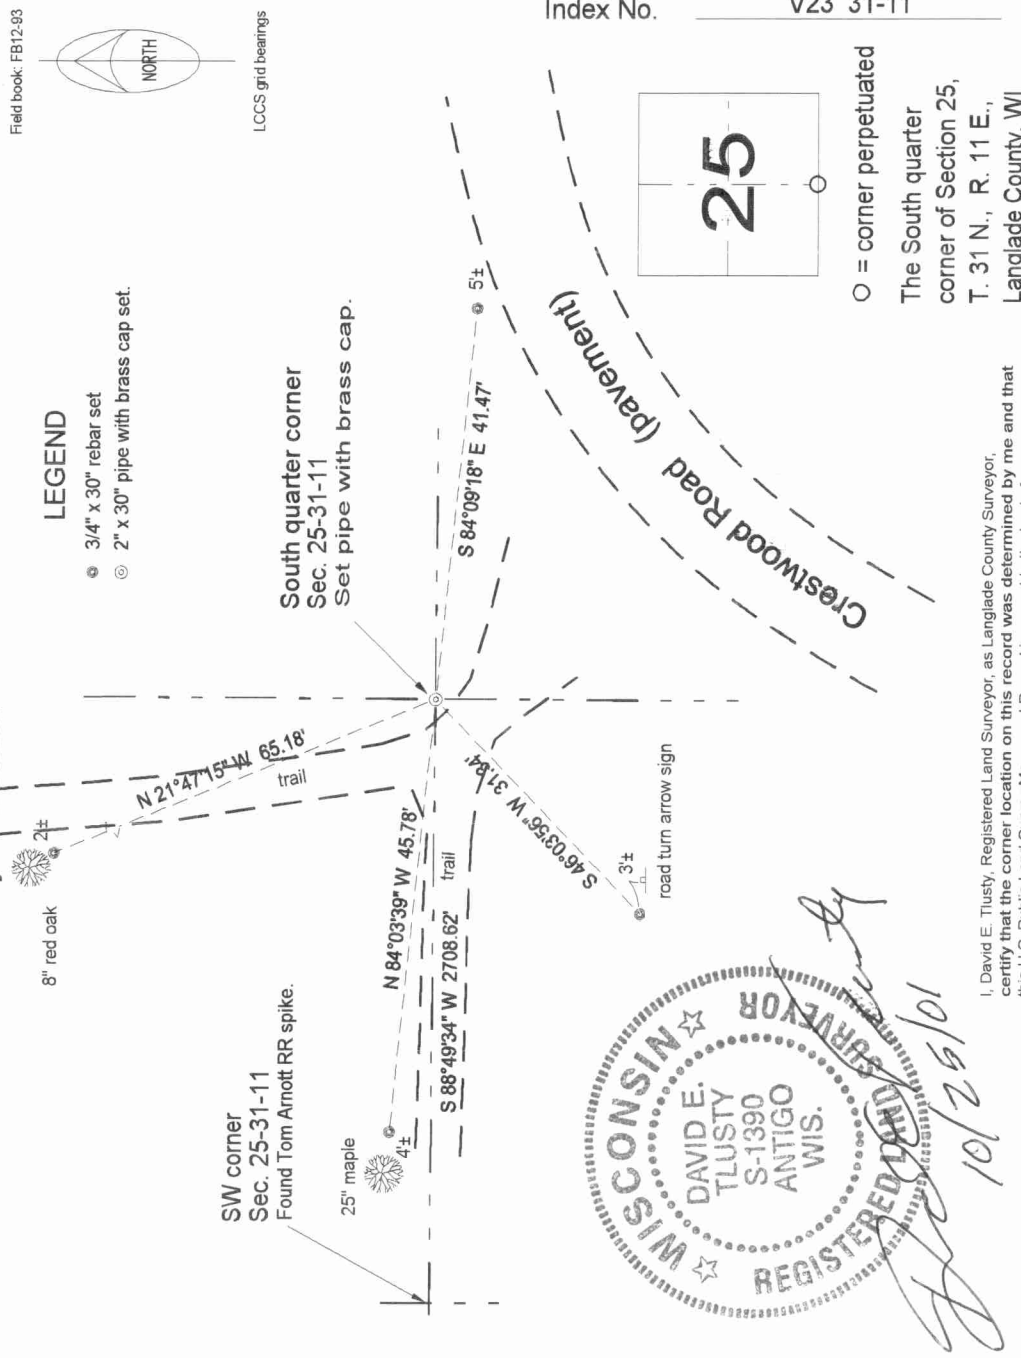
**Describe the accessories used to perpetuate the corner. Include a plan view drawing and accessories found/set. Describe measuring point on bearing trees. Show any topographic features that would aid in future recovery of the corner.**

Set 2" (ID) x 30" galvanized, flared bottom iron pipe with brass cap, flush with ground.  
Set white vinyl sign post 2' north of corner monument.
