# U. S. PUBLIC LAND SURVEY MONUMENT RECORD

South Quarter corner of Section 27, Township 31 North, Range 11 East, Langlade County, Wisconsin.

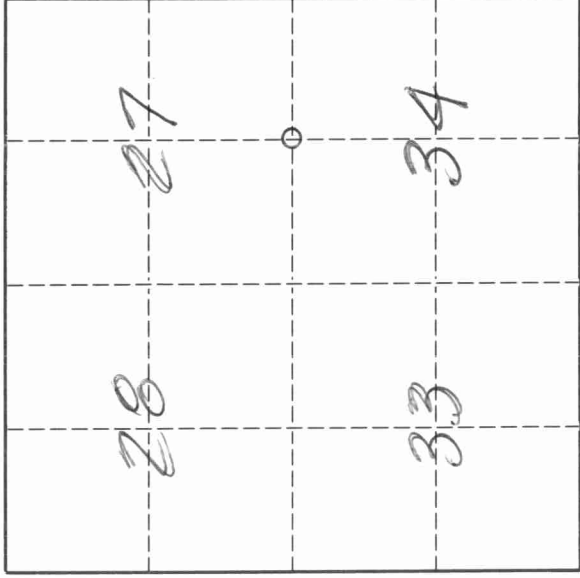
T. 31 N., R. 11 E.

- (a) Identify the corner by reference to the U.S. public land survey system.
- O = Corner monument restored.

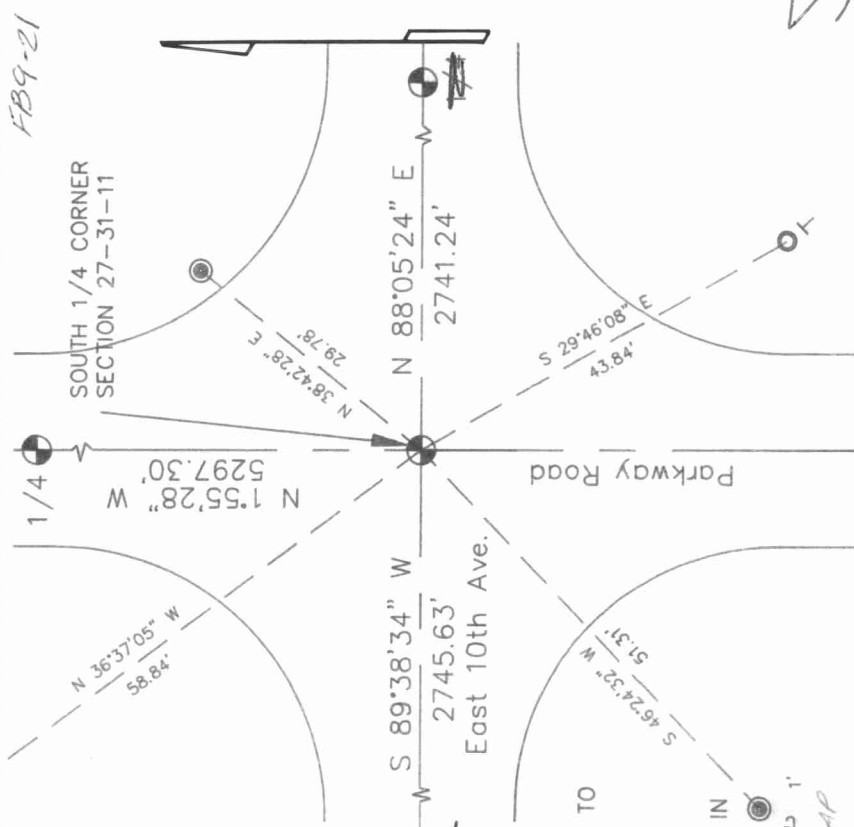
- (d) Show a plan view drawing depicting the relevant monuments and reference ties which is sufficient in detail to enable accurate relocation of the corner monument if the corner monument is disturbed. Indicate north.

- 2" IP W/BC WITNESS FOUND
- 3/4" RE-BAR WITNESS FOUND
- ⊥ POWER POLE
- ⊥ VINYL SIGN POST SET
- 60d SPIKE SET FOR TEMPORARY CORNER MARKER IN ROAD PATCH.
- BEARINGS ASSUMED & REFERENCED TO SECTION LINES SHOWN.
- △ PK NAIL TRAVERSE POINT

SET 1 1/2" X 18" ± IR. WITH 4" BRASS CAP OVER NONE FOUND.

Topped stone with a 1 1/2" x 20" iron pipe with brass cap.

Stone found is approximately N 77°52' E, 3.9' from the Kelly/Becher-Hoppe corner.
