LANGLADE COUNTY U.S. PUBLIC LAND CORNER RESTORATION

The East quarter corner of Section 32, T. 31 N., R. 11 E., Langlade County, WI.

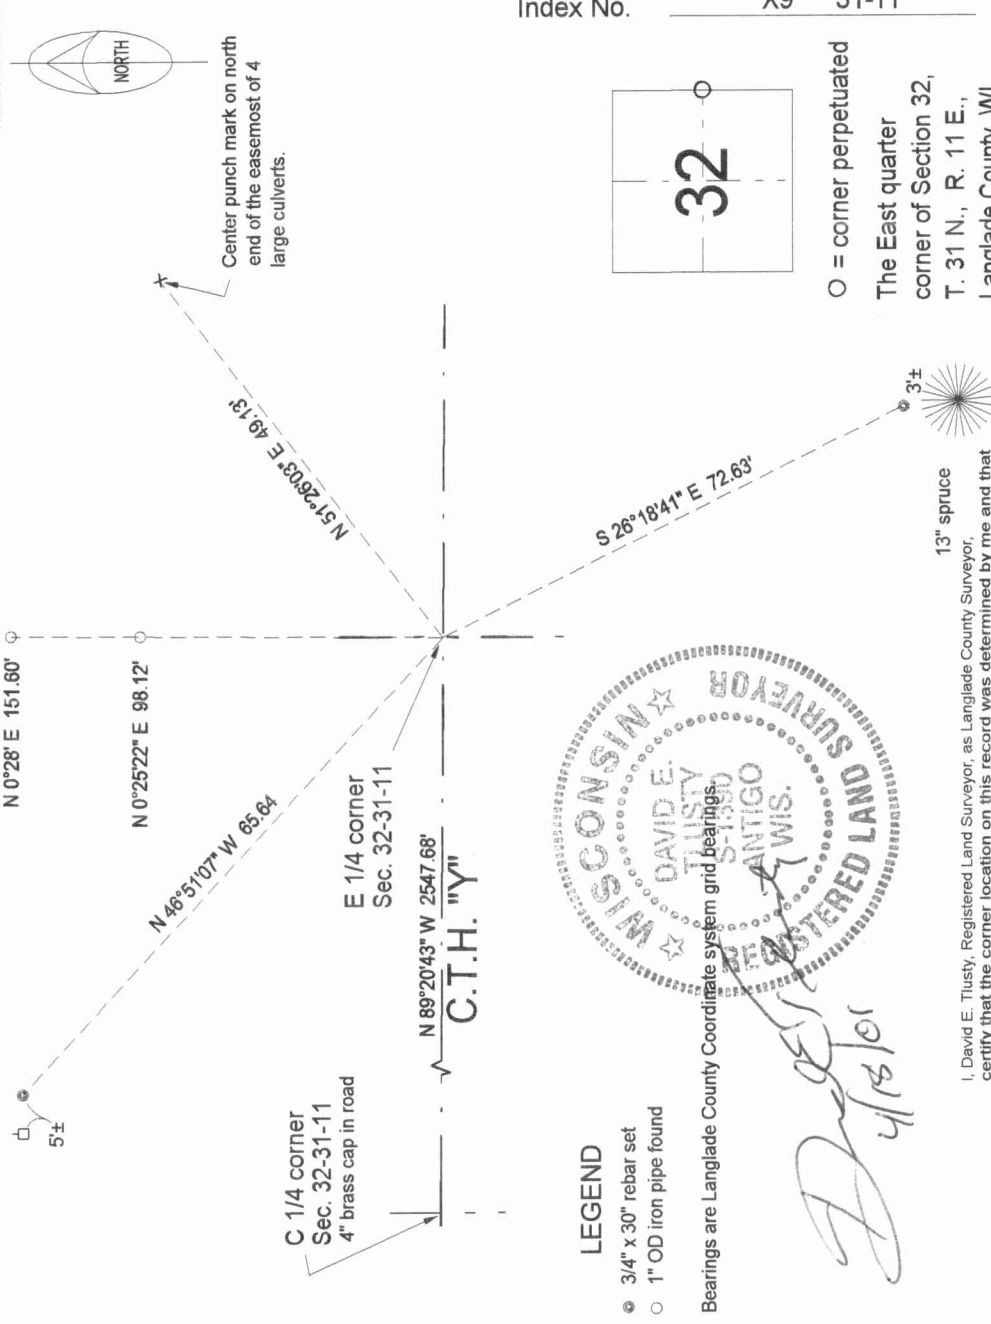
Surface monument is a 1 1/4" x 18" iron pipe with 4" brass cap set flush with the road.

Describe the accessories used to perpetuate the corner. Include a plan view drawing and accessories found/set. Describe measuring point on bearing trees. Show any topographic features that would aid in future recovery of the corner.

The original corner was established in 1860 by Hiram C. Fellows. Original bearing trees: birch 15", S75°W, 27 links, and a birch, 16", N57°E, 30 lks. In 1910, E.S. Brooks, measured east from the center of section 32, at 1274.1' he set "gass" pipe for 1/8 corner. In 1993, I dug for the 1/4 corner with a County backhoe. At 6' down, we found a 1 1/4" x 36" well point, upright and in good condition. I accept this well point as the best evidence of the original corner location. I replaced the well point with a 1 1/4" x 24" pipe with 4" brass cap, top of which is 5.8' below the road surface. The distance from here to the center of Section 32 agrees with Brooks. I set temporary ties to hold corner position during road construction. 4/06/94 Tom Arnott set a PK nail from my temporary ties. 08/18/98 I checked the temporary ties and replaced the PK with a 1/2" x 12" rebar, 12" down, then topped this rebar with a 1 1/4" x 18" iron pipe with 4" brass cap flush with the new road surface.
