LANGLADE COUNTY U.S. PUBLIC LAND CORNER RESTORATION

The South Quarter corner of Section 14, T. 32 N., R. 10 E., Langlade County, WI.

3210140020

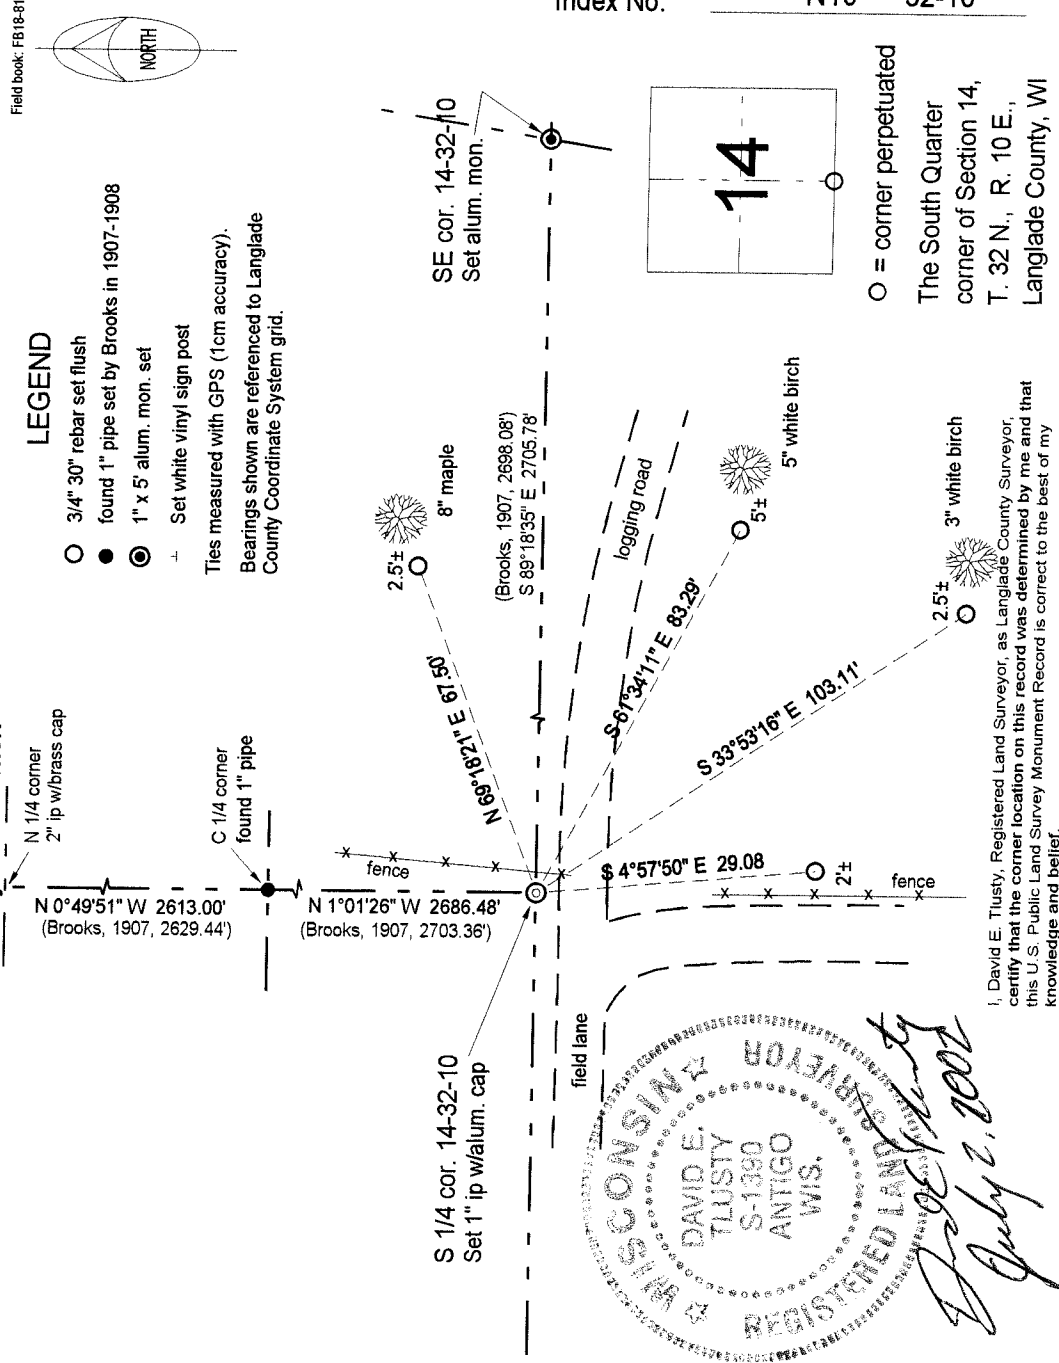
I set a 1" dia. x 5' long, new iron pipe with 2" aluminum cap for the corner.
Set a 6' white vinyl sign post on the North side of the monument.

Describe the accessories used to perpetuate the corner. Include a plan view drawing and accessories found/set. Describe measuring point on bearing trees. Show any topographic features that would aid in future recovery of the corner.
