U.S. PUBLIC LAND SURVEY MONUMENT RECORD

The SOUTH QUARTER corner of Section 20, T. 32 N., R. 10 E., Langlade County, WI

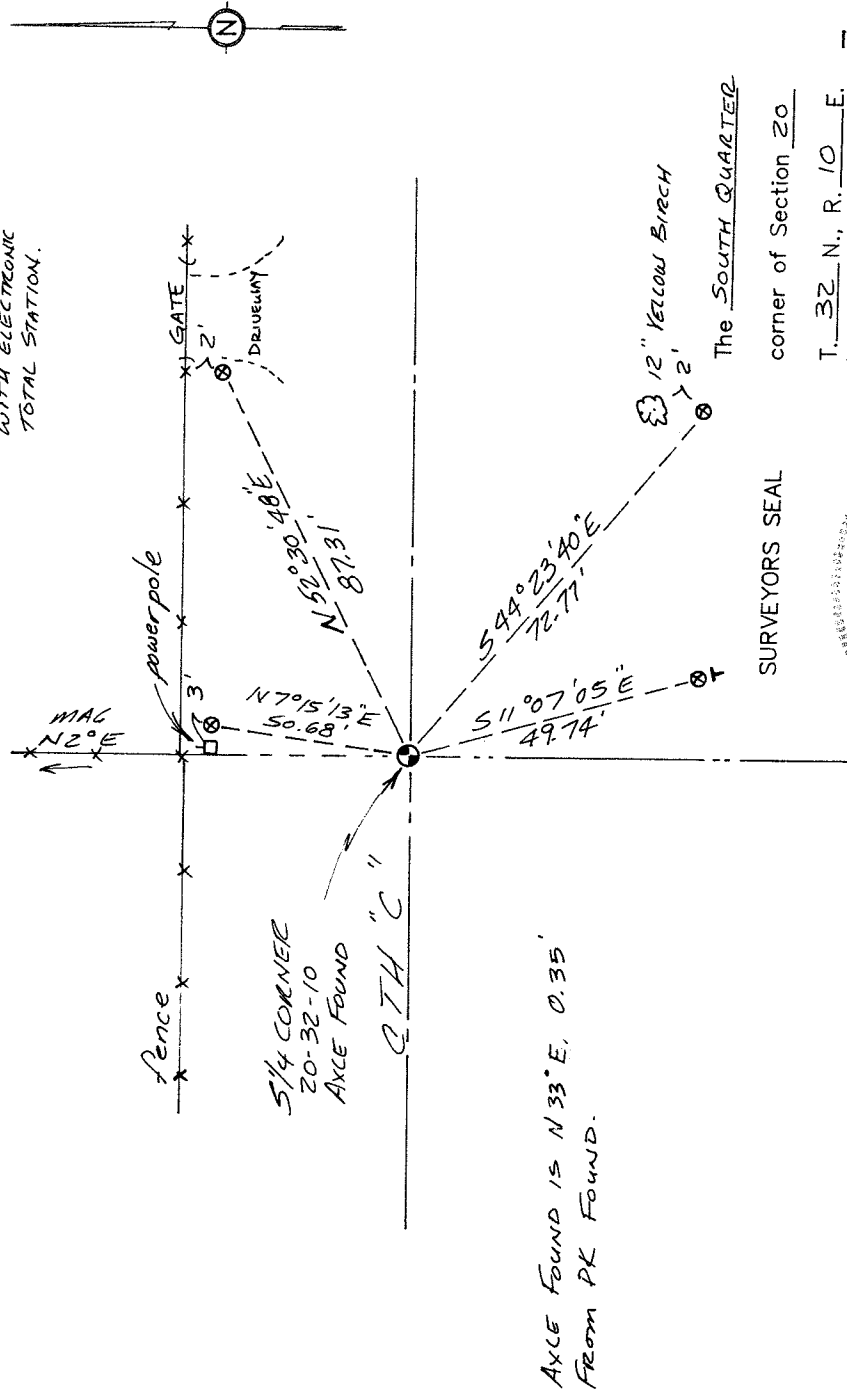
Describe the accessories used to perpetuate the location of the corner. Include a plan view drawing and indicate accessories found/set. Describe measuring point on bearing trees. Show any topographic features that would aid in future recovery of the corner.

⊗ = 3/4" x 30" rebar set flush

⊕ = white vinyl sign post with "Survey Marker" sign set bearing referenced to compass bearing (N2°E) up fenceline

TIES MEASURED WITH ELECTRONIC TOTAL STATION.

AXLE FOUND IS N 33° E, 0.35' FROM PK FOUND.

The original corner was established in 1860 by Hiram C. Fellows. Original bearing trees: maple, 12", S26°E, 14 links and a birch, 20", N36°W, 22 links. In 1939, Hutchinson, in FB122-153, described the corner as a buggy axle. In 1981, former surveyor Kelly described corner as "1" iron pipe, found in place." He set 1 1/2" pipes with brass caps, north and south, 33 feet from the corner. 06/02/99 D. Tlusty, D. Williams found PK in road. Kellys witness pipes are gone. Set short ties. Dug in road and down 0.2' found a piece of 1" x 10" iron pipe, directly under PK. Down 2.6 feet, found 1 1/4" square-ended iron shaft upright & in good condition. Accepted this iron shaft as the buggy axle mentioned by Hutchinson, and as the best evidence of the original corner location. Axle found is slightly north of PK and iron pipe at surface.
