LANGLADE COUNTY U.S. PUBLIC LAND CORNER RESTORATION

The Southeast corner of Section 12, T. 32 N., R. 11 E., Langlade County, WI.

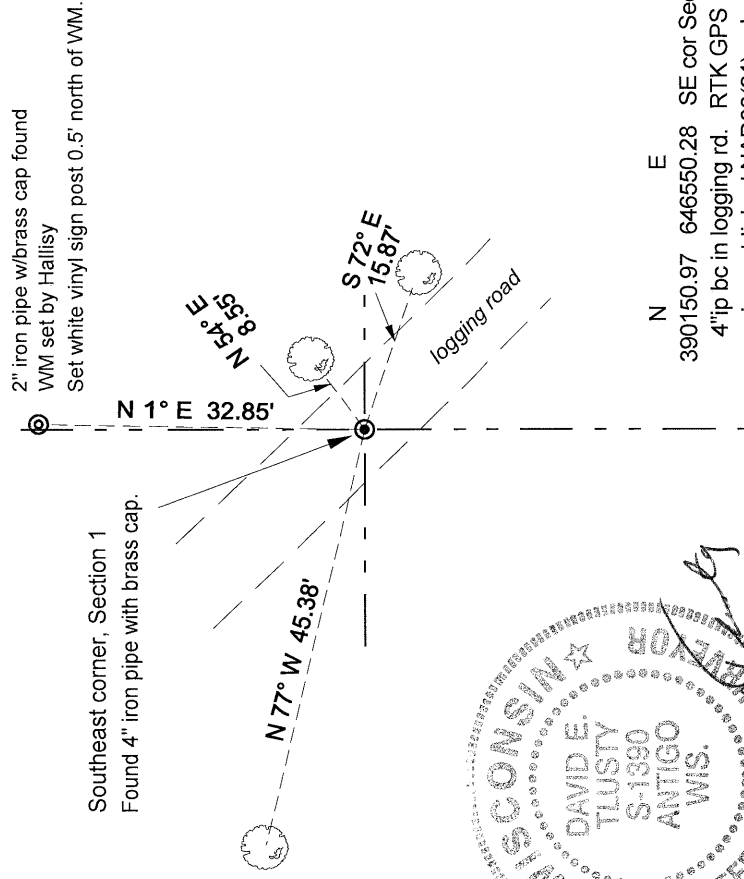
Describe the accessories used to perpetuate the corner. Include a plan view drawing and accessories found/set. Describe measuring point on bearing trees. Show any topographic features that would aid in future recovery of the corner.

2" iron pipe w/brass cap found
WM set by Hallisy
Set white vinyl sign post 0.5' north of WM.

Southeast corner, Section 1
Found 4" iron pipe with brass cap.

Bearing trees are blazed and painted blue and have "Bearing Tree" sign facing corner.
Measurement is to an aluminum nail as noted.
Bearings magnetic with hand compass.

Left existing 4" iron pipe with brass cap in place.
Set white vinyl sign post 0.7' north of the Hallisys WM
