# LANGLADE COUNTY U.S. PUBLIC LAND CORNER RESTORATION

The South 1/4 corner of Section 20, T. 32 N., R. 11 E., Langlade County, WI.

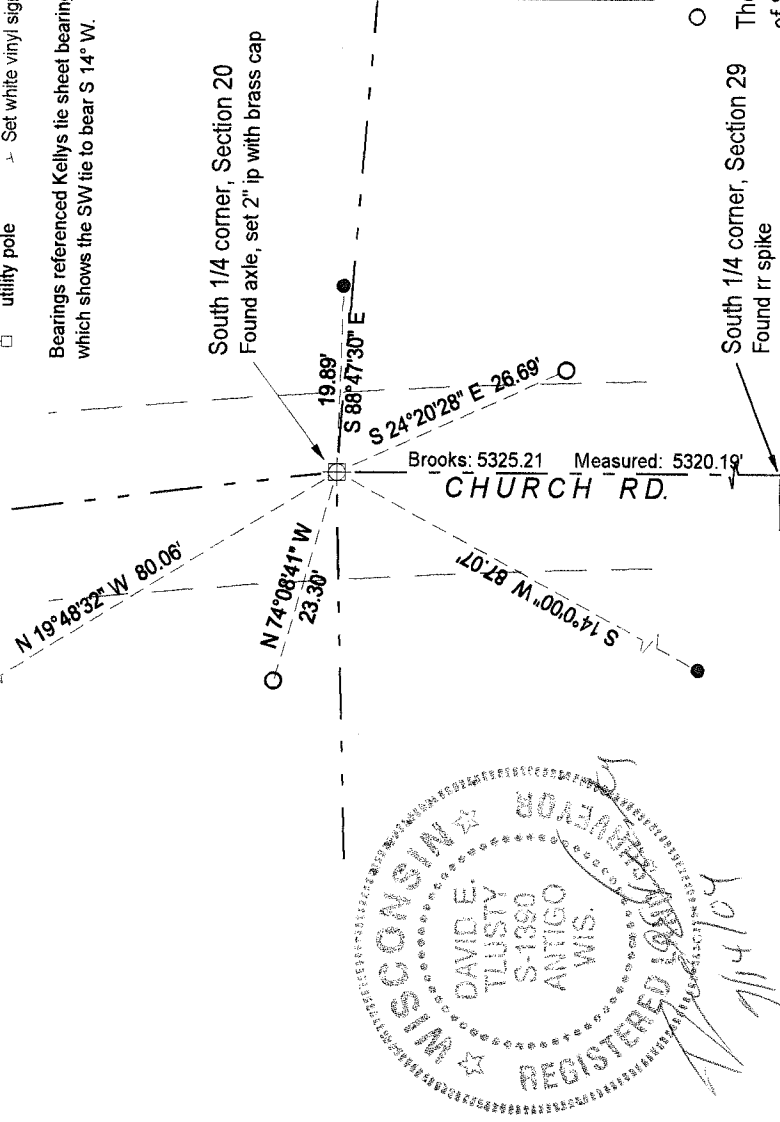
**Describe the accessories used to perpetuate the corner. Include a plan view drawing and accessories found/set. Describe measuring point on bearing trees. Show any topographic features that would aid in future recovery of the corner.**

*Brooks, FB 94-73, 1910  
N-S 1/4 LINE 29 @ 5311.02'  
DT. 11/16/09*

- LEGEND**
- 3/4" x 30" rebar set ● 1" OD iron pipe found
  - x — x — fenceline
  - ⊙ 2" alum. witness mon. found
  - ▽ RR spike found
  - utility pole → Set white vinyl sign post
- Bearings referenced Kelly's tie sheet bearings which shows the SW tie to bear S 14° W.
