(Prepared and as required by S. A-E 7.08 WI Administrative Code)

The <u>West Quarter</u> Corner of Section <u>5</u>, T. <u>32</u> N., R. <u>14</u> E., Langlade County, WI

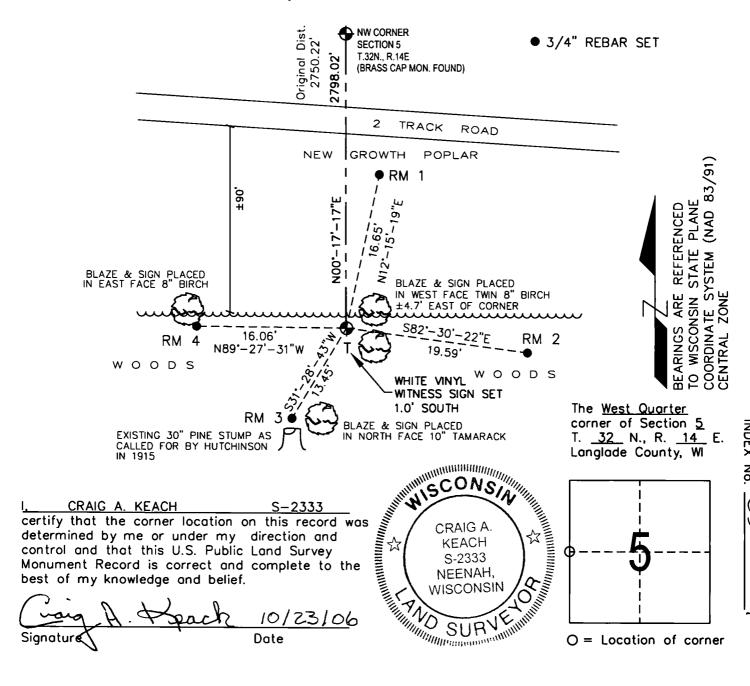
I set a 2" X 30" Iron Pipe with Brass Cap at corner.

Describe the accessories used to perpetuate the location of the corner. Include a plan view drawing and indicate accessories found/set. Describe measuring point on bearing trees. Show any topographic features that would aid in future recovery of the corner.

In 1915 Malcom Hutchinson described the corner and placed a 1-1/2" Iron Pipe at the location. He references a new 30" Pine stump at S24'W 20-1/2 Links. I recovered the 1-1/2" Iron Pipe and found the 30" Pine stump as called for. I accepted this location and replaced the Iron Pipe with a 2"X30" Iron Pipe and Brass Cap
