# U. S. PUBLIC LAND SURVEY MONUMENT RECORD

The Southwest corner of Section 2, Township 33 North, Range 9 East, Langlade County, Wisconsin.

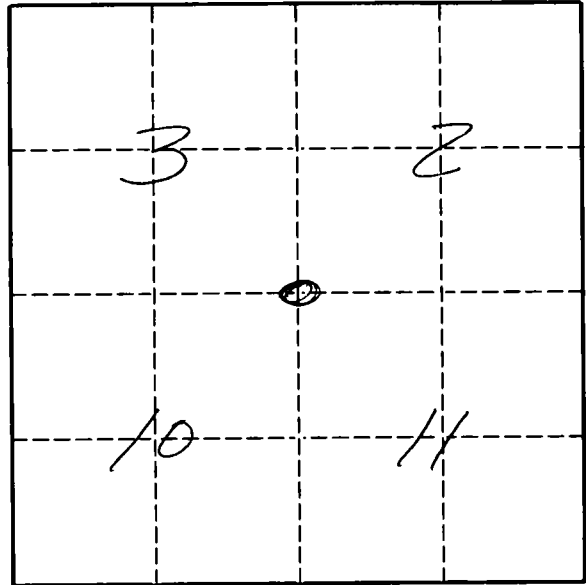
T. 33 N., R. 9 E.

- (a) Identify the corner by reference to the U.S. public land survey system.  
 O = Corner monument restored.

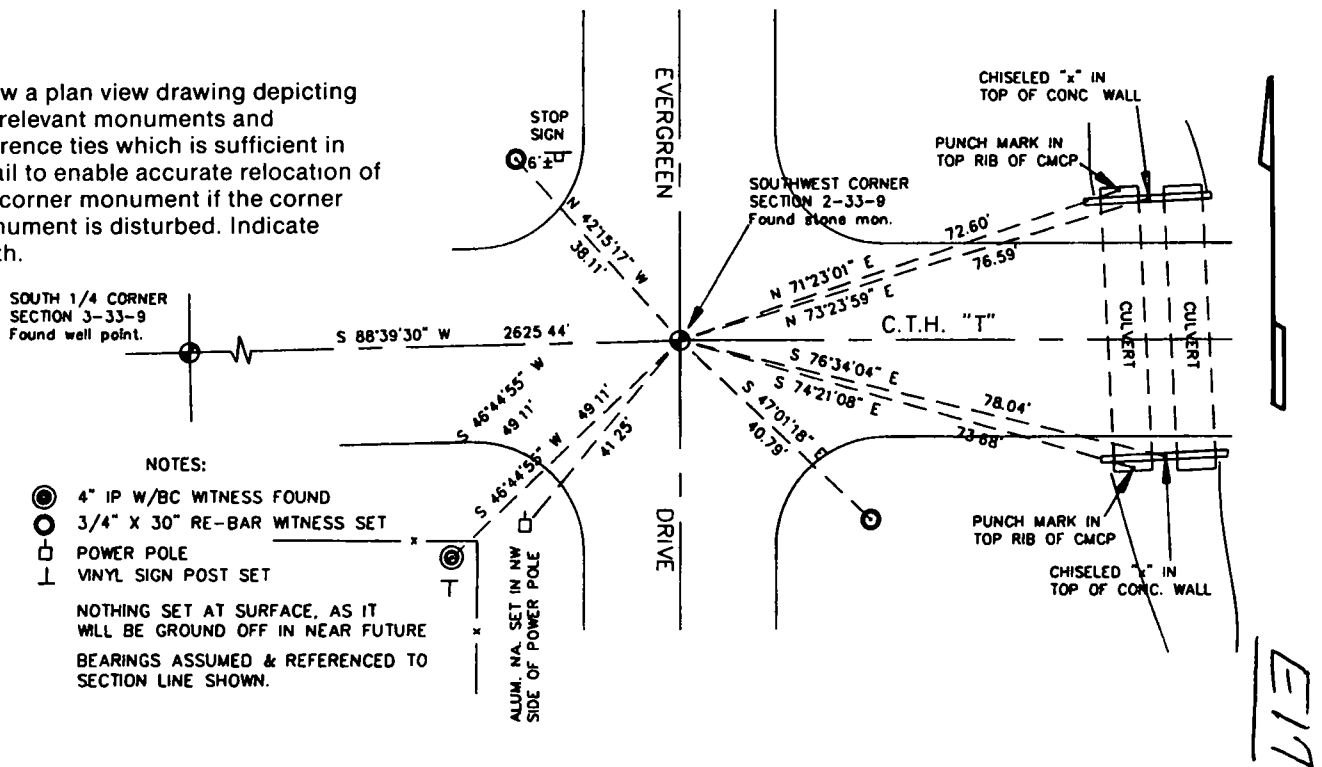
E17

- (c) In the plan view drawing below, provide reference ties to at least 4 witness monuments, or, if the location is within a municipality, to at least 2 witness monuments. (Witness monuments shall be made of concrete, natural stone, iron or other equally durable material.)  
 Describe witness monuments. FB7-13

- (d) Show a plan view drawing depicting the relevant monuments and reference ties which is sufficient in detail to enable accurate relocation of the corner monument if the corner monument is disturbed. Indicate north.

Stone found 2.5' below road surface. Accepted stone found as the best evidence of the original corner location. Replaced it with a 1½" x 36" iron pipe with 4" brass cap which is 2.2' below road surface.

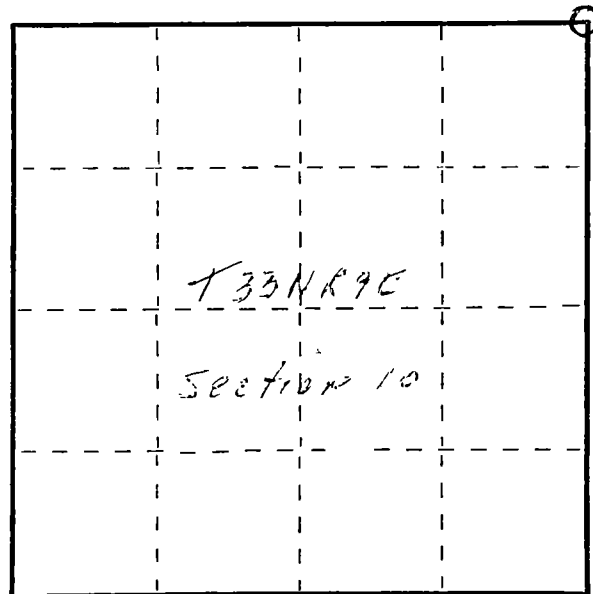
○ = Corner monument restored.
