# LANGLADE COUNTY U.S. PUBLIC LAND CORNER RESTORATION

The Southeast corner of Section 34, T. 33 N., R. 10 E., Langlade County, WI.

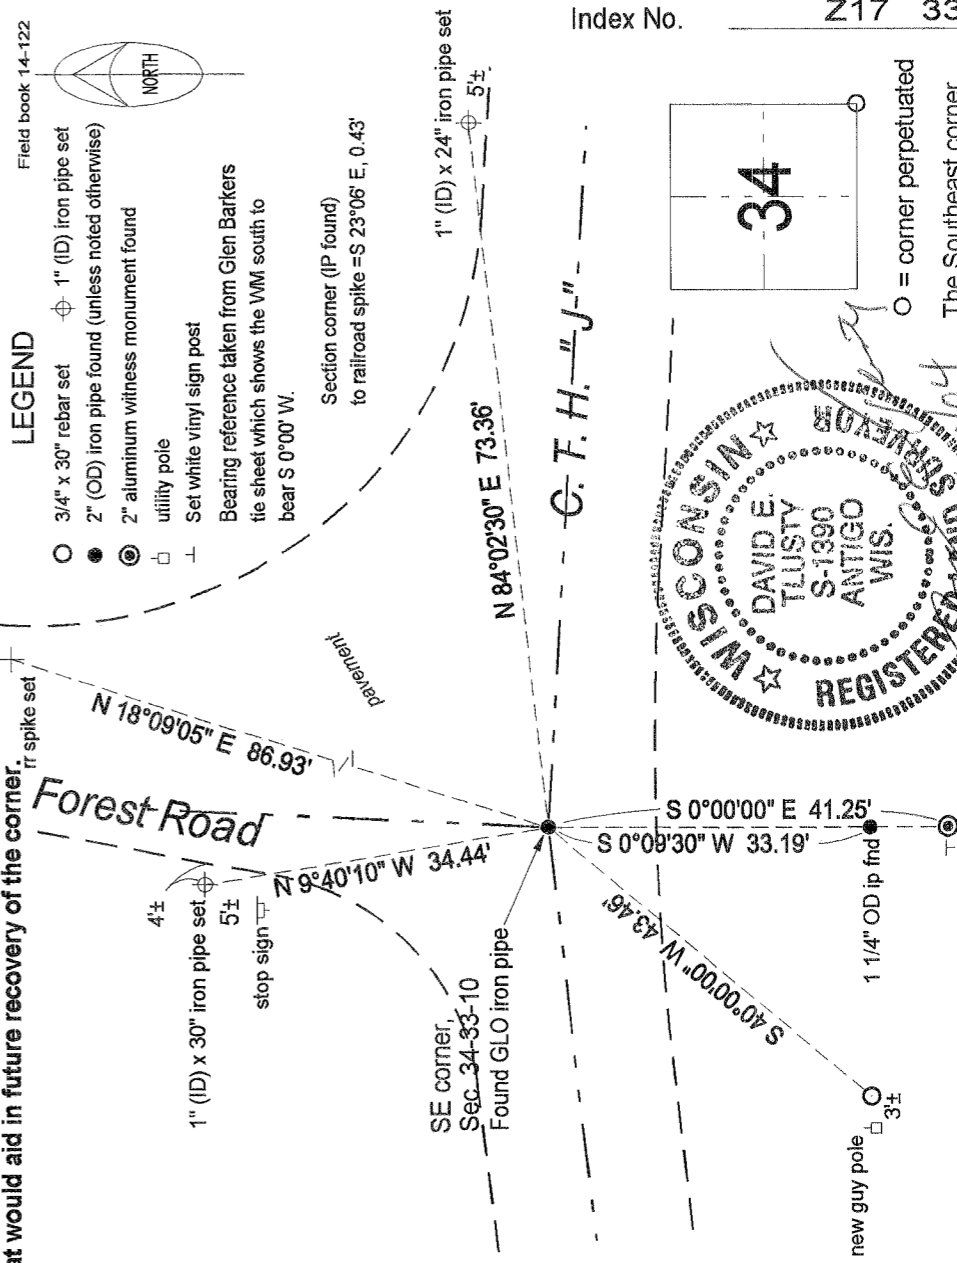
Left existing iron pipe in place. I set a Bernissen "Deep1" magnet on the east side of the wood post and on south side of the pipe found.

**Describe the accessories used to perpetuate the corner. Include a plan view drawing and accessories found/set. Describe measuring point on bearing trees. Show any topographic features that would aid in future recovery of the corner.**

The original corner was established in 1860 by Hiram C. Fellows. Original bearing trees: cedar, 7", N43°W, 14 links; cedar, 12", N65°E, 12 links; cedar, 6", S70°E, 10 links and a cedar, 6", S18°W, 16 links. In 1905, Brooks: (FB94-6) "SE cor S34.2 orig. BT's" dist right but course should be N instead of S. In 1917, Webley (FB101-71) went "north between S34 & S35" for a road survey, but didn't describe the corner. In 1931 a GLO surveyor described the corner as "marked by a post, 4 x 4 ins., set flush with surface of ground, at intersection of centerlines of County road.... Set an iron post, 3' long, 2 ins. diam., 38" in the ground for the cor. of secs 2, 3, 34 & 35, with brass cap..." In 1986, Glen Barker, found and accepted a railroad spike for the corner, and set several ties. 06/21/04 D. Tlusty pulled the existing railroad spike. Got good reading with metal detector. Dug with backhoe. At 2.4' down, found 4" x 4" wood post. At 2.6' down and on NE side of the wood post, found a 2" OD iron pipe, upright and in good condition. Lying on the east side of the found pipe is a 7" portion of the same pipe. There is no brass cap to be found. The pipe is obviously the pipe set by the GLO to mark the corner and I accept it as the best evidence of the original corner location.
