LANGLADE COUNTY U.S. PUBLIC LAND CORNER RESTORATION

The South Quarter corner of Section 35, T. 33 N., R. 10 E., Langlade County, WI.

History
of the Quarter corner common to
Section 2, T32N, R10E and Section 35, T33N, R10E

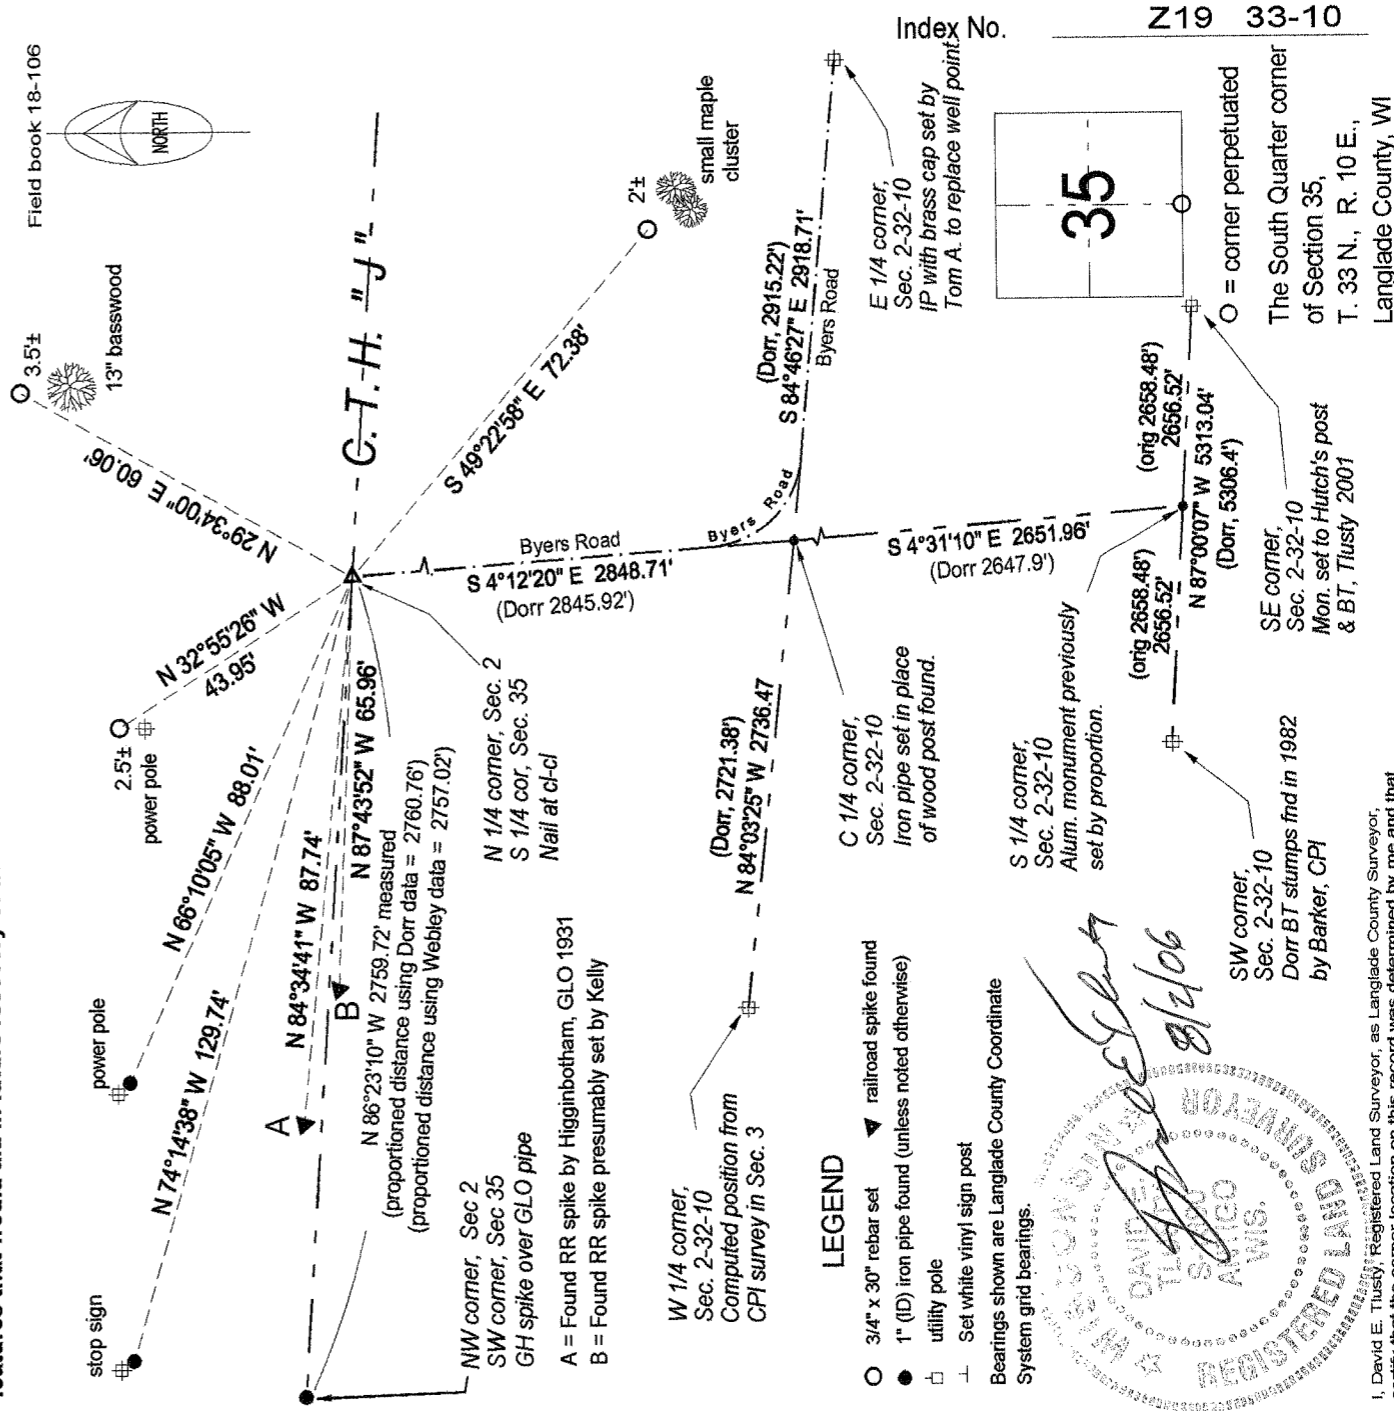
Describe the accessories used to perpetuate the corner. Include a plan view drawing and accessories found/set. Describe measuring point on bearing trees. Show any topographic features that would aid in future recovery of the corner.

- 3/4" x 30" rebar set
- 1" (ID) iron pipe found (unless noted otherwise)
- utility pole
- ⊥ Set white vinyl sign post

Bearings shown are Langlade County Coordinate System grid bearings.

○ = corner perpetuated
The South Quarter corner of Section 35, T. 33 N., R. 10 E., Langlade County, WI

SE corner, Sec. 2-32-10 Mon. set to Hutch's post & BT, Tlusty 2001

SW corner, Sec. 2-32-10 Dorr BT stumps fnd in 1982 by Barker, CPI

E 1/4 corner, Sec. 2-32-10
IP with brass cap set by Tom A. to replace well point

(orig 2658.48')
2656.52'
N 87° 00' 07" W 5313.04'
(Dorr, 5306.4')

S 4° 31' 10" E 2651.98'
(Dorr 2647.9')

C 1/4 corner, Sec. 2-32-10
Iron pipe set in place of wood post found.

(Dorr, 2721.38')
N 84° 03' 25" W 2736.47'

N 1/4 corner, Sec. 2
S 1/4 cor, Sec. 35
Nail at cl-cl

NW corner, Sec 2
SW corner, Sec 35
GH spike over GLO pipe

Corner is currently marked with PK nail at CLCL. Road construction in July-Aug 2006 will remove nail.

02/02/2006 D. Thusty after several years of research, field work and analysis of the conflicting monuments in this area, I accept the intersection of the centerlines of CTH "J" and Byers Road as the best evidence of the quarter corner location as established by B. F. Dorr in 1908. Dorr used proper procedures to establish this "lost" corner and the corners he used for proportioning (section corner and MC on west side of Long Lake) both had good evidence of the original government survey bearing trees as noted by Webley only 6 years earlier. This position is in agreement with Dorr's work in Section 2 as shown by the comparative measurements on my tie sketch. This position is 87.74 feet from the Hutchinson location as shown on the tie sketch. I can only assume that Hutchinson, who I generally consider to have been a very good surveyor, may not have been aware of the previous work by Webley and Dorr and he apparently missed any remaining evidence of the MC on the west side of Long Lake.
