LANGLADE COUNTY U.S. PUBLIC LAND CORNER RESTORATION

The Southeast corner of Section 9, T. 34 N., R. 10 E., Langlade County, WI.

4341009 0000 2007

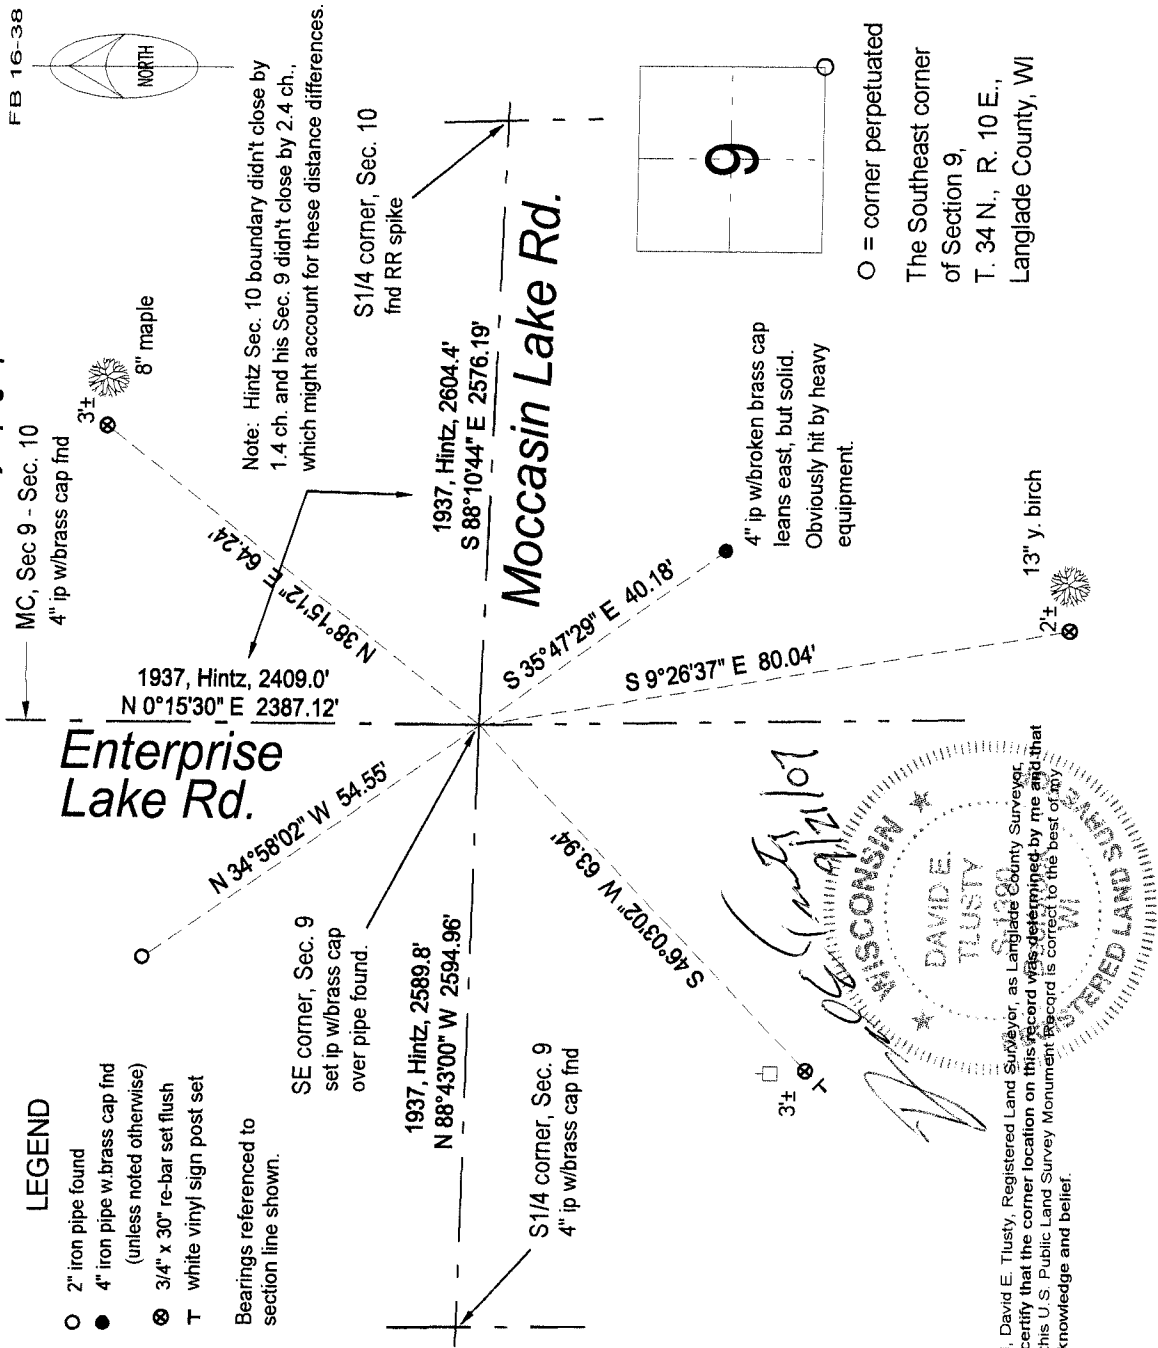
For the corner, I topped the found iron pipe with a 1 1/2" x 19" iron pipe with 4" brass cap flush with road. The corner is approx. 13 feet north of the center of pavement on Moccasin Lake Rd. and approx. 3 feet east of the center of pavement of Enterprise Lake Rd.

Describe the accessories used to perpetuate the corner. Include a plan view drawing and accessories found/set. Describe measuring point on bearing trees. Show any topographic
