LANGLADE COUNTY U.S. PUBLIC LAND CORNER RESTORATION

The Southeast corner of Section 3, T. 34 N., R. 11 E., Langlade County, WI.

CERTIFIED LAND CORNER RESTORATION

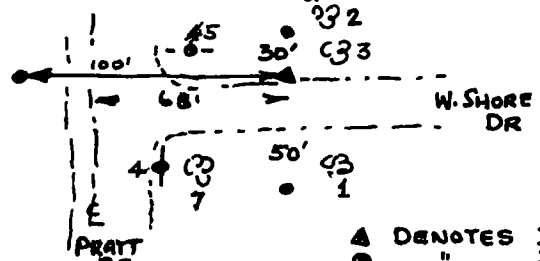
Description of monument and accessories I established to perpetuate the original location of this corner.

2" IRON PIPE } MKD WIT. CORN SET
W/BRASS CAP } WIT. COR 50.0 NORTH of COR
 } SEC 2-2 50.0 SOUTH of "
 } 10" 6 100.0 WEST " "

- 1 = OAK W/OLD BLAZE & SCRIBE 12 S25.5E 33.0'
- 2 = W/PNE " " " 20 N47E 39.6'
- 3 = OAK 18-18 N50E 21.6 BLAZED & SCRIBED NBT.
- 4 = POWER POLE 933 1/2 W 67.4'
- 5 = STREET NAME POST N70W 48.6'
- 6 = HEMLOCK 12 N41 1/4 E 41.0' BLAZED & SCRIBED NBT
- 7 = TRIPLE OAK (MOST NLY) S34 1/2 W 43.3' BLAZED & SCRIBED NBT

○ = Corner monument restored.
