LANGLADE COUNTY U.S. PUBLIC LAND CORNER RESTORATION

The East 1/4 corner of Section 11, T. 34 N., R. 11 E., Langlade County, WI.

U. S. PUBLIC LAND SURVEY MONUMENT RECORD

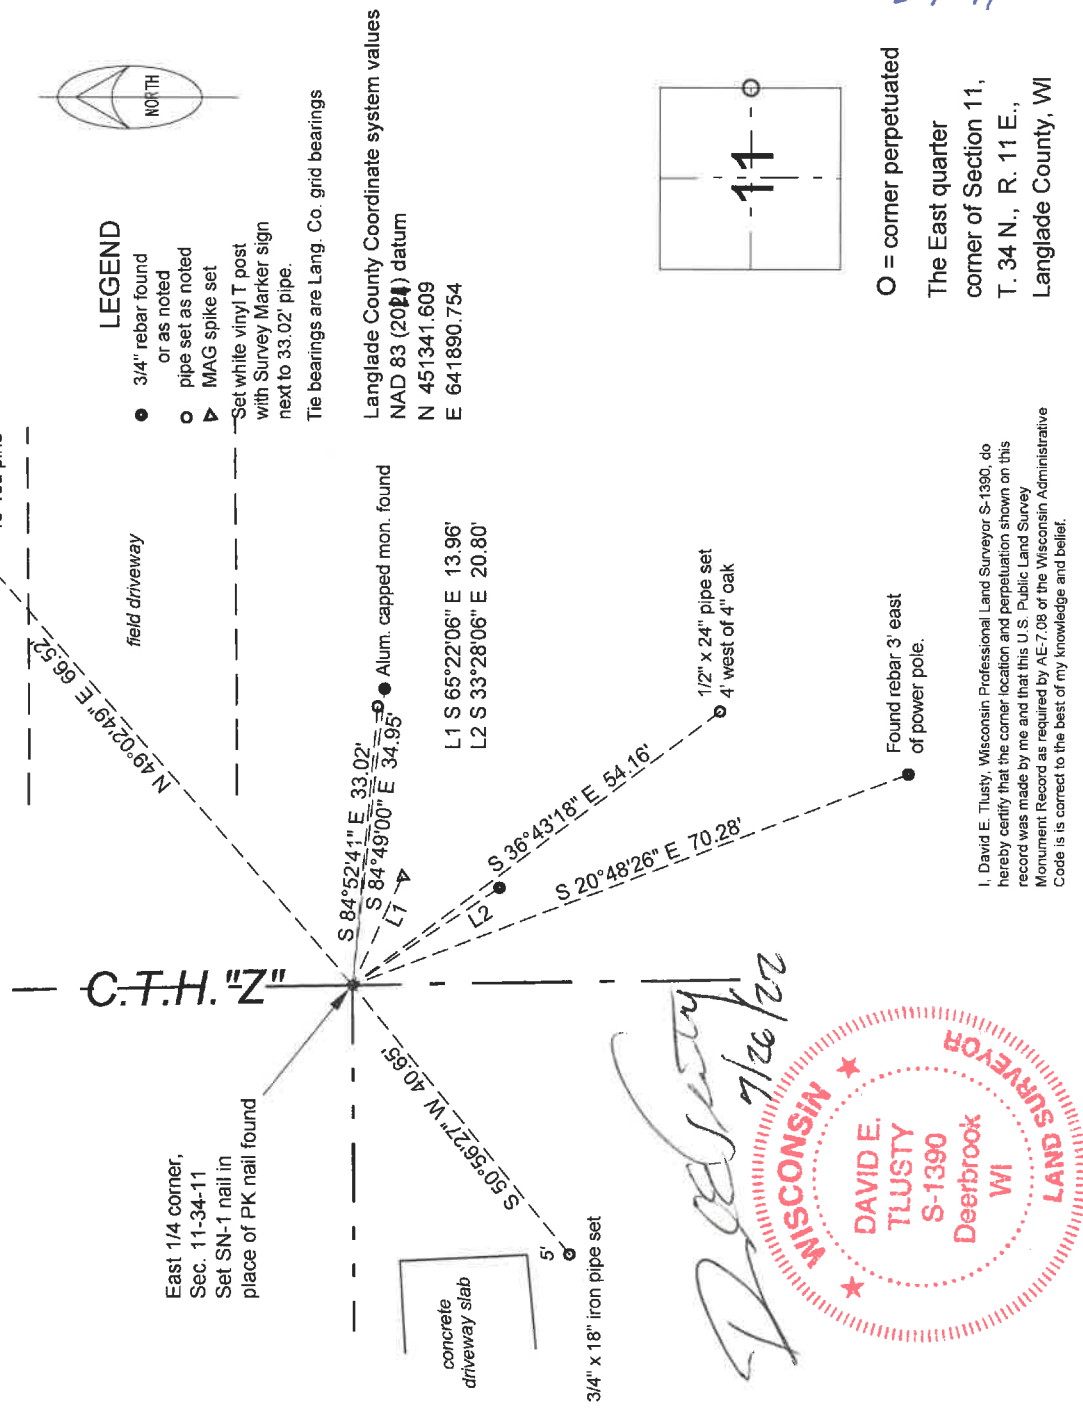
Describe the accessories used to perpetuate the corner. Include a plan view drawing and accessories found/set. Describe measuring point on bearing trees. Show any topographic features that would aid in future recovery of the corner.

- LEGEND**
- 3/4" rebar found or as noted
 - pipe set as noted
 - ▶ MAG spike set
- Set white vinyl T post with Survey Marker sign next to 33.02' pipe.
Tie bearings are Lang. Co. grid bearings

Langlade County Coordinate system values
 NAD 83 (2011) datum
 N 451341.609
 E 641890.754

O = corner perpetuated
 The East quarter
 corner of Section 11,
 T. 34 N., R. 11 E.,
 Langlade County, WI

I set a Berntsen SN-1 nail in place of PK nail found.

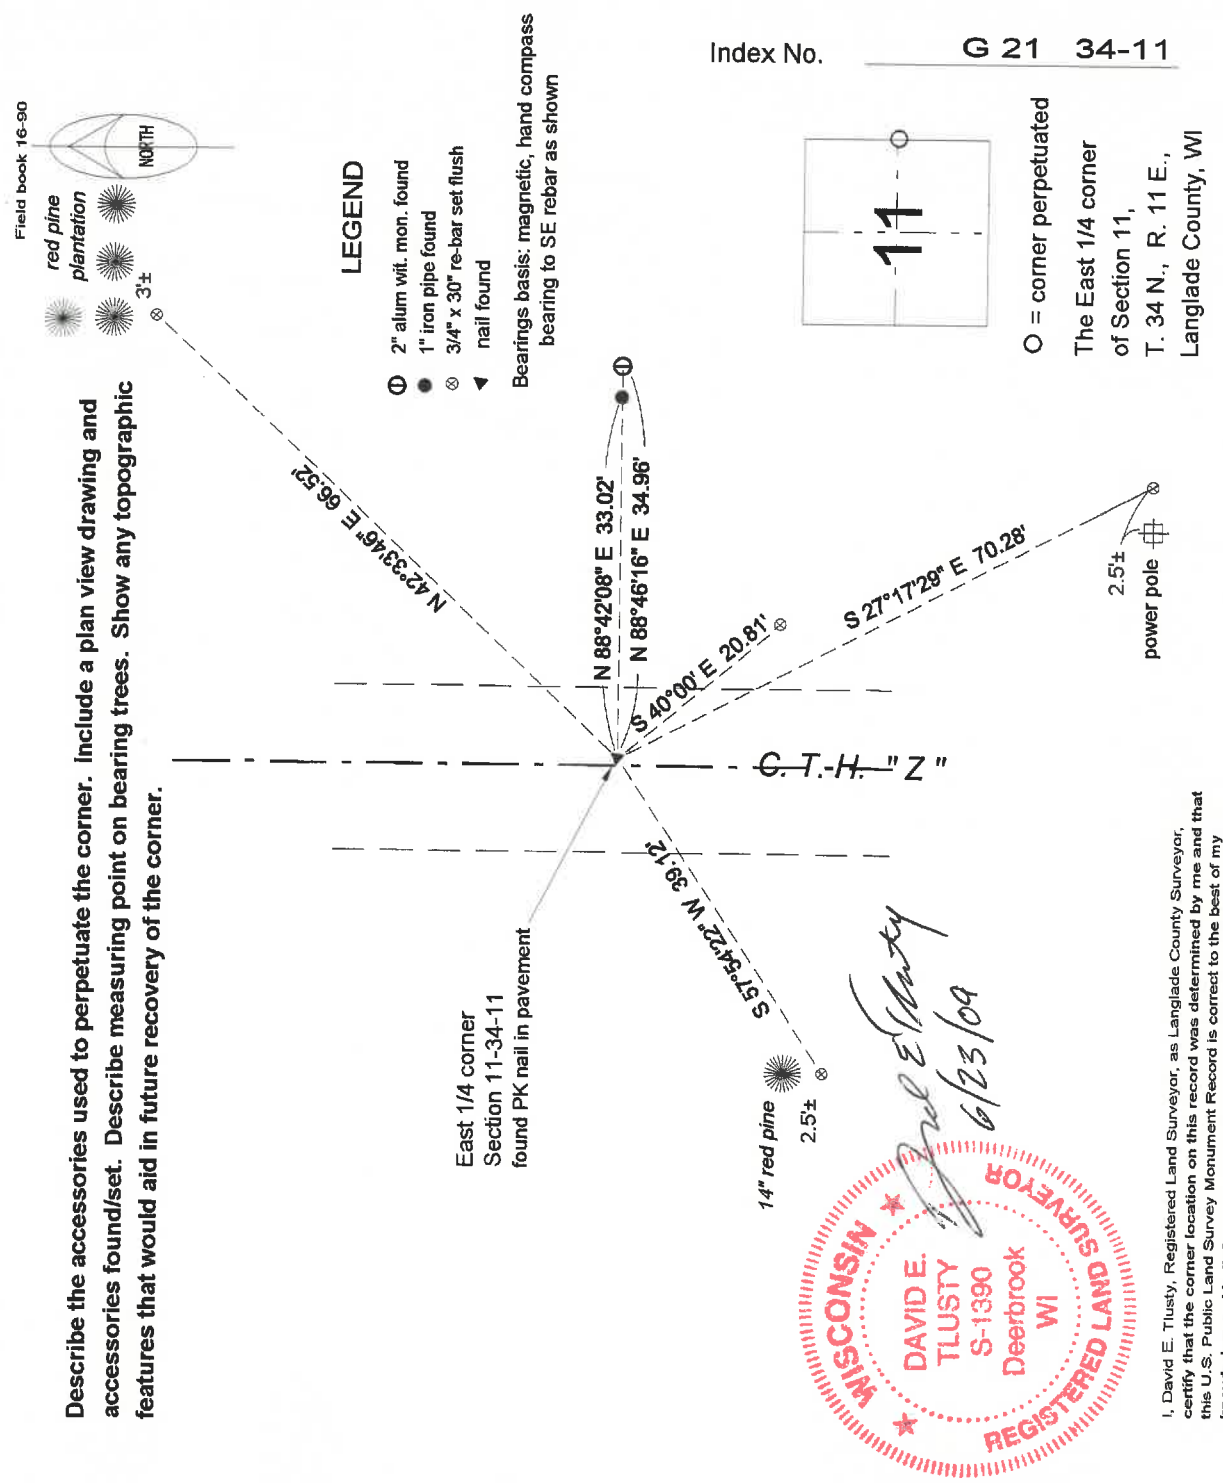
Describe the accessories used to perpetuate the corner. Include a plan view drawing and accessories found/set. Describe measuring point on bearing trees. Show any topographic features that would aid in future recovery of the corner.

○ = corner perpetuated
The East 1/4 corner of Section 11, T. 34 N., R. 11 E., Langlade County, WI

The original corner was established in 1859 by William E. Daugherty. Original bearing trees: yellow pine, 10", S87E, 28 links and a black pine, 10", S63W, 33 links. In 1914, Hutchinson (FB122-63) ran: "N bet 11 & 12. 41.94 1/4 post. Stone by Brooks. Stump OK. orig. BT marked some 20 years ago Y. pine, 12", S23W, 100.5 lks". In 1917, Hutchinson (FB122-28): from this corner to North measured 38.33 ch. In 1990, former surveyor Kelly: "I found R/R spike under blacktip surface. Set P. K. nail over R/R spike & set 3" al. witness monument East 35 ft." 07/14/08 D. Tlusty found PK in pavement, approx. 3' east of N-S centerline CTH "Z". Measured 64.41 to PK in power pole SE (Kelly had 64.45') and 35.0' to Alum. mon. east. Added ties as show below.

For the corner, I left the existing PK nail in place. Road is to be paved in the very near future.

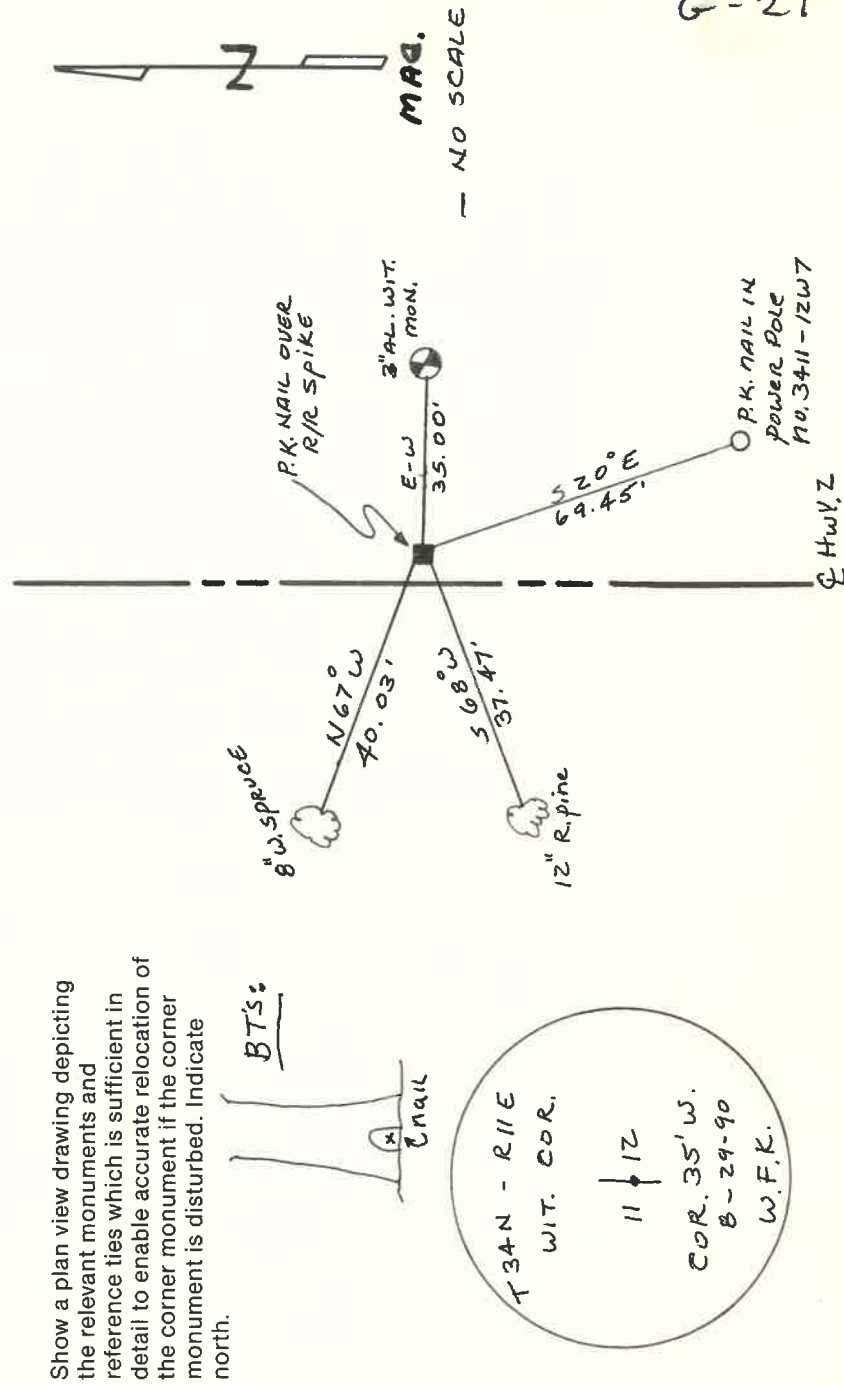
O = Corner monument restored.

- (c) In the plan view drawing below, provide reference ties to at least 4 witness monuments, or, if the location is within a municipality, to at least 2 witness monuments. (Witness monuments shall be made of concrete, natural stone, iron or other equally durable material.) Describe witness monuments.

AUGUST 29, 1990; I FOUND R/R SPIKE UNDER BLACK TOP SURFACE. SET P.K. NAIL OVER R/R SPIKE & SET 3" AL. WITNESS MONUMENT EAST 35 FT.
