# U. S. PUBLIC LAND SURVEY MONUMENT RECORD

Quarter corner to Sections 31 and 6, T.33-34N., R.14E.

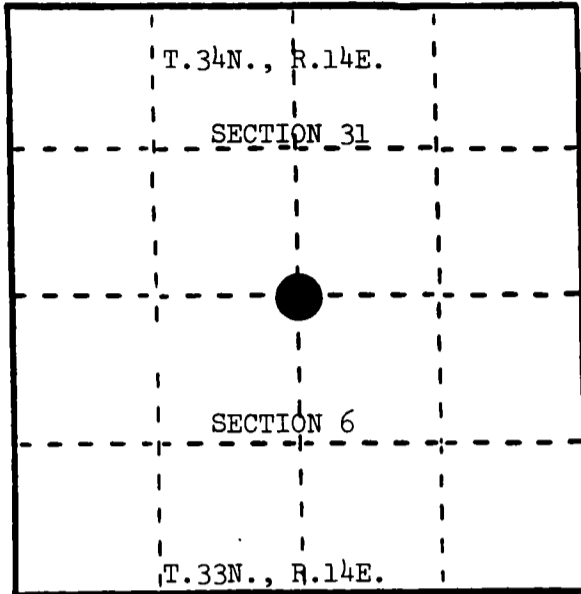
○ = Corner monument restored.

(d) Show a plan view drawing depicting the relevant monuments and reference ties which is sufficient in detail to enable accurate relocation of the corner monument if the corner monument is disturbed. Indicate north.

1. Sugar, 10", N.37°E., 48.39 feet
2. Basswood, 6", S.6°E., 13.84 feet
3. Sugar, 7", N.18°W., 35.18 feet
4. Steel Sign Post, East, 2.30 feet
5. Squared Wood Post, East, 10.00 feet
6. 2" x 36" aluminum monument stamped to identify the corner.

Squared wood post of unknown origin appears to be at proportional position between township corner and Kimberly Clark corner to Sections 31, 32, 5, and 6, which was erroneously positioned.
