CERTIFIED LAND CORNER RESTORATION

Index No. G-25
30-11

I WESLEY J. TRADEWELL, do hereby certify that on the 17TH day of MAY, 19 79, I found evidence of the WEST 1/4 corner of SECTION 7 Township 30, North, Range 12 EAST., Fourth Principal Meridian, as described hereon; and that from this evidence I established a new monument and accessories as described hereon to perpetuate the original location of this corner.

EAST QUARTER CORNER
SECTION 12, T. 30 N., R. 11 E.

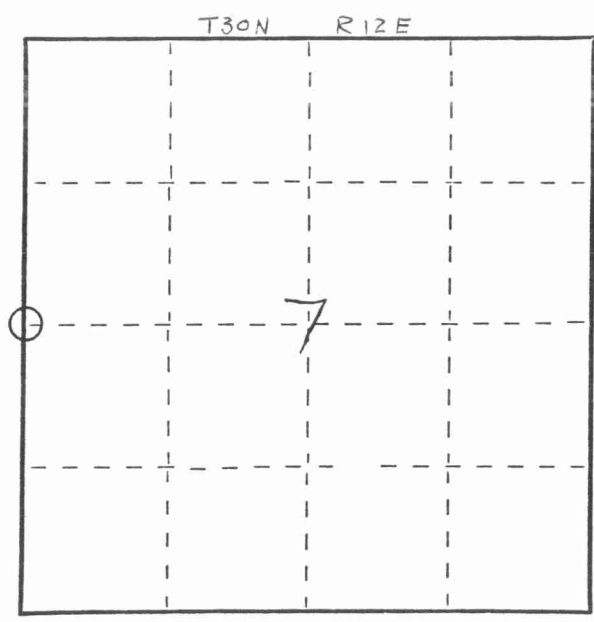
○ = Corner monument restored.

CORNER OBLITERATED. SET 3/4" x 24" IRON ROD AT THE INTERSECTION OF THE CENTERLINE OF N. ROLLWOOD RD. AND OLD FENCE TO THE WEST. CHECKED DISTANCE TO CORNERS TO THE NORTH AND SOUTH.

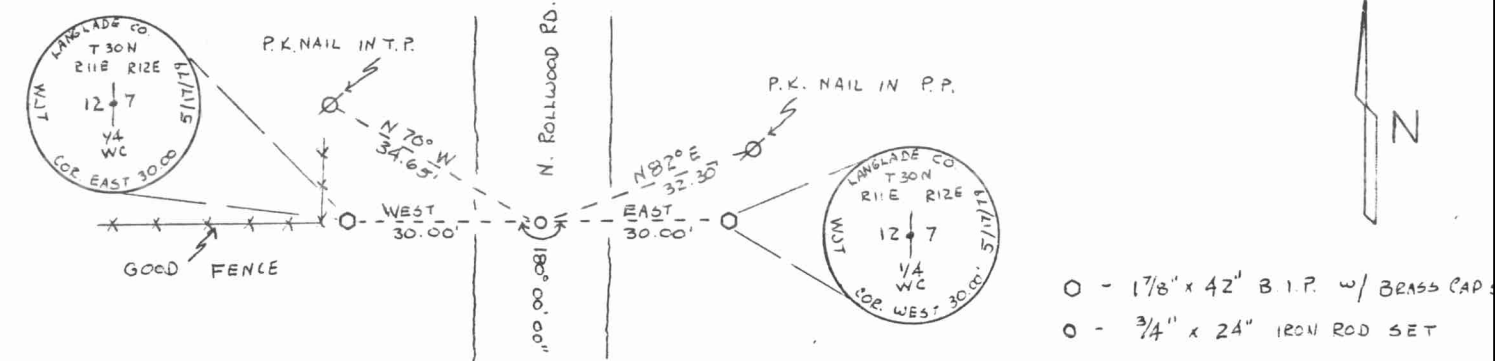
Description of monument and accessories I established to perpetuate the original location of this corner.

- - 1 7/8" x 42" B.I.P. w/ BRASS CAP.
- - 3/4" x 24" IRON ROD SET
